**GEOLOGICAL SURVEY OF CANADA
MISCELLANEOUS REPORT 56**

The Lemieux landslide of June 20, 1993, South Nation Valley, southeastern Ontario - a photographic record

G.R. Brooks, J.M. Aylsworth, S.G. Evans, and D.E. Lawrence

1994

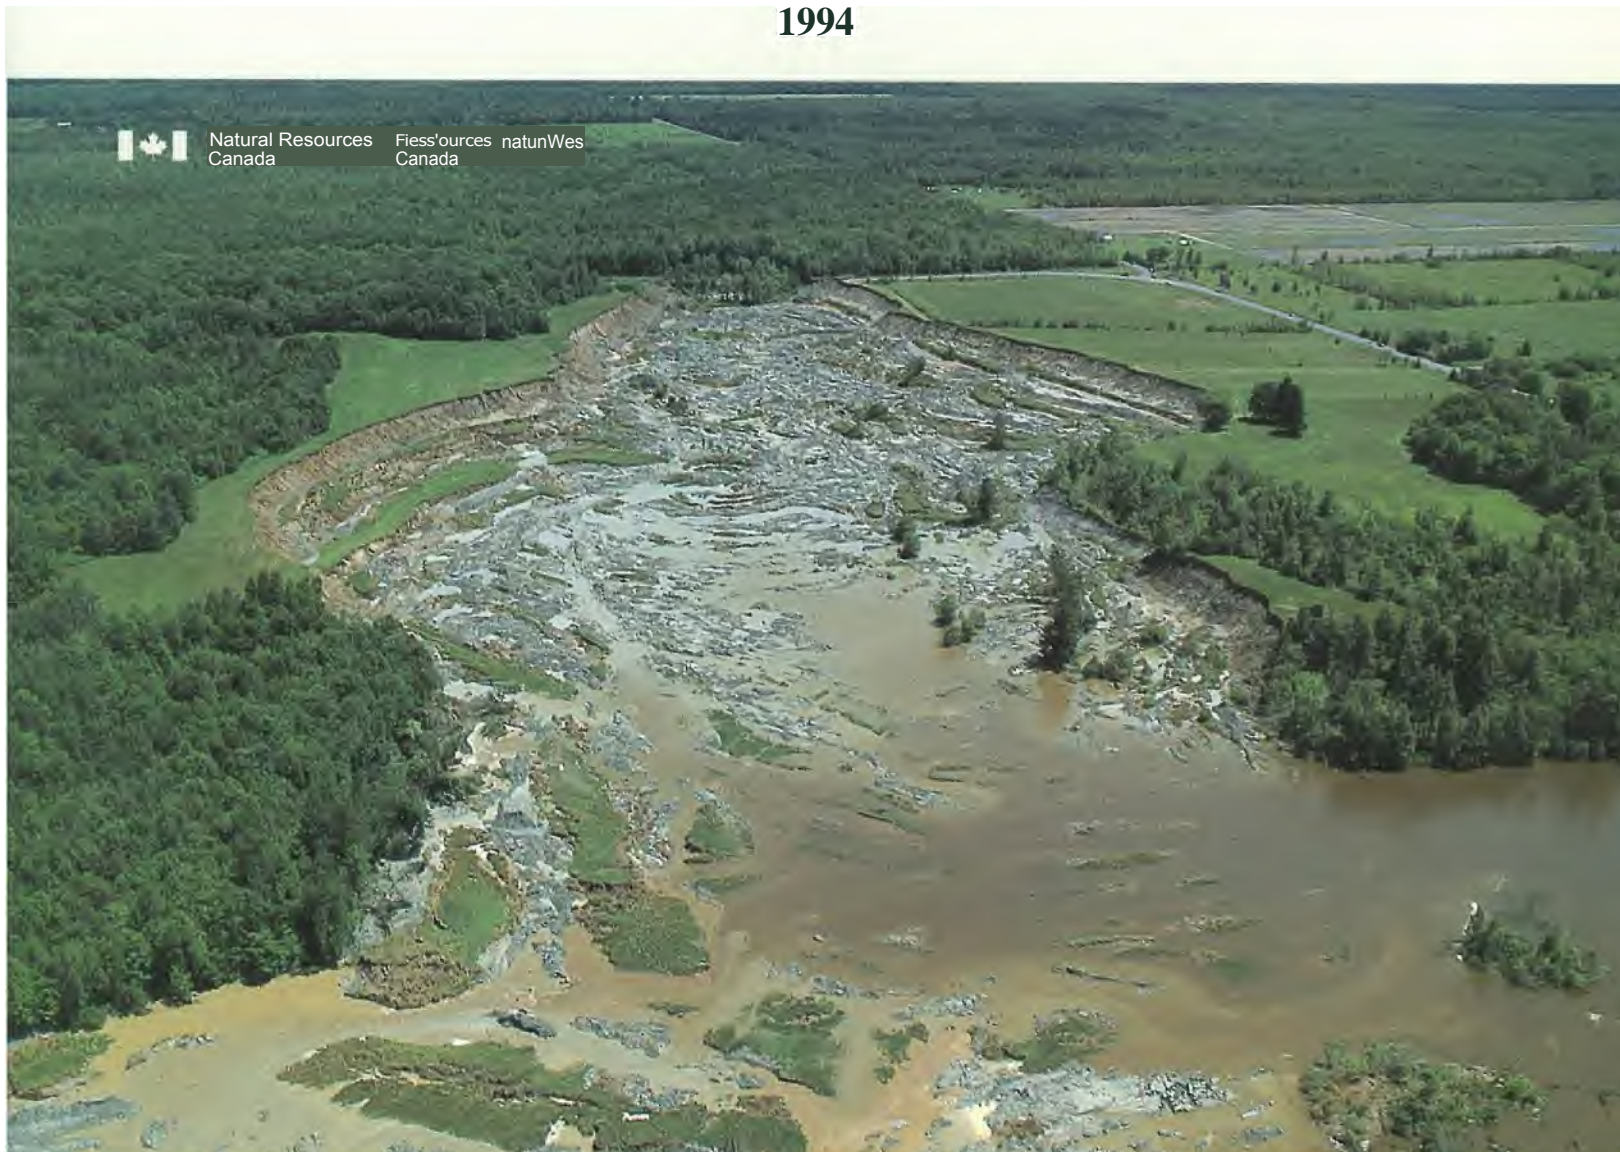
Lemieux landslide of June 20, 1993. This sensitive clay flow occurred near the former townsite of Lemieux, Ontario. The failure involved 2.5 to 3.5 Mm³ of sand, silt, and clay which flowed into the South Nation River valley, inundating 3.3 km of the valley bottom and impounding the South Nation River. GSC 1993-296

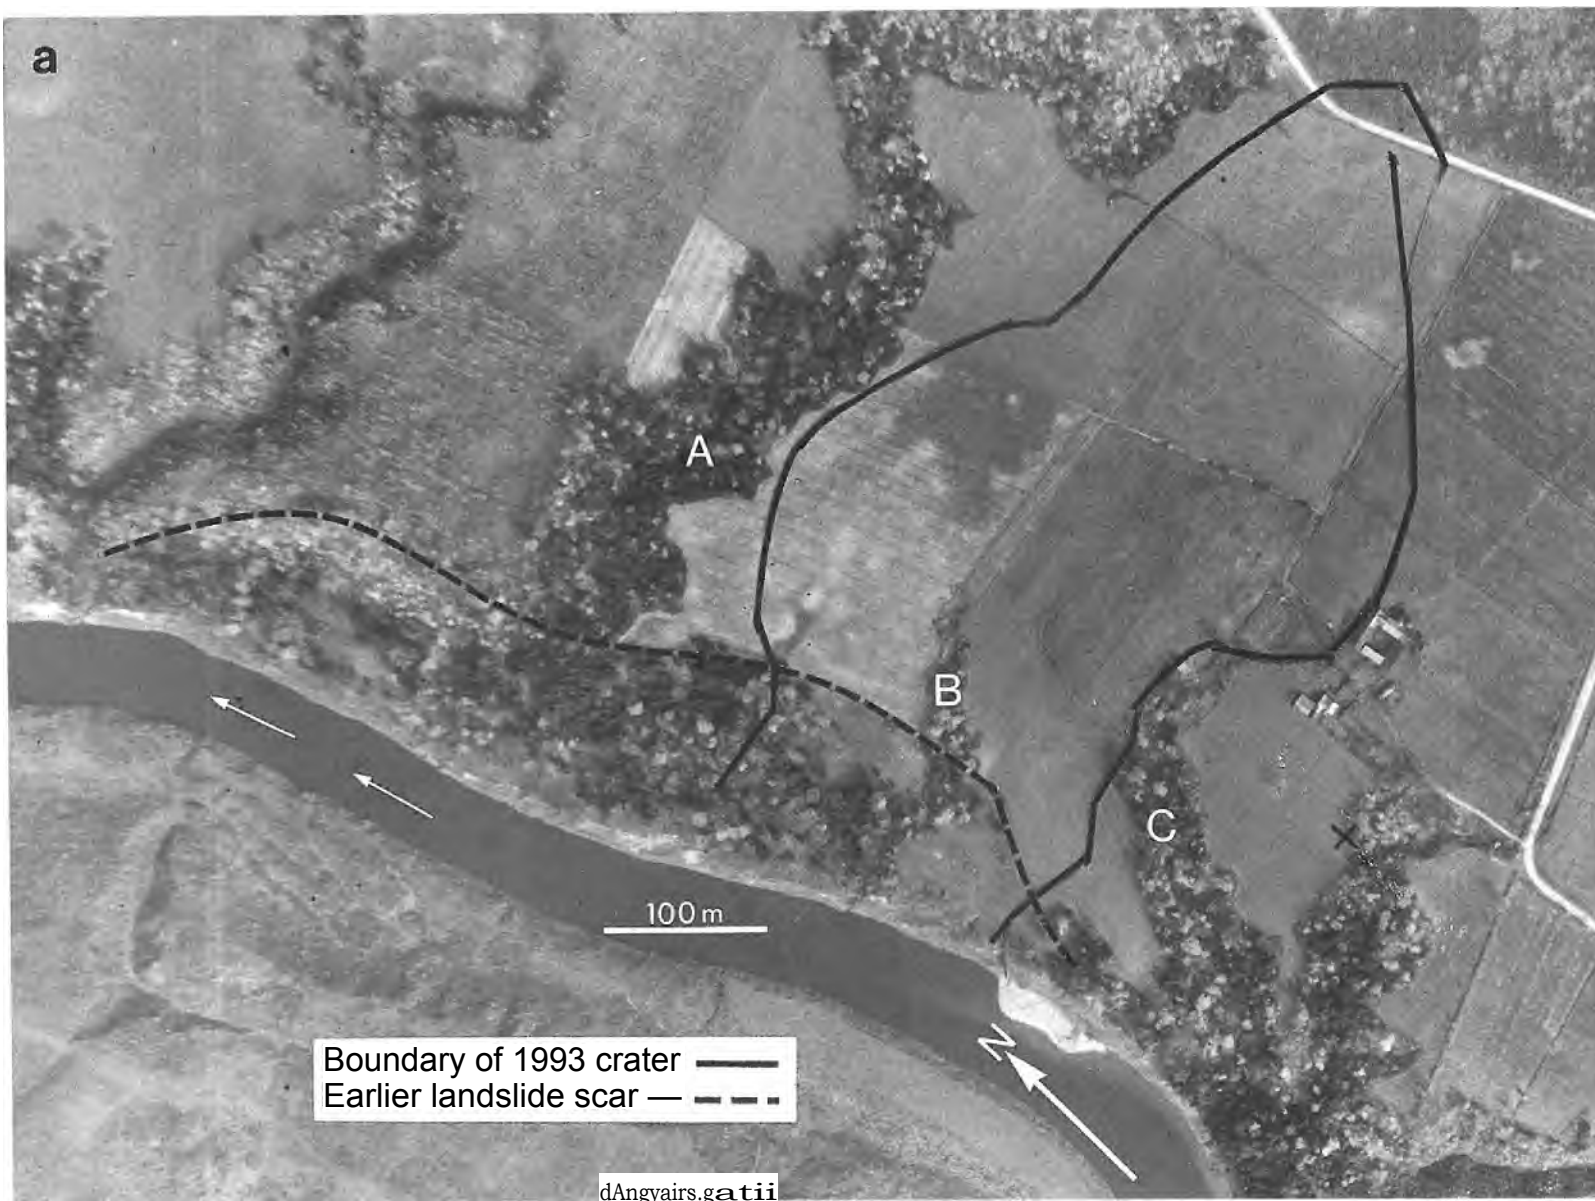
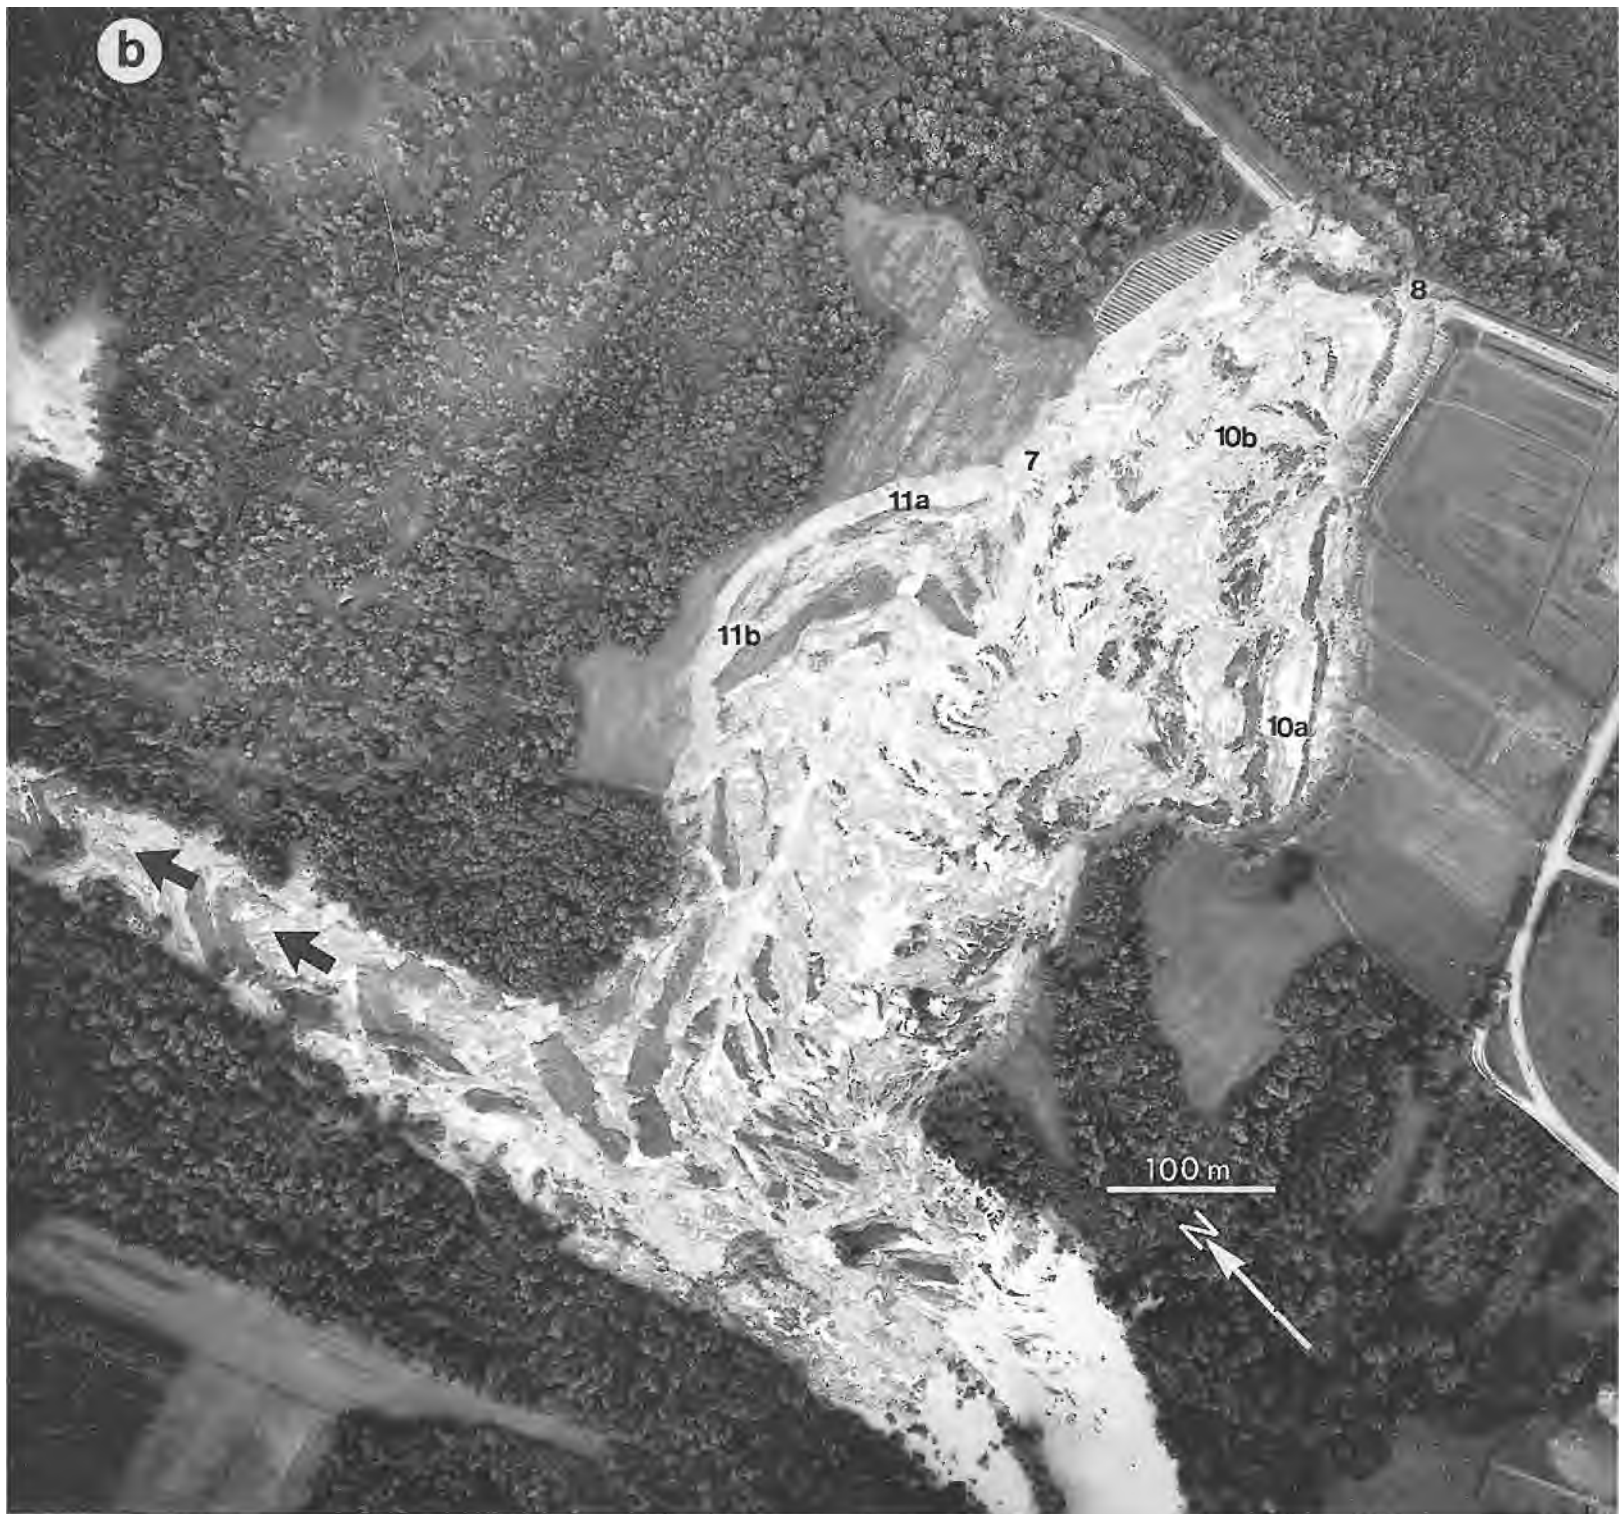
Figure 2. Aerial photographs of the Lemieux site **a)** pre-slide (November 21, 1945; NAPL A9615-91) and **b)** post-slide (June 22, 1993 ; CAS 93049-13). This site is along a straight section of South Nation Valley just downstream of the outer bank of a bend (Fig. 1). The 1993 landslide occurred at the site of an earlier retrogressive slide scar; a dashed line delineates the backwall of the earlier scar. This scar forms a terrace along the valley side about 15 m above the pre-slide river channel. Most of the failed area was abandoned farmland with some mixed forest. The failure occurred between two gullies extending eastward from the valley side (A and C). A smaller gully (**B**) located between these gullies was obliterated by the landslide. The extent of the failure seems to have been restricted by the presence of gully C since the crater roughly follows the upper edge of the gully then begins to curve around behind it (Fig. 2b). The presence of this gully probably allowed sufficient drainage of the immediate area to prevent failure. Note the river bar that coincides approximately with the upstream lip of the crater mouth; it appears on maps and aerial photographs of the site beginning at least in the 1940s.

Photo b) was taken two days after the landslide and before the impounded river had overtopped the spoil in South Nation Valley. The landslide crater is 680 m long and up to 320 m wide, covering 17 ha (Evans and Brooks, in press). The elongated shape is not symmetrical; outward embayments extend from both its north and south side. Numbers refer to location of Figures 7, 8, 10a, 10b, 11a, 11b.

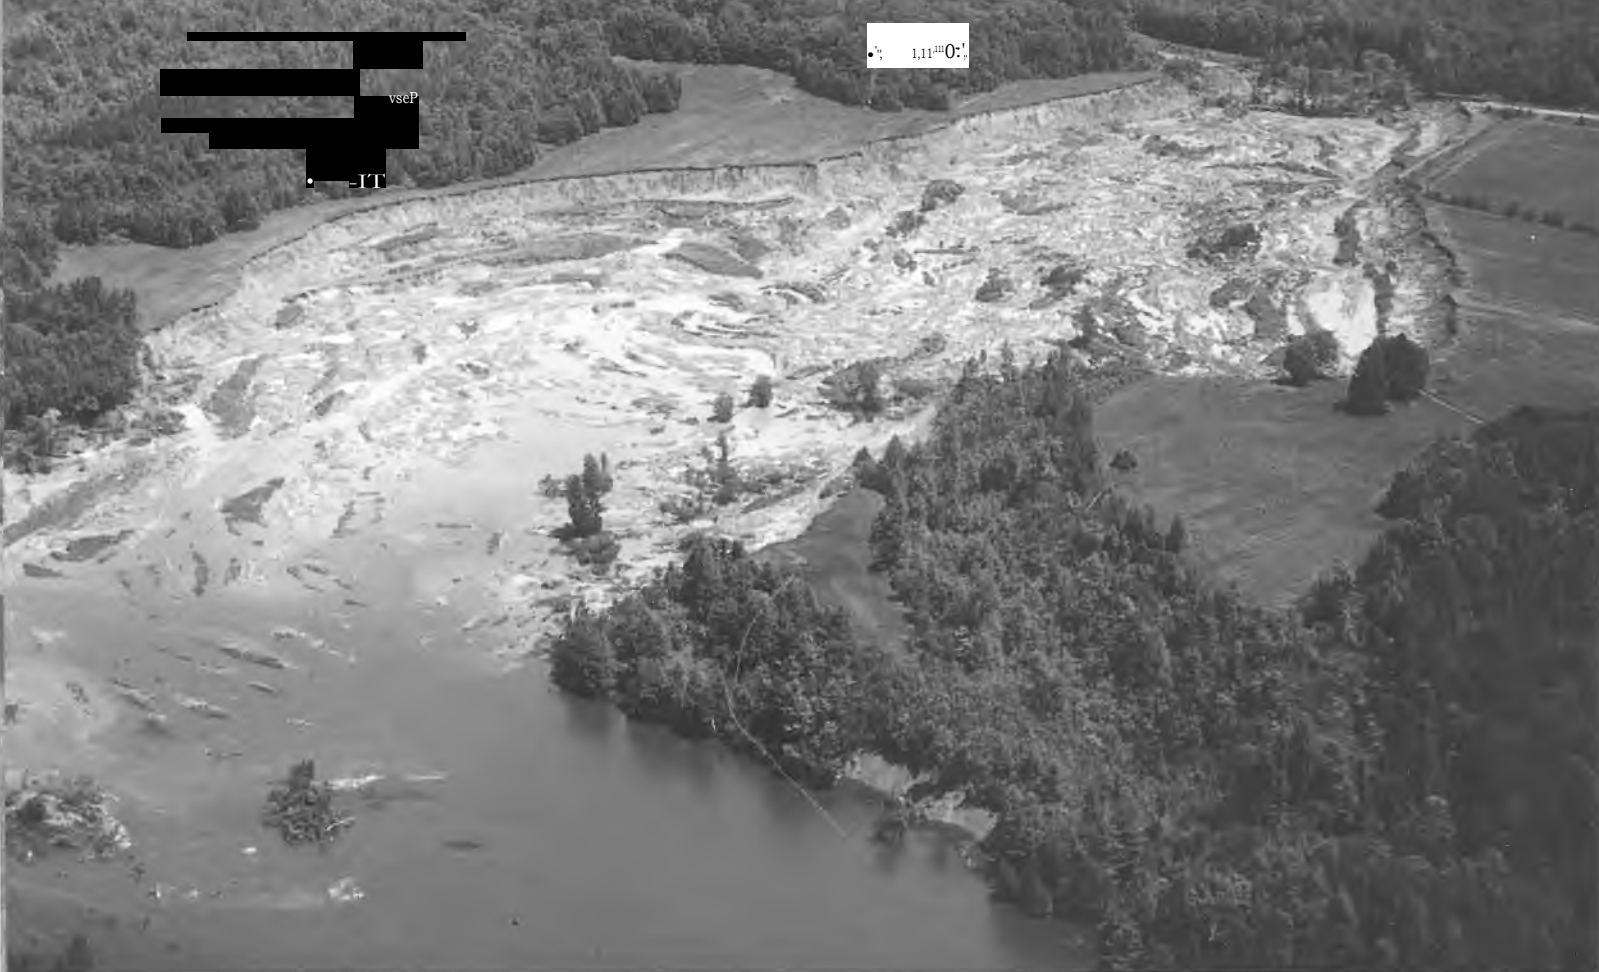
Figure 3. Aerial view of the Lemieux landslide (GSC 1993 -254F), late morning Wednesday, June 23 , 1993. The landslide involved the failure of 2.5 to 3.5 Mm³ , much of which flowed into South Nation Valley causing the impoundment of the river (foreground). The surface of the crater is up to 12 m below the Russell and Prescott sand plain and slopes gently towards South Nation Valley.

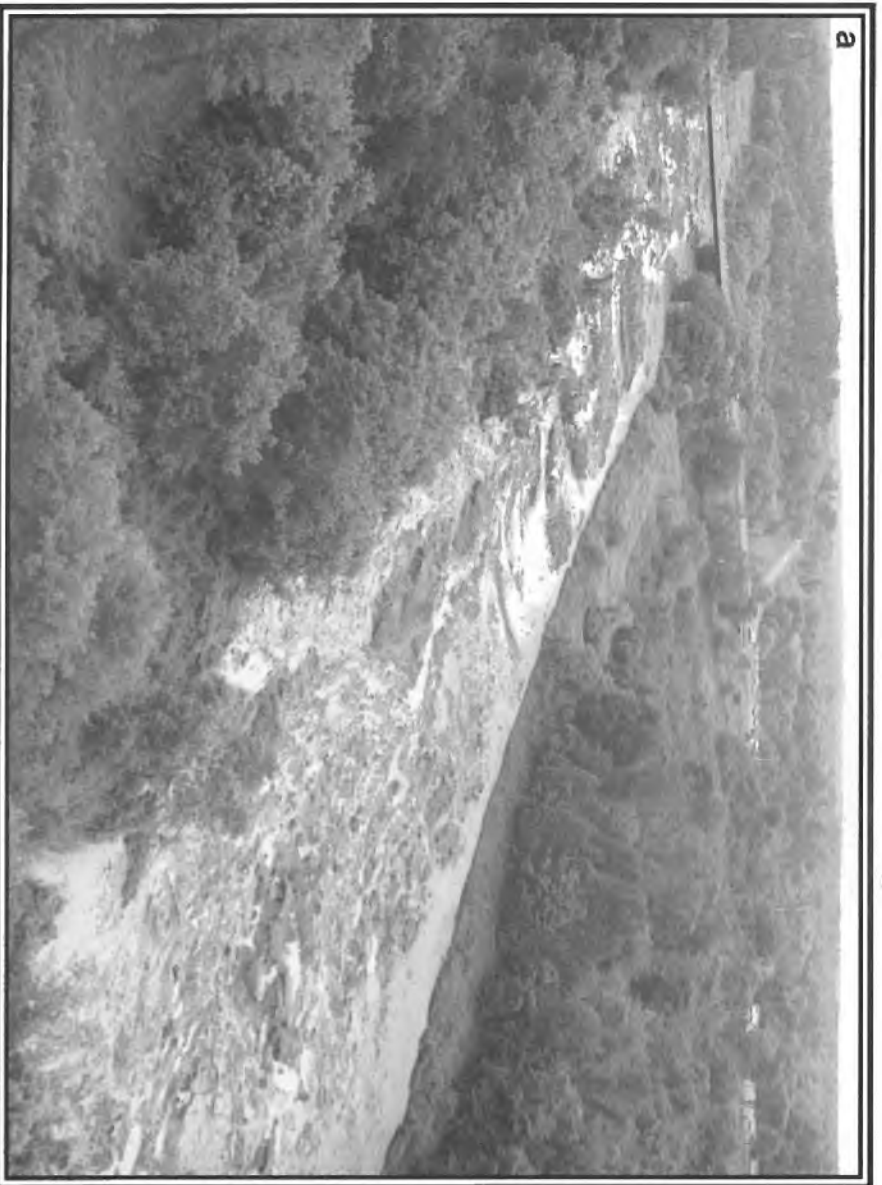
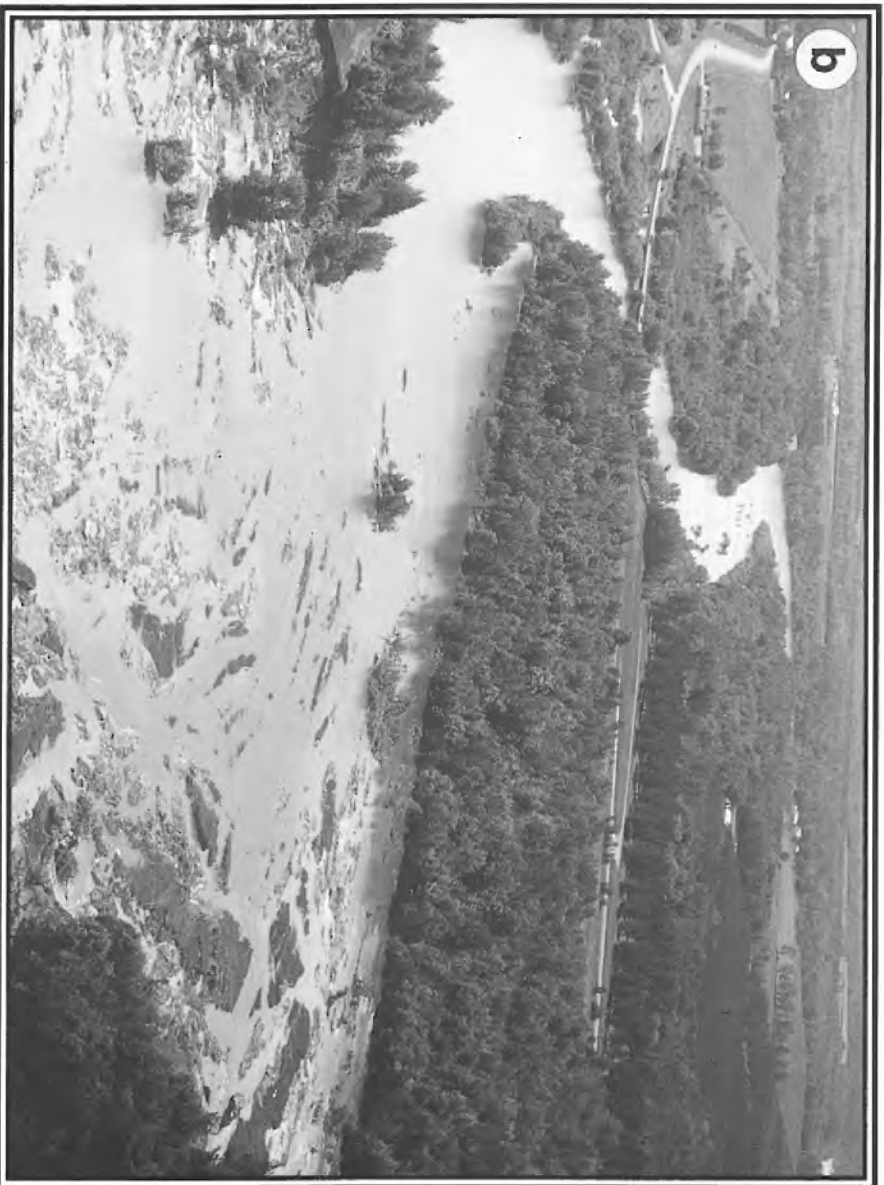
Figure 4. a) Landslide spoil, consisting of rafted blocks of relatively intact material within a matrix of liquefied clay and silt, buried the valley bottom extending about 1.6 km upstream and 1.7 km downstream of the crater mouth. This view is looking downstream towards the County Road 8 bridge which crosses South Nation River about 800 m upstream of the crater, and shows spoil which flowed upstream along the valley bottom. At the bridge, spoil filled the valley to an estimated depth of about 12 m. (photo Ottawa Citizen) **b)** The accumulation of spoil within South Nation Valley impounded the river upstream of the crater. Immediately after the landslide, river waters rose until they eventually overtopped the spoil. The impounded water reached a maximum height of about 12 m above the pre-slide valley bottom which caused flooding upstream as far as Casselman, Ontario (Fig. 1). This photograph was taken late morning Wednesday, June 23 , 1993 at approximately the maximum height of the river impoundment and is looking across the crater mouth upstream into the flooded South Nation Valley (GSC 1993-254B).

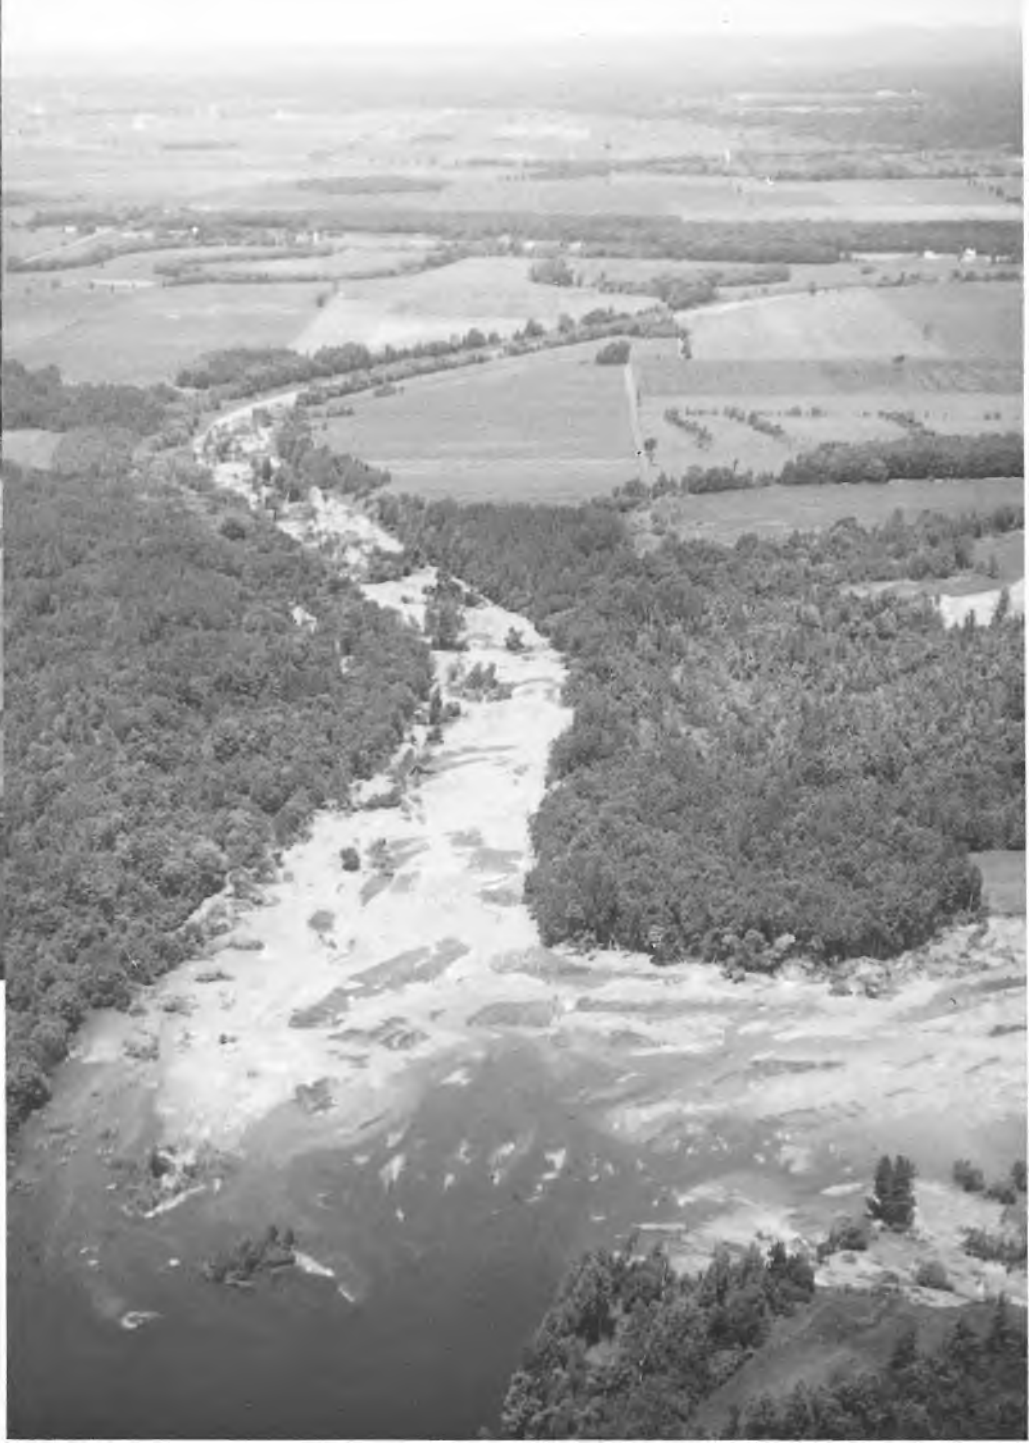
Figure 5. View downstream across the crater mouth showing the landslide spoil which travelled downstream along the valley bottom (GSC 1993-254A). It was taken late morning Wednesday, June 23, 1993, hours after the impounded river waters overtopped the landslide dam and began flowing downstream. Reflecting a rapid change in water turbidity, water colour changes from dark to light beginning at the mouth of the crater where flow starts to accelerate across the crest of the landslide dam causing erosion and entrainment of the spoil. High levels of water turbidity adversely affected water quality to farms and communities downstream for several days after the river flow was restored.

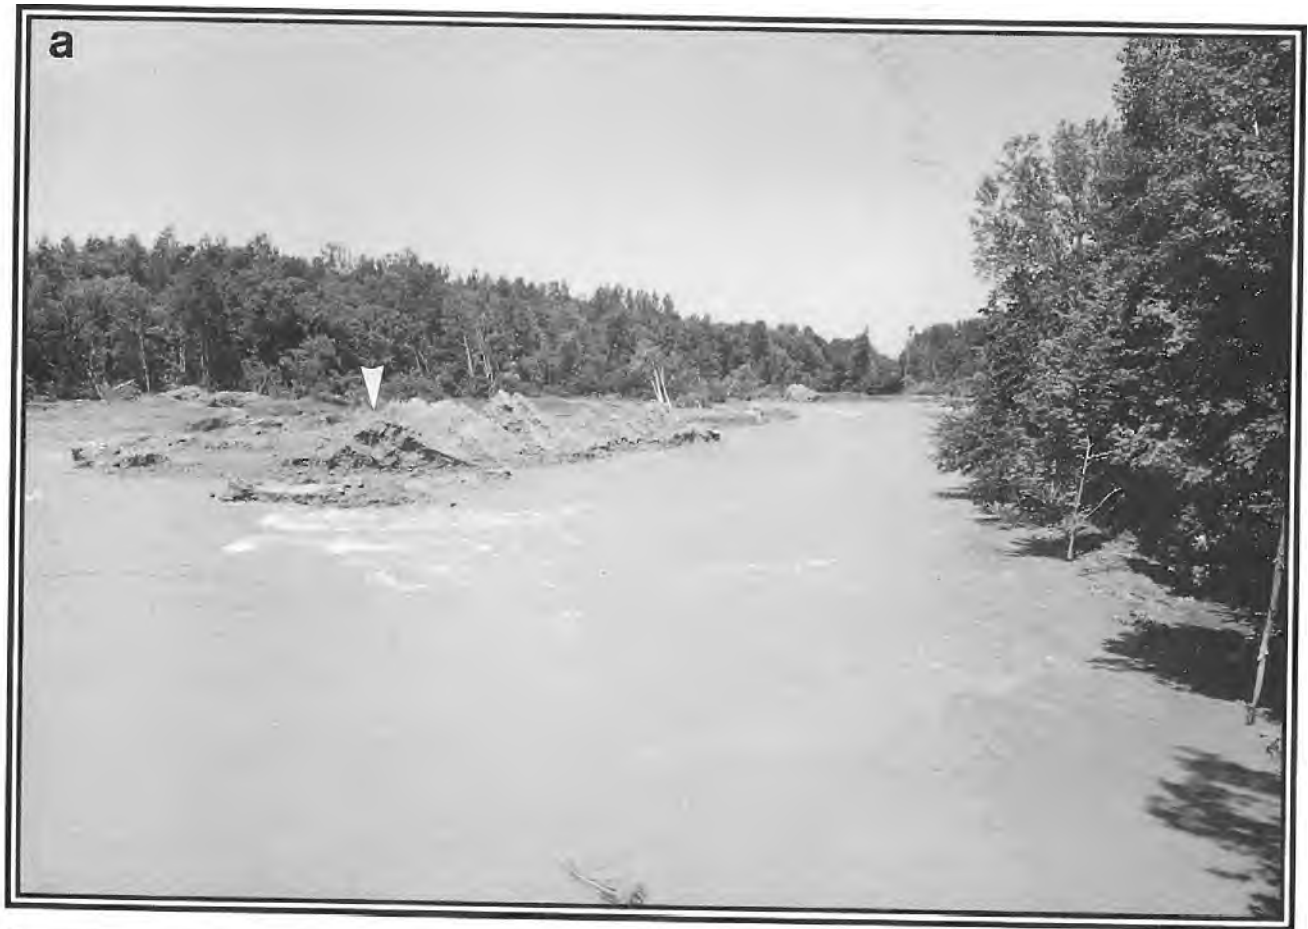
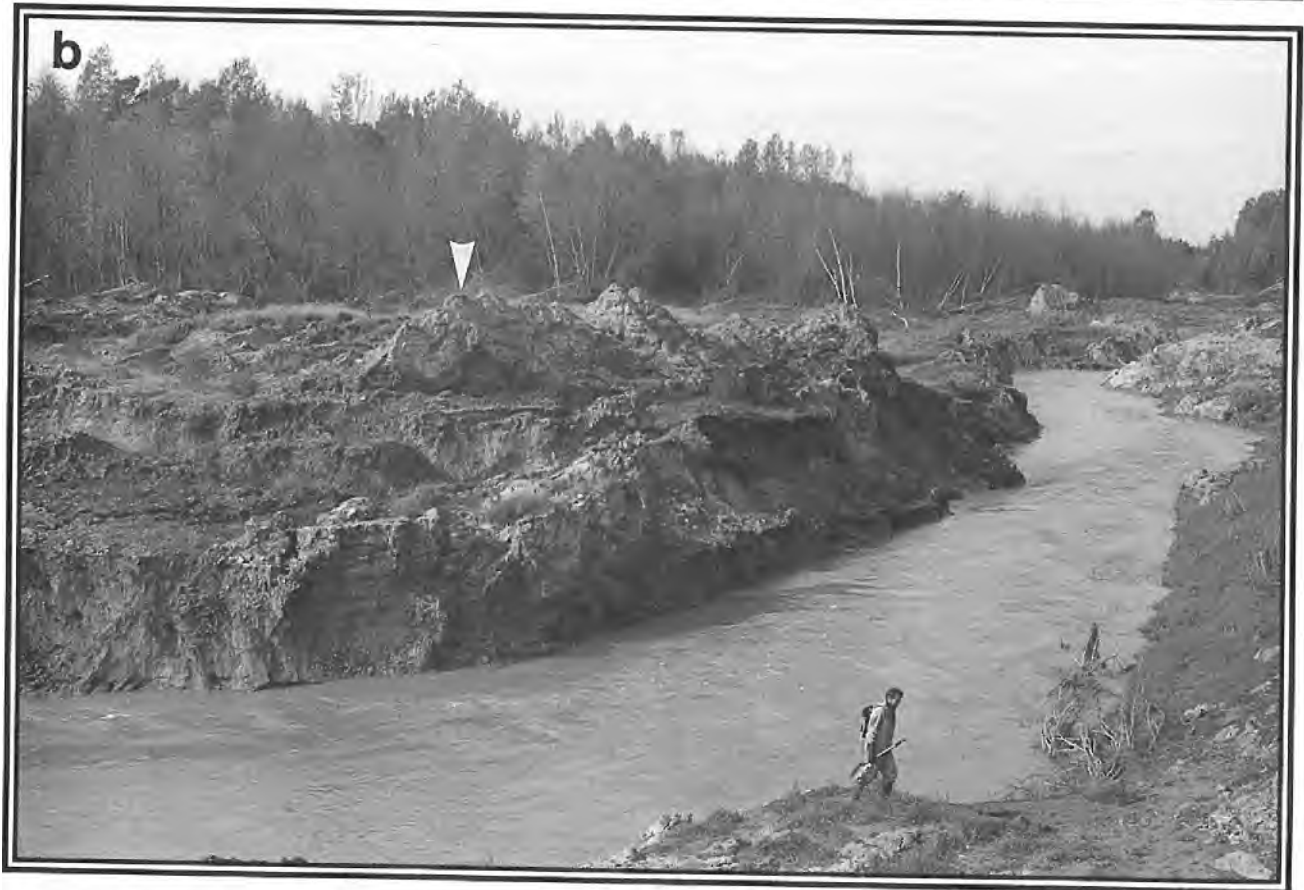
Figure 6. After the overtopping of the landslide dam, the restored flow of South Nation River occurred initially as a broad sheet subdivided by intact sediment blocks and rafted vegetation (cf., Fig. 5). The river gradually incised the spoil (2 m by July 7), reducing the level of the impoundment and creating a relatively narrow, sinuous channel. Comparative photographs of the river reach looking downstream immediately below the lower lip of the crater mouth reveal this change: **a)** taken early afternoon Thursday June 24, 1993 before significant incision (GSC 1993-2541) and **b)** October 11, 1993 after about 5 m of incision. The photographs are taken from the same position; arrows in **a)** and **b)** depict a common prominent ridge. (GSC 1993-306)

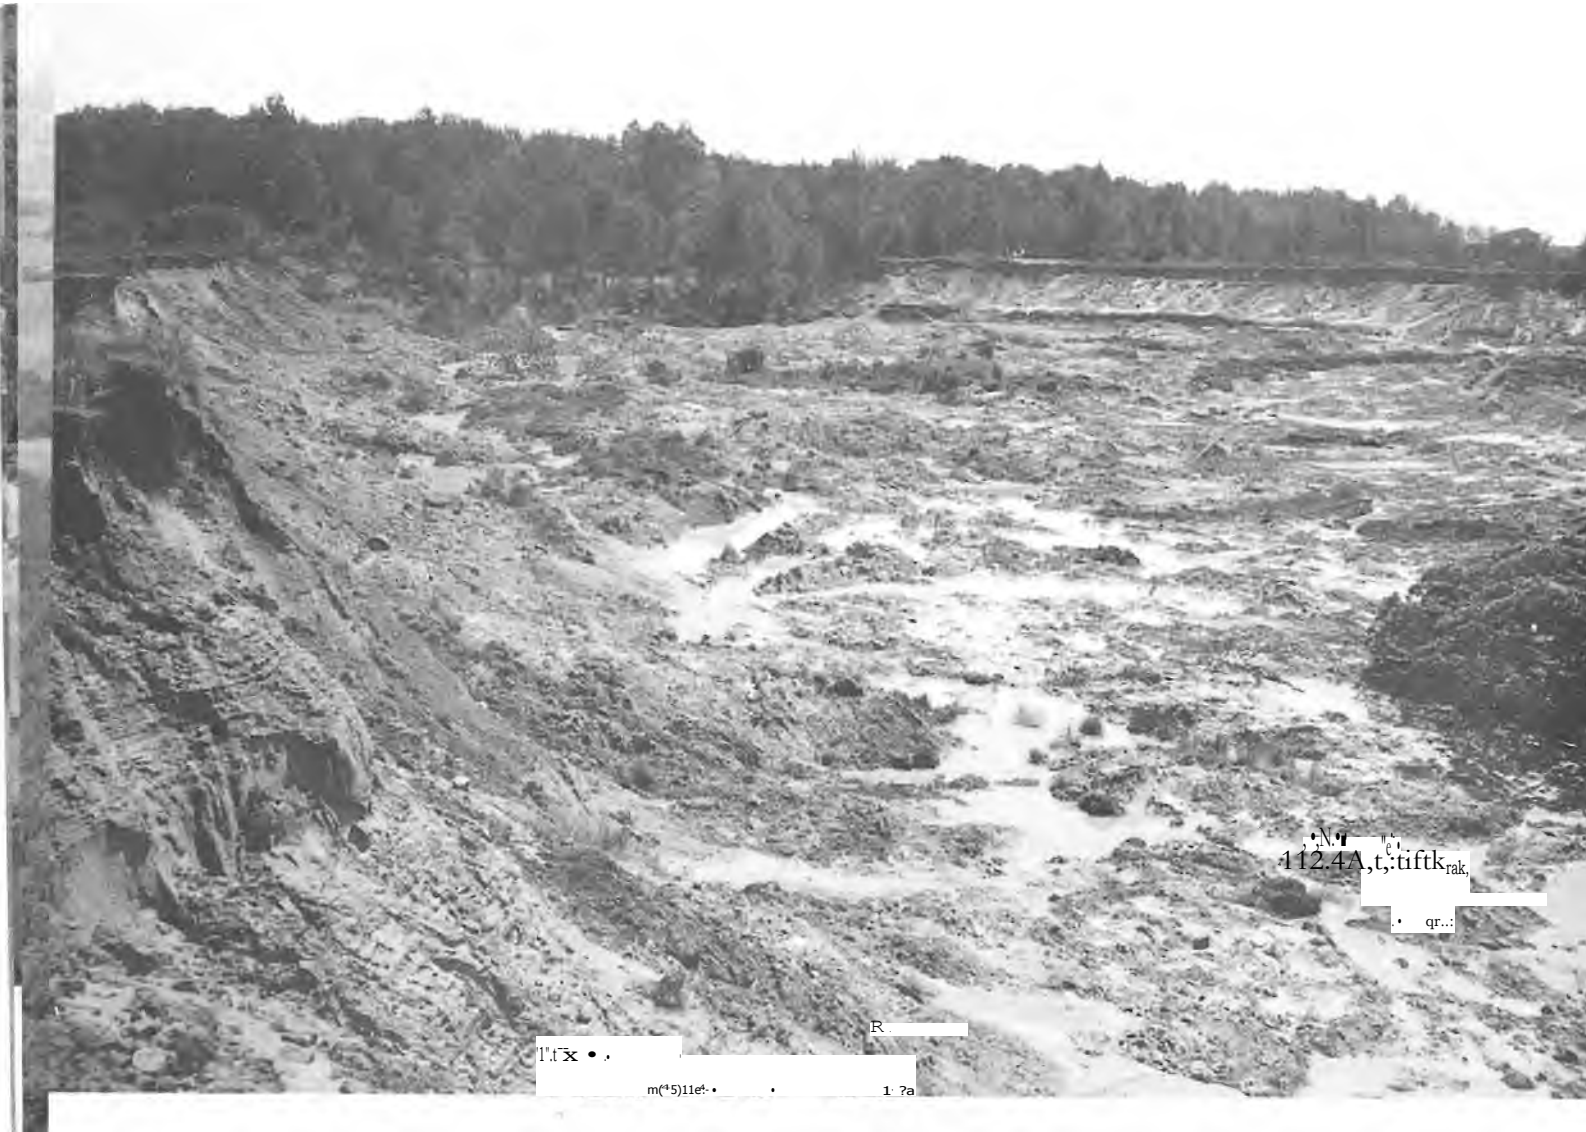
Figure 7. View along north sidewall towards the headwall. Along the reach of South Nation Valley prone to landslides, glaciomarine sediments (silts and clays) are buried beneath deltaic sands. The crater walls reveal a sequence of sediment fining downwards from structureless sand, through interbedded silty sand, laminated fine sand/silt with thin clay layers, to laminated clay with thin silt layers. Deposits in the upper part of the sequence did not remold during the landslide, but rather fractured to form blocks rafted within the spoil. For months after the landslide, water seeped from all coarser laminations in the crater walls. GSC 1993-295A

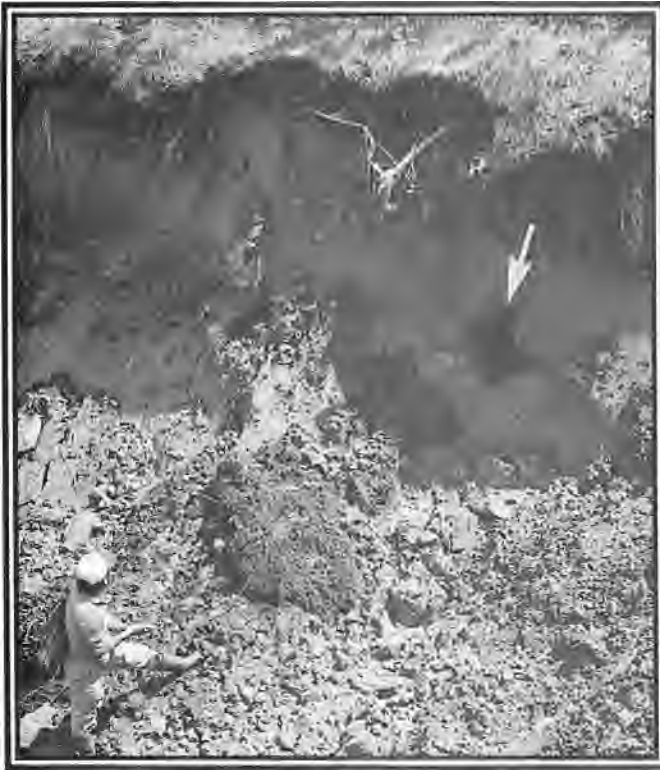
Figure 8. Indicative of the high water table at the time of the landslide, there was widespread standing water and evidence of drainage into the subsoil on the undisturbed surface around the margin of the crater. After the failure, groundwater seeped from the crater sides, with horizontal pipes being eroded at locations of concentrated flow. Pipe diameter ranged from 0.1-1 m and most were located at a depth of about 2.5 m at the sand/ silt interface. The pipe in this photograph was located at the headwall of the crater where eighteen active pipes were observed on Thursday, June 24, 1993. Many of these pipes continued to enlarge in diameter and depth over the summer. GSC 1993-295B

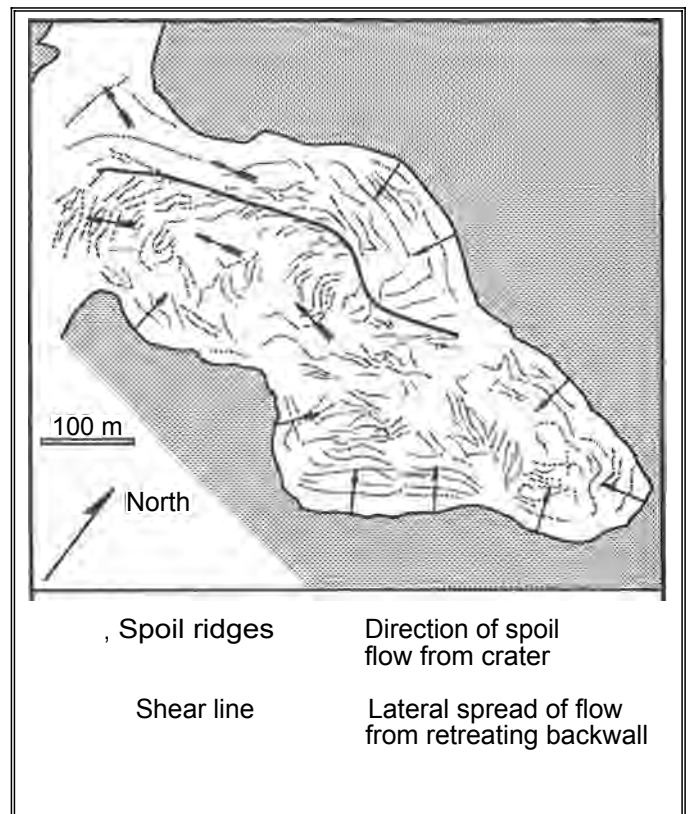
Figure 9. Within the spoil remaining in the crater are blocks of intact sediment and strips of sod and upright trees that form linear ridges within the remolded clay and ponded water (Fig. 2b). The arrangement of the ridges relates to the pattern of backwall retreat, but since much of the spoil has flowed into the river valley, the pattern of retreat probably relates only to the final stage of the landslide. Assuming that the direction of retreat is perpendicular to the ridges, an outline of the ridges reveals that failure generally has occurred along the crater sides obliquely with respect to the long axis of the crater. This pattern of retreat significantly increased the crater width and has contributed to the formation of an embayment on both the north and south side of the crater. In the lower two-thirds of the crater, there is a lineation running up from the river that appears to be a shear-zone between the flow of spoil in the central portion of the crater and that flowing from the north side embayment.

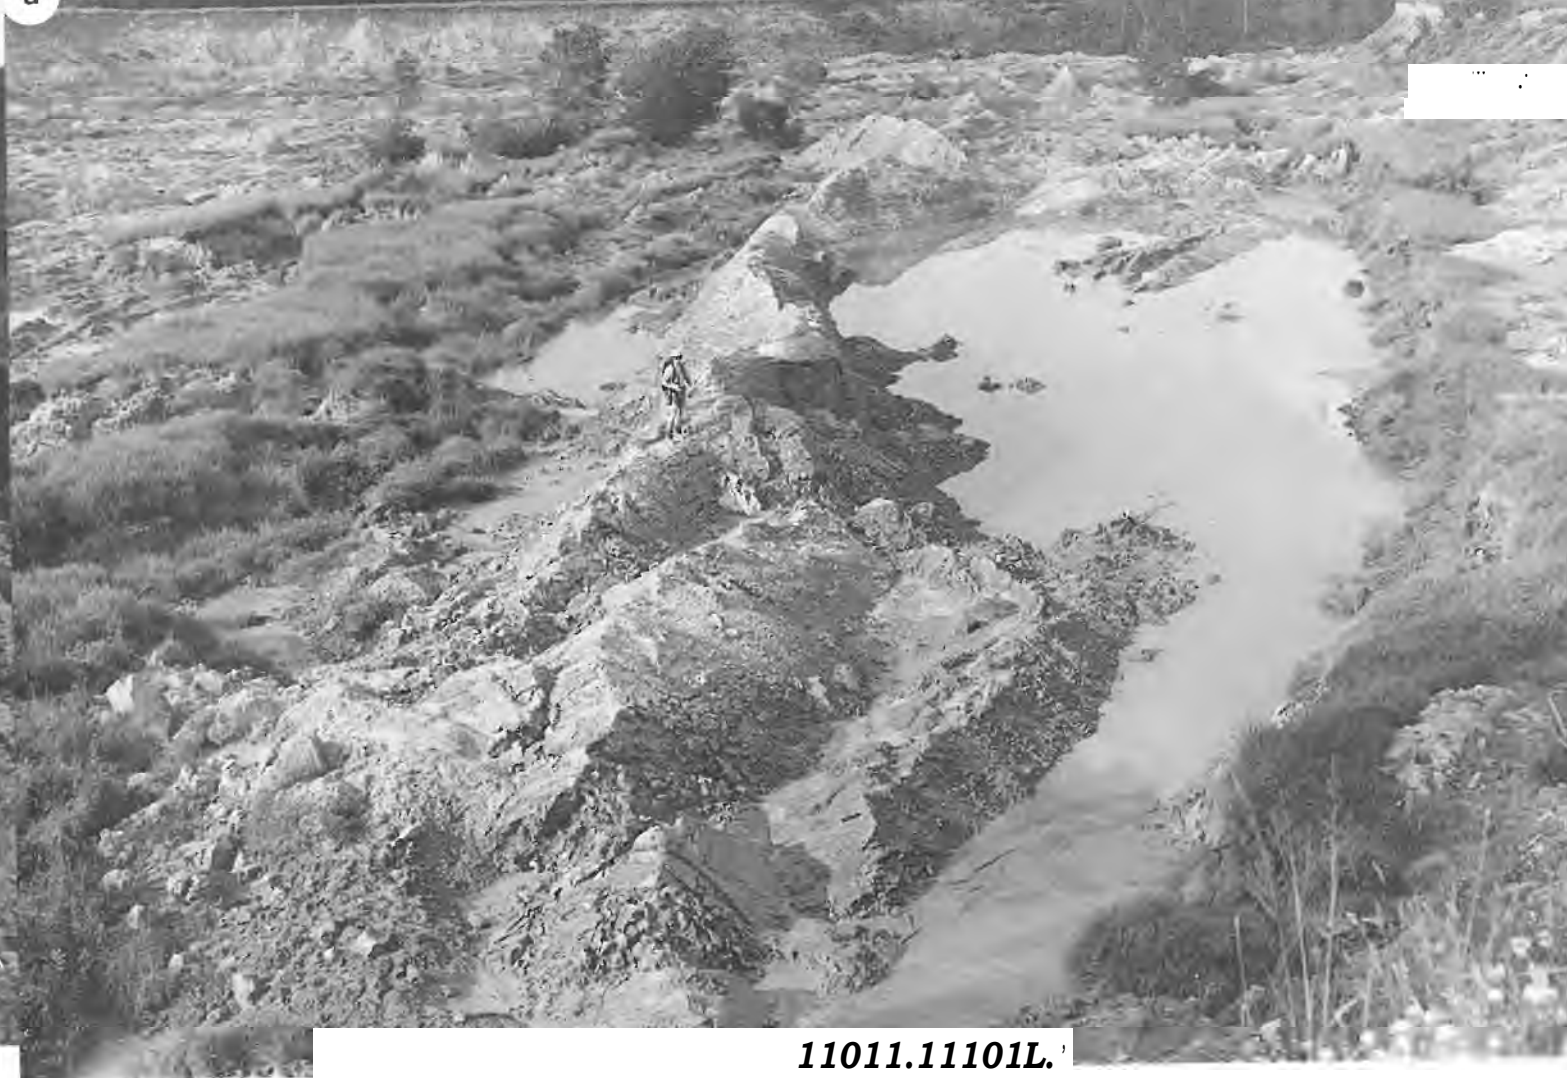
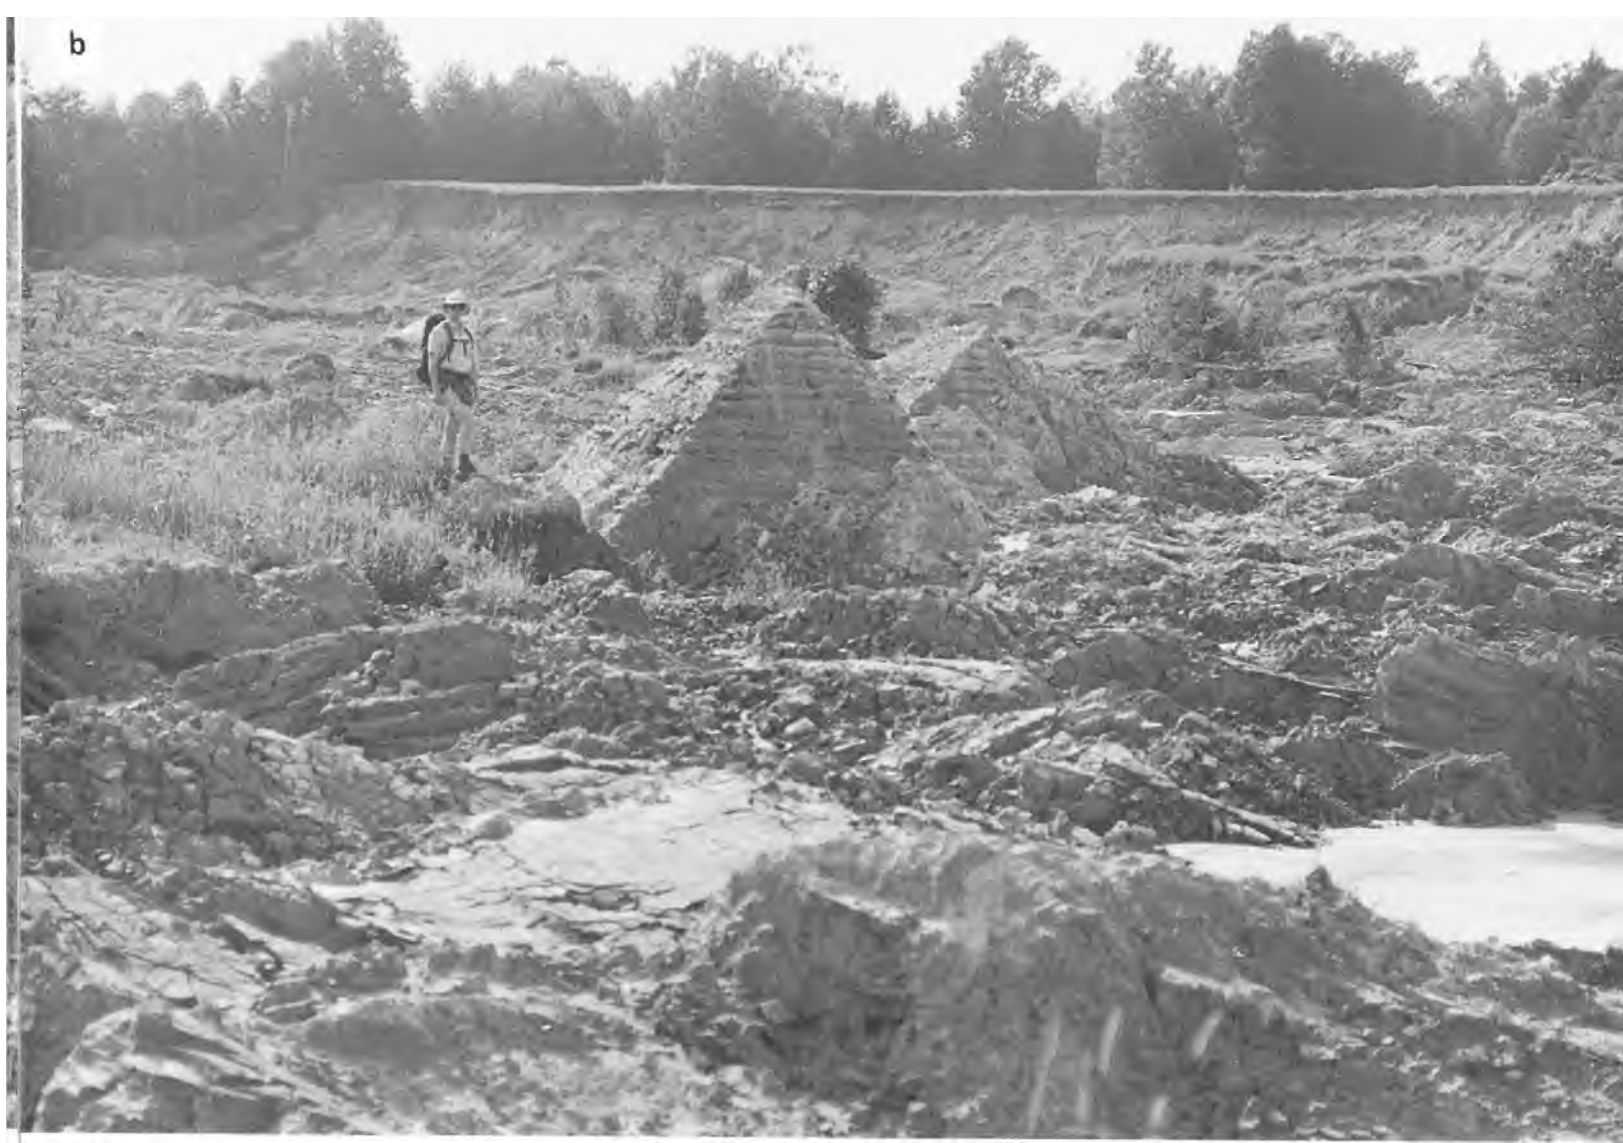
Figure 10. a) Sharp crested ridges and **b)** prismatic-shaped blocks of intact sediments are prominent features of the spoil particularly within upper part of the crater; note the person for scale. The ridges are composed of horizontal interbeds of clay, silt, and sand which are visible in b). The comparison of the interbeds within the ridges and blocks with the intact deposits of the sidewall suggests that there has been some subsidence as well as translation.

Because of the horizontal nature of the interbeds, these ridges cannot be attributed to rotational failure, but rather to the lateral translation and differential subsidence of the blocks (see Carson, 1977). Between the sharp-crested ridges, the spoil generally consists of disturbed blocks and remolded sediments with the more disrupted and tilted blocks showing evidence of sliding along the interbeds. GSC 1993-295C; GSC 1993-295D
