An earthflow in sensitive Champlain Sea sediments at Lemieux, Ontario, June 20, 1993, and its impact on the South Nation River^s

S.G. EVANS AND G.R. BROOKS

Geological Survey of Canada, 601 Booth Street, Ottawa, ON K1A 0E8, Canada

Can. Geotech. J. 31, 384-394 (1994)

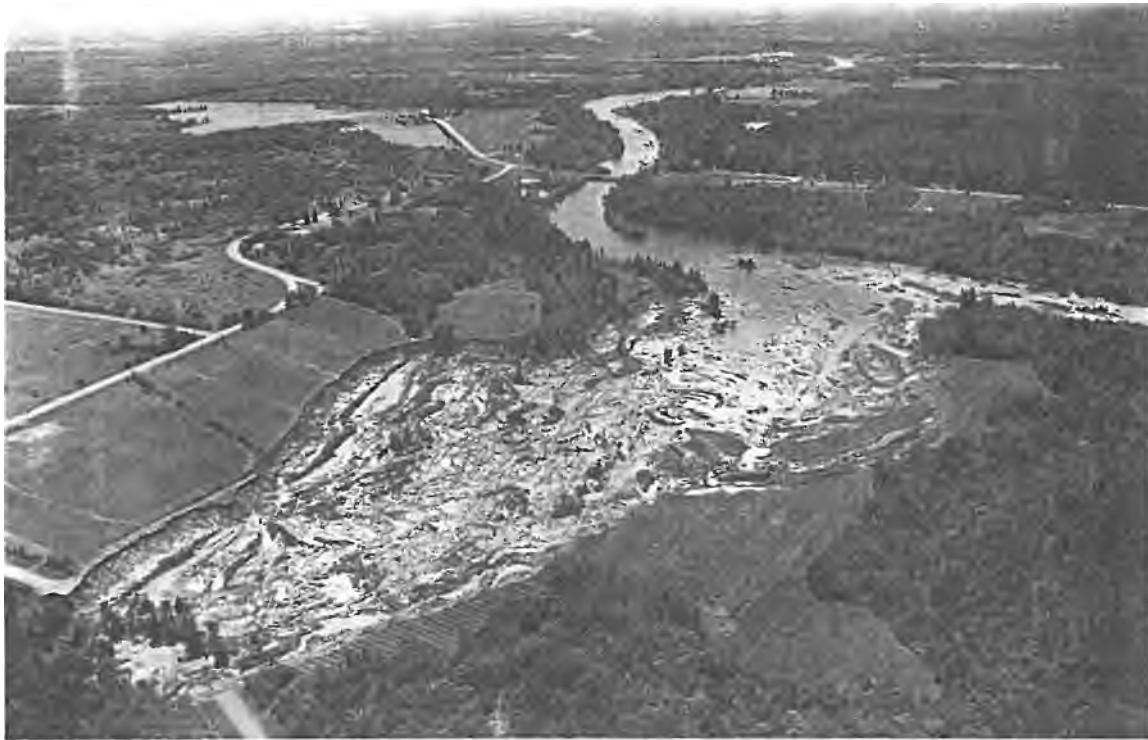
Beginning at approximately 15:30 on 20 June, 1993, a large landslide (Fig. 1), hereafter referred to as the Lemieux landslide, occurred in sensitive Champlain Sea sediments on the east bank of the South Nation River, 0.5 km north of the former townsite of Lemieux, Ontario, 50 km east of Ottawa at 45.4°N , 75.06°W (Fig. 2). The landslide occurred 4.5 km downstream of the well-known 1971 South Nation River landslide (Eden et al. 1971; Mitchell 1978a, 1978b; Mitchell and Markell 1974) (Figs. 2 and 3). The landslide severed County Road 16. A man was injured when he drove his pickup truck into the crater formed by the landslide, and was later rescued by a Canadian Forces helicopter. The statements of eyewitnesses summarized in Brooks et al. (1994) indicate that the major movements of the landslide lasted about an hour and had ceased by about 16:30.

FIG. 1. Aerial view of the 1993 Lemieux landslide which took place on June 20, 1993. View is toward the southwest looking up the South Nation River. Severed County Road 16 is seen at bottom left and County Road 8 bridge discussed in text is seen upstream of the landslide in the middle distance. Note impoundment of river and upstream flooding. Photo taken on June 23, 1993.

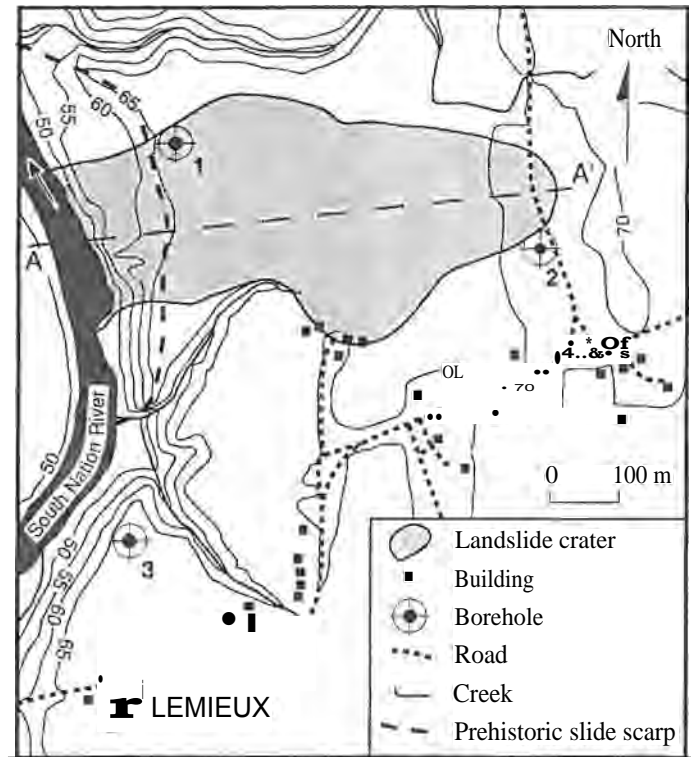
Fro. 4. Map showing the extent of the 1993 Lemieux earth-flow, area of prelandslide retrogressive sliding adjacent to the South Nation River channel, and locations of boreholes drilled in the late 1980s. A—A' is line of section in Fig. 8. Map shows the location of buildings before 1989–1990 buyout. Contour interval is 5 m. Modified from Province of Ontario 1 : 10 000 map 10-18-4950-50250.

A band of inactive retrogressive sliding, about 100-130 m in width, formed the valley side at the location of the landslide (Fig. 4) (Richard 1982). A partial cross section through the slide complex is now exposed in the north wall of the crater mouth. The 1993 landslide was probably triggered

by a reactivation of these failures, although it is not clear why the initial retrogressive sliding did not trigger the quick clay flow that eventually took place in 1993. A gully was also present upslope of the retrogressive slide complex (Fig. 4). Erosion in this gully may have locally destabilized the slope, leading to the larger scale failure.

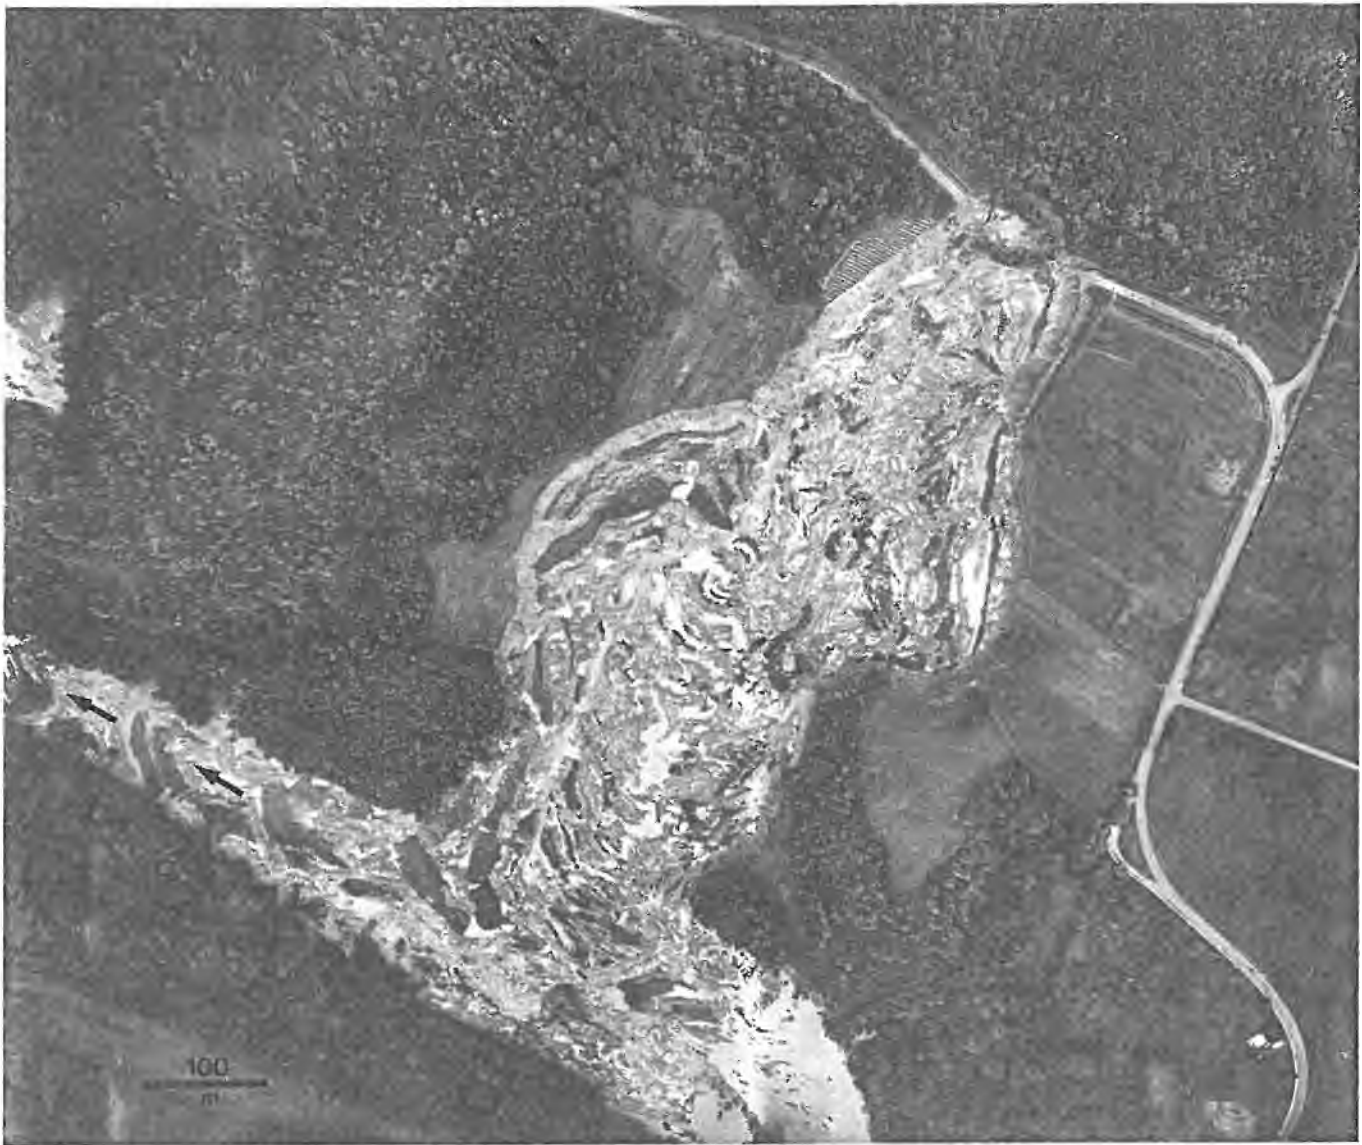
Large-scale pre- and post-slide topographic maps are not available at present, but a minimum volume estimate has been made based on the outline of the landslide crater in Fig. 4 and the minimum average depth noted above. The landslide covers an area of 17 ha, 14 ha of which is flat farmland (assuming a mean thickness of 18 m) is therefore about $2.5 \times 10^6 \text{ m}^3$; the volume in the valley-side slope is about $0.3 \times 10^6 \text{ m}^3$ yielding a total of about $2.8 \times 10^6 \text{ m}^3$, which is within the volume range of $2.5\text{--}3.5 \times 10^6 \text{ m}^3$ estimated by Brooks et al. (1994).

About $1.5 \times 10^6 \text{ m}^3$ of the debris evacuated the crater and flowed into the South Nation River (Fig. 5).

Fig. 5. Vertical aerial photograph of the 1993 Lemieux landslide taken on June 22, 1993 (courtesy of South Nation River Conservation Authority). Direction of flow of South Nation River is shown by arrows. Scale is approximate.

From aerial photography taken on June 22, the landslide deposit ranges in width from 120 to 160 m in the area immediately opposite the crater mouth (Fig. 5). This width occurs because the debris crossed the valley bottom and buried a terrace along the opposite side of the valley. Towards the downstream end, the deposit narrows to about 50 m where it is confined entirely within the South Nation River channel

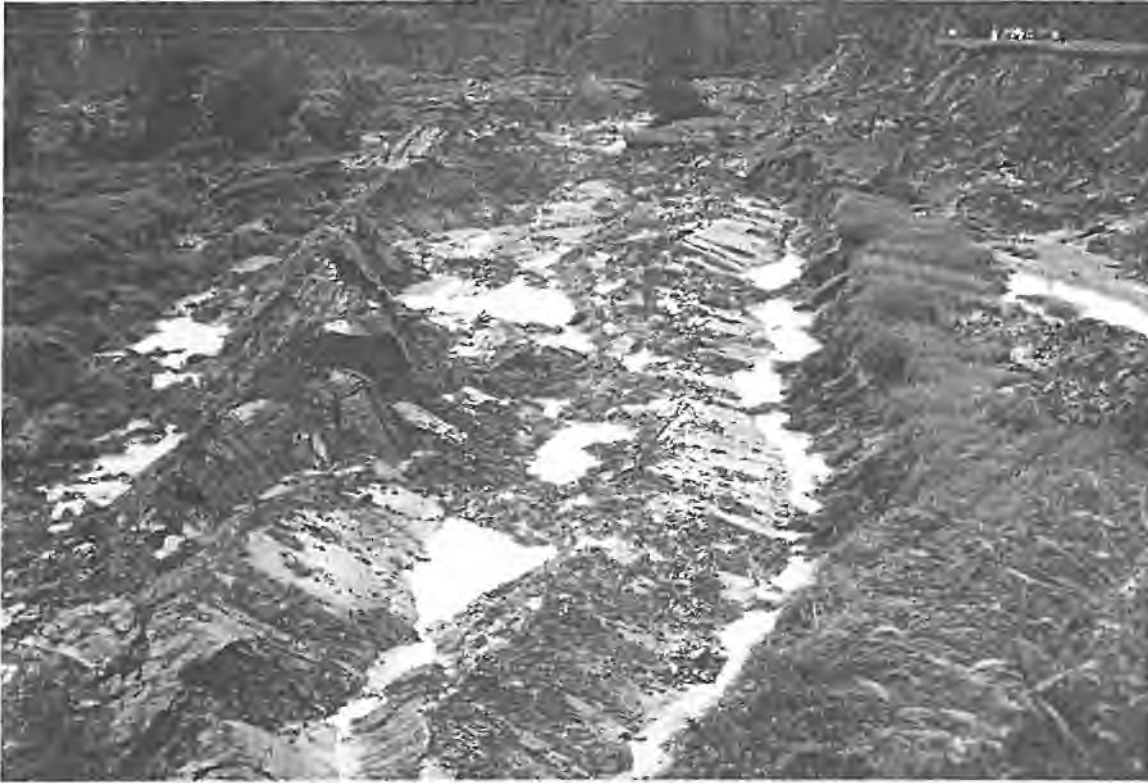
Within the crater, grounded, prismatic-shaped blocks are found in a mass of remoulded spoil at various locations (Figs. 6 and 7) including near the crater mouth. Within these blocks, laminations are horizontal, or near horizontal, in attitude. In addition, in the areas of the debris nearest the crater margin, contiguous sharp-crested ridges, about 3 m in height and consisting of blue-grey laminated silts and sands, parallel the sides of the crater (Figs. 5 and 6). As in the case of the individual blocks the laminations exposed in these ridges are invariably horizontal, or near horizontal, in attitude and the fact that the sediments are lower than their original position in the crater side indicates that translation has been accompanied by some subsidence. Rafts of sod are also present in the crater (Fig. 5), some with trees still standing upright in their growing position. Rotated blocks are also evident in the debris, particularly around the margins of

the crater (Fig. 6). They are also found in the vicinity of the prismatic blocks, where they have appeared not only to have rotated and sunk into the remoulded spoil, but have been subject to disintegration by sliding along laminations in response to the rotation (Fig. 7).

FIG. 6. The Lemieux landslide crater on June 21, 1993, about 24 h after the landslide took place. View is to the east along the south rim where onlookers (top right) provide scale. Note (from right to left) rotational blocks below the scarp, an exposed sliding surface within displaced blocks which formed along rotated lamination surfaces, clay ridges about 3 m in height, and sod from former field surface, and another clay ridge. Laminations in the clay ridges are horizontal.

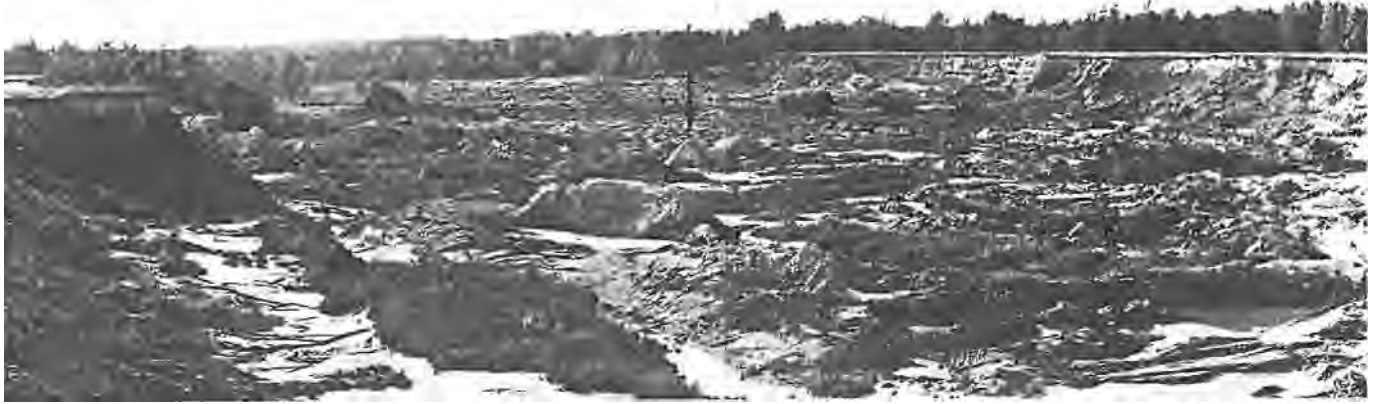
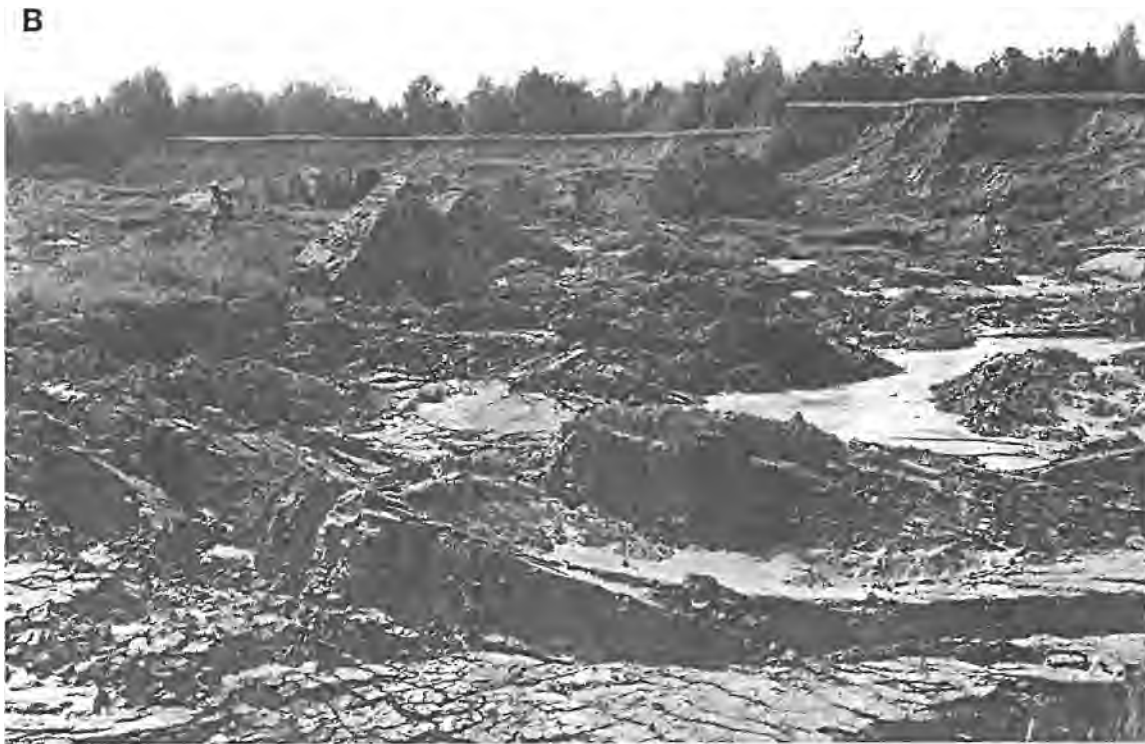
The morphology of the debris is therefore consistent with a mechanism that involves the break up of a stiffer cap and the subsidence and transport of the cap blocks in a mass of remoulded spoil, much of which flowed out of the crater into the valley of the South Nation River.

Fig. 7. (A) View to the west toward the mouth of the crater of debris and intact blocks. Scarp at left is approximately 9 m high. Arrowed pyramidal block is that shown in (B) (photograph courtesy of J.M. Aylsworth, taken on September 21 1993, 3 months after the landslide). (B) Grounded prismatic blocks, rotated blocks, and remoulded spoil in the centre of the crater. Pyramidal block to right of person is that arrowed in (A). View is toward the north rim. Photograph taken July 7, 1993.

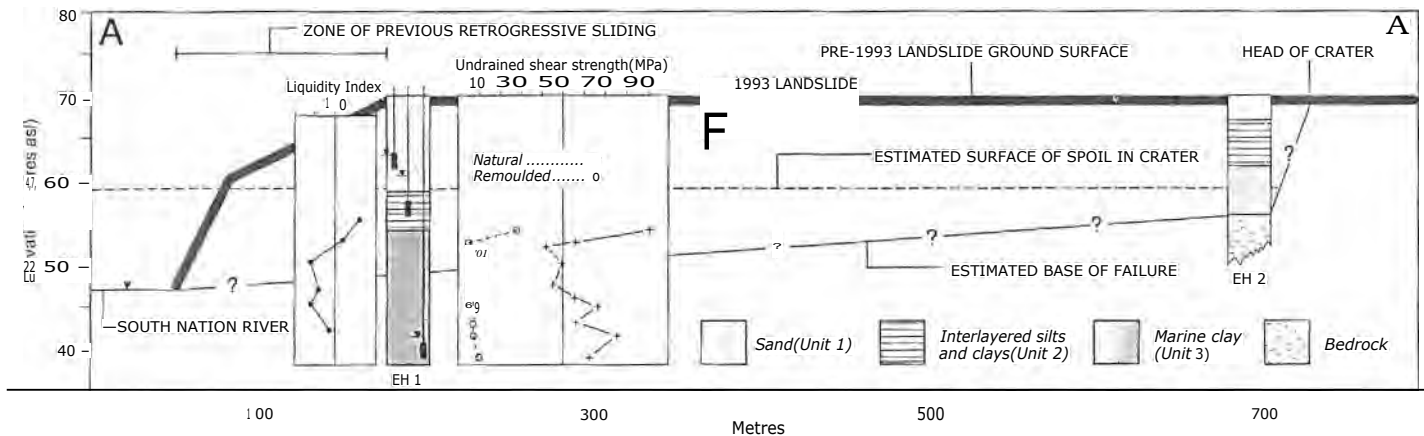
Stratigraphic and geotechnical data for the landslide site are available from the three boreholes (located in Fig. 4), which had been drilled in 1986 by the Ontario Ministry of Natural Resources (borehole 2) and in 1987 by Golder Associates (boreholes 1 and 3). In broad outline the stratigraphy of the site consists of three units (Fig. 8; Table 1) that coarsen upward, consistent with emergent conditions

Subsurface stratigraphical and geotechnical data (Fig. 8; Table 1), therefore, indicate the presence of a lower unit of soft marine clay overlain by a stronger, stiffer cap consisting of the grey-blue laminated interbedded sands and silts and the overlying brown silty sand. In the middle to lower part of the marine clay unit, values of I_L in excess of 1 indicate that the unit is very sensitive to remoulding. Field vane tests measured high sensitivities (>4) in the upper part of the unit at a location that corresponds to the base of the landslide. This evidence suggests that the Lemieux landslide occurred as a result of strength loss in a sensitive clay zone located between 8 and 23 m beneath the surface and that the liquefaction of most of the slide mass beneath the stiffer cap was due to its high liquidity index ($I_L > 1$).

Fig. 8. Approximate cross section (A-A' in Fig. 4) and geotechnical profile of Lemieux landslide based on drilling carried out in 1986 and 1987. Vertical exaggeration is five times horizontal. Boreholes (BH) projected onto cross section. Data in borehole 1 provided by Golder Associates.

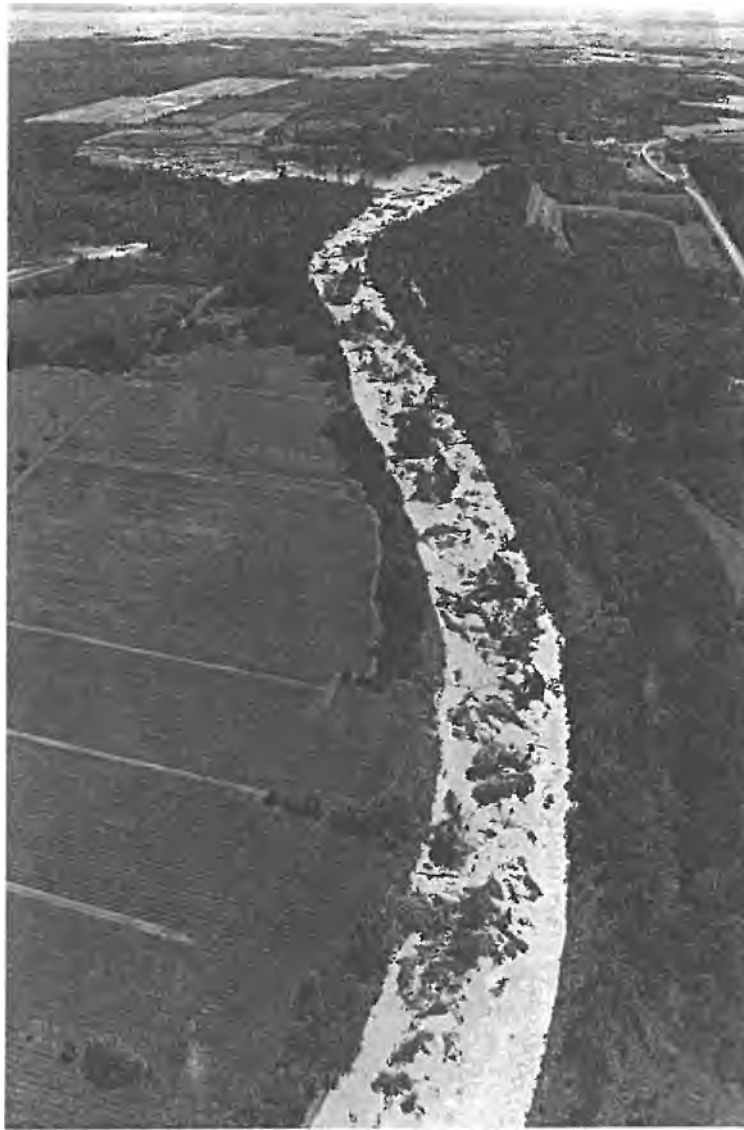
Upon failure, the landslide debris, consisting of liquefied silts and clays, intact silt and sand blocks, and rafts of sod, some with trees still upright in their growing position, flowed directly into the bottom of the South Nation valley (Figs. 5 and 9), then spread laterally in both the upstream and downstream directions. The upstream arm of the flow travelled underneath the County Road 8 bridge situated about 800 m from the landslide source area (Fig. 10). No damage occurred to the bridge, as there was sufficient clearance to allow the debris to pass safely underneath, although upright trees being carried in the flow struck the span. When it finally came to rest, the landslide debris covered about 3.3 km of the valley bottom up to 12 m in depth, extending approximately 1.6 km upstream and 1.7 km downstream of the flow crater.

FIG. 9 . Aerial view of landslide debris in the channel of the South Nation River downstream of landslide crater, which is visible at top left. Photograph taken on June 23, 1993.

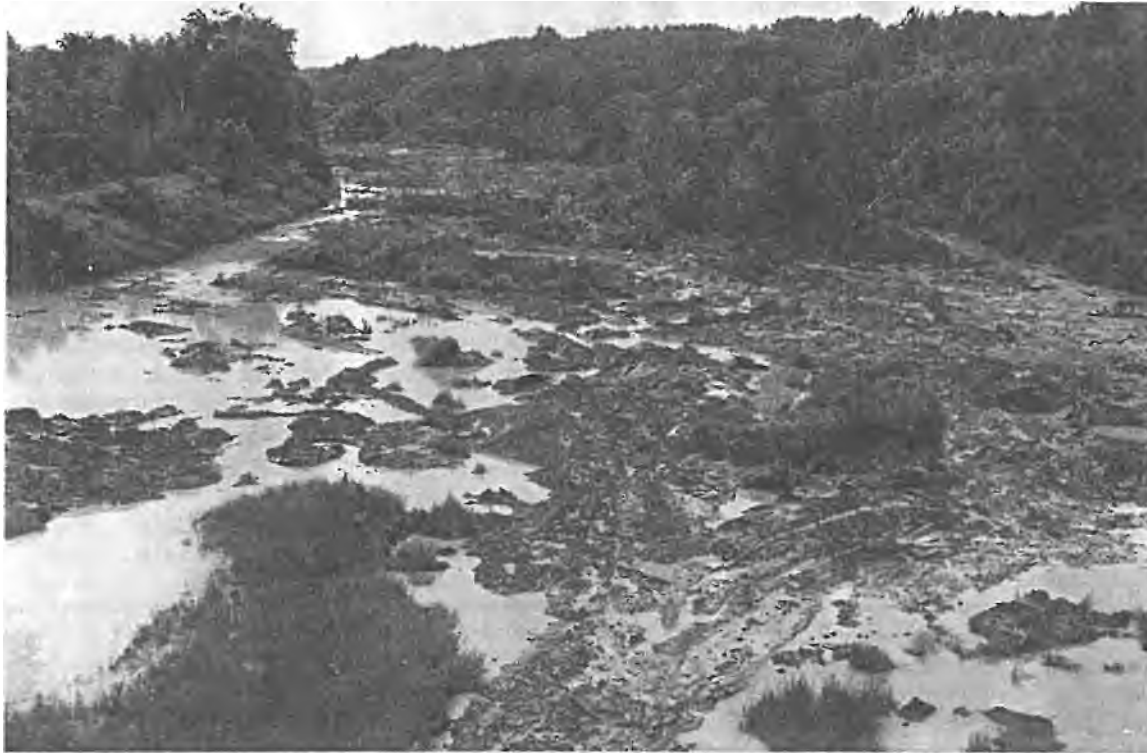
FIG. 10. Landslide debris consisting of remoulded spoil and clay blocks in the channel of the South Nation River upstream of landslide crater. Photograph taken on June 21, 1993, from County Road 8 bridge (see Fig. 1) looking upstream.

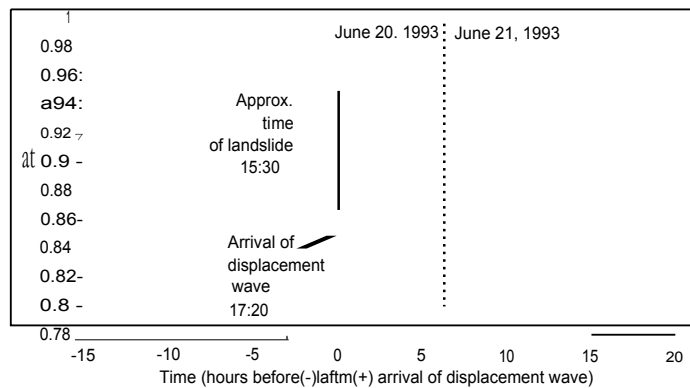
(28.4 km downstream) shows an abrupt rise in stage at 17:20 on June 20, about 110 min after the beginning of the landslide (Fig. 11).

The impoundment of the South Nation River by the landslide debris is apparent in the discharge record at the Plantagenet Springs station (Fig. 11), but the flow was not affected severely. Over the course of Sunday, June 20, 1993, the river stage had been falling gently (Fig. 11). At the time of the landslide (15:30) the stage was 0.868 m, equivalent to a discharge of about 22.4 m³/s (Fig. 11). At 17:20, the stage rose abruptly by 0.082 m. As noted above this is believed to represent a wave of water displaced downstream by the landslide as it surged along the South Nation valley bottom.

Immediately after the rise, the stage fell by about 0.028 m, then continued to decrease more slowly, attaining its pre-wave level at 19:40. The 2.33 h period between the rise and fall stage reflects the very slight gradient of the river channel (D. Rowe, personal communication, 30 June 1993) and severe dampening of the wave by the channel bottom over the 28.4 km distance from the landslide to the stage recorder.

From 19:40 to 01:00 on June 21, the river stage continued to fall, eventually reaching 0.787 m (or a discharge of 11.9 m³/s), reflecting the impoundment of the river by the landslide. After 01:00 on June 21 the flow increased in response to heavy precipitation falling within the watershed (Fig. W).

FIG. 11. River level at the Plantagenet stage recorder, 28.4 km downstream of the landslide. The water surface of the South Nation River rose abruptly by 0.082 m at 17:20 June 20 (110 min after the beginning of the landslide) in response to a displacement wave generated by landslide debris flowing down the South Nation valley. After passage of this wave, stage fell gradually to 0.78 m, reflecting the impoundment of the river by the landslide debris. The rise in stage, beginning after 01:00 June 21, reflects rainfall being routed through those areas of the watershed unimpeded by the landslide (data courtesy of Environment Canada).
