## South Nation River Landslide, 16 May 1971<sup>1, 2</sup>

This brief account lists the dimensions, and the soil and climatic conditions concerned in a large landslide which occurred along the South Nation River in Eastern Ontario.

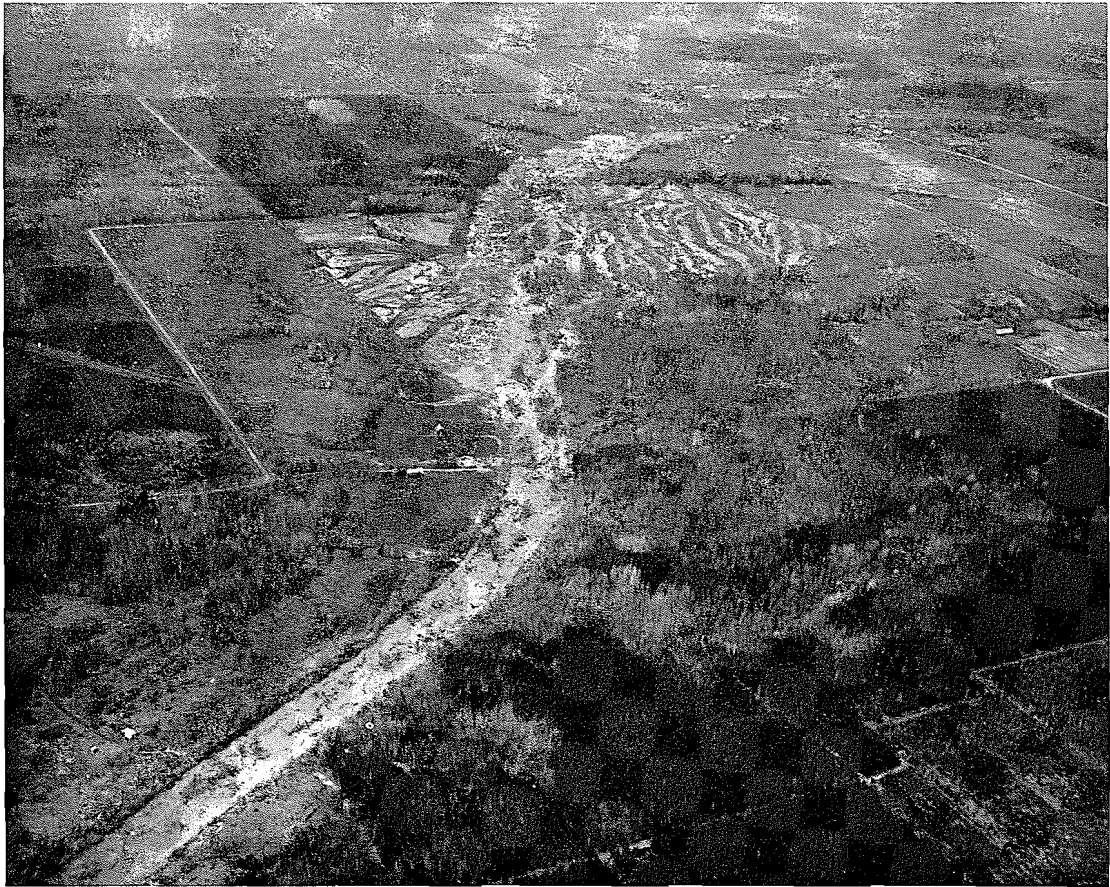
Figure 1 is an oblique aerial view of the site looking downstream. The landslide scar is on the right (east) bank of the river. On the left bank, immediately upstream, is the scar of an old landslide that took place within the memory of the residents of the area and has been dated as 28th February 1910.

The old landslide scar, which extends about 1000 ft (~300 m) back from the river and is about 1500 ft (~460 m) wide, occurred during

an unseasonal spring-melt according to newspaper accounts. The ground surface in the old cavity is reasonably level at an elevation about 50 ft (~15 m) below the upland elevation of 210 ft (64 m). The cavity material consists of about 10 ft (~3 m) of silty, fine sand over silty clay. Other old scars in the area have been left as pasture land and show a sharply undulating surface.

FIG. 1. Oblique aerial view of the South Nation River landslide.

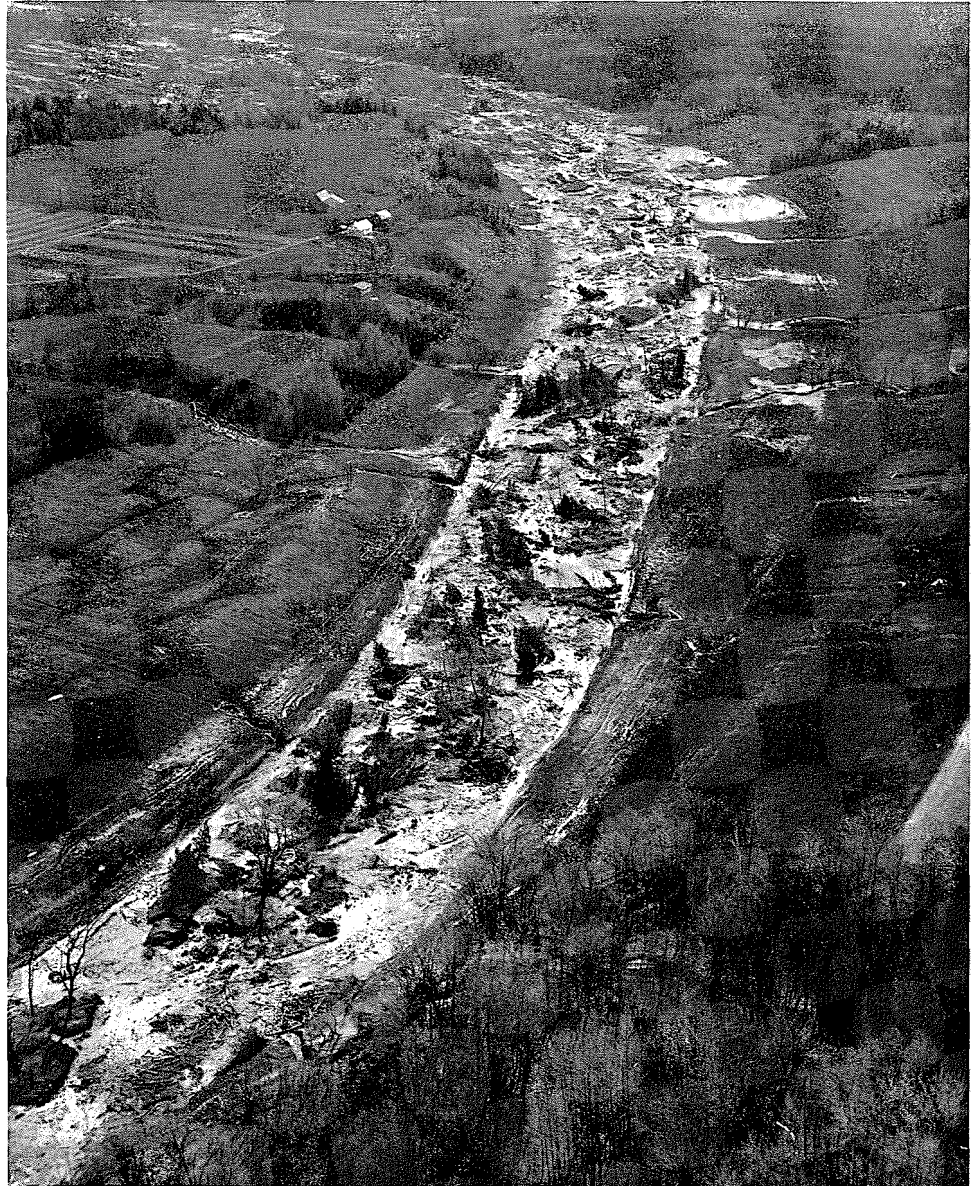
The present landslide occurred during a heavy thunderstorm and is believed to have started after 11:00 p.m. A power failure occurred about midnight, when trees being carried along in the landslide debris knocked down power lines spanning the river downstream from the slide. Figure 2 is a view of the downstream end of the debris, showing many trees still in an upright position. The disrupted power line is located in the middle of the photograph.

FIG. 2. View of debris in the river downstream from the landslide.

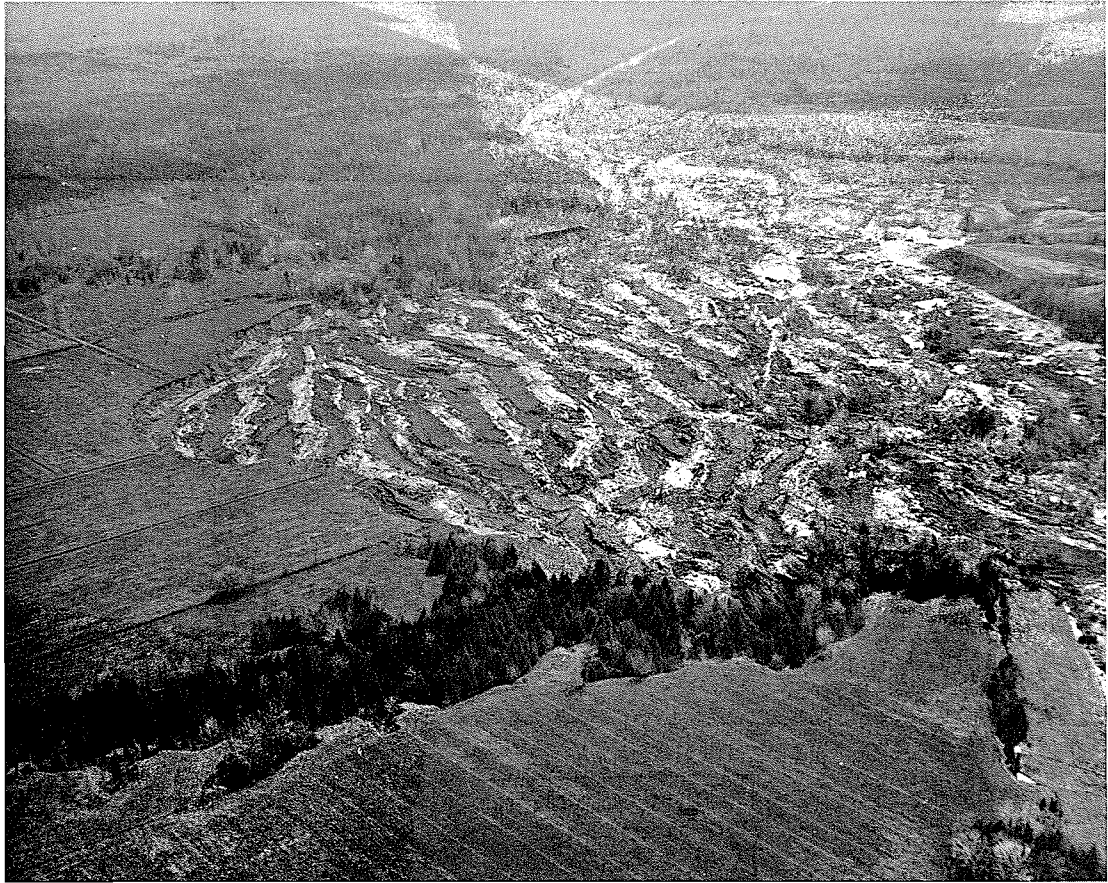
Figure 3 is a view of the cavity formed by the landslide. The succession of individual failures

are well preserved by sod on the sand horizon overlying the clay. Figure 4 is a closer view of the succession of slips and shows the back scarp, which is about 30 ft (~9 m) high.

FIG. 3. Aerial view of cavity formed by the landslide.

Amid the grassy top surfaces of the retrogressive slices evident in the photographs there are pinnacles of gray clay pushed up by the rotation. These clay pinnacles seem to indicate that the failure did not extend into the till layer. Average properties of the gray clay layer, as obtained from the investigations noted above, are as follows:

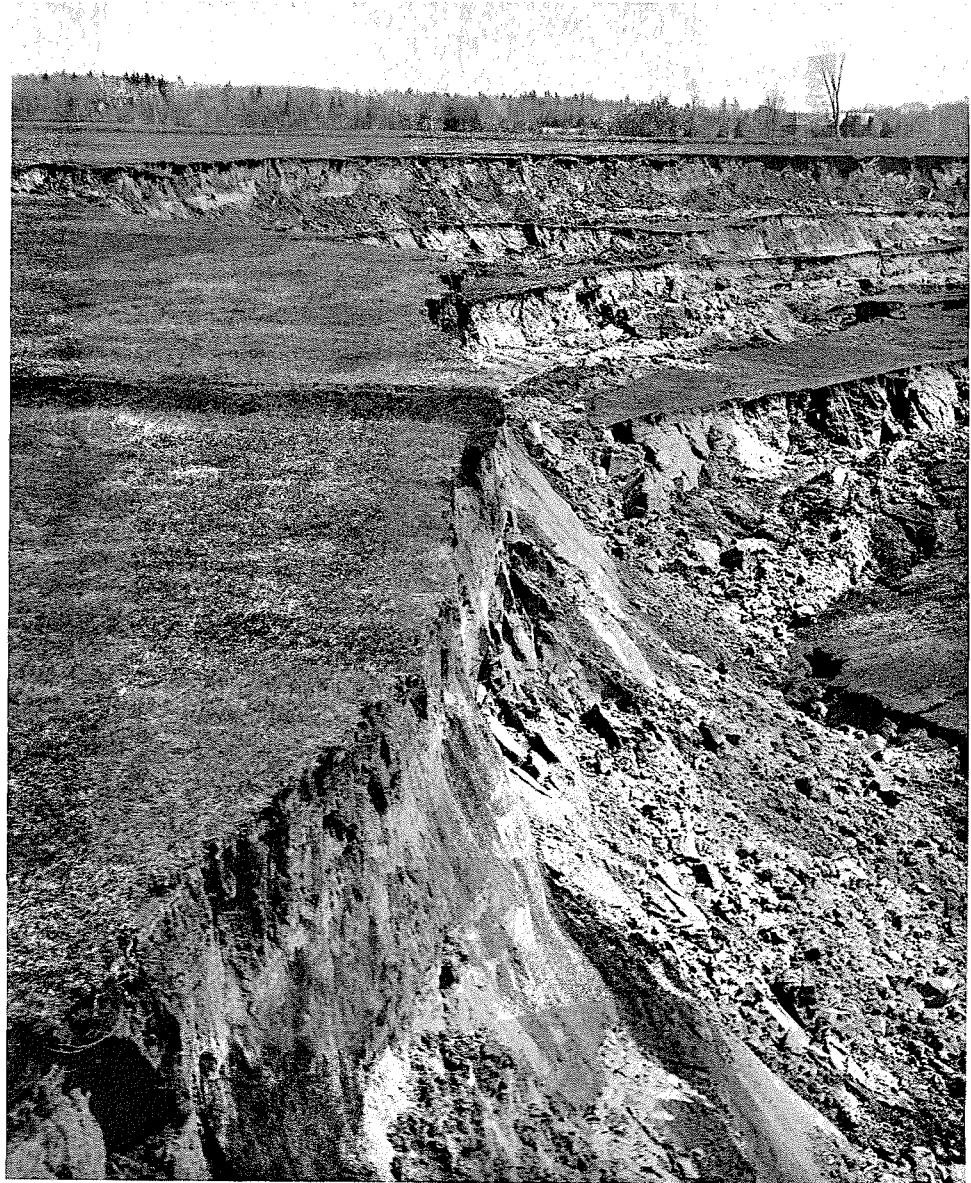
FIG. 4. View of back scarp of the landslide.

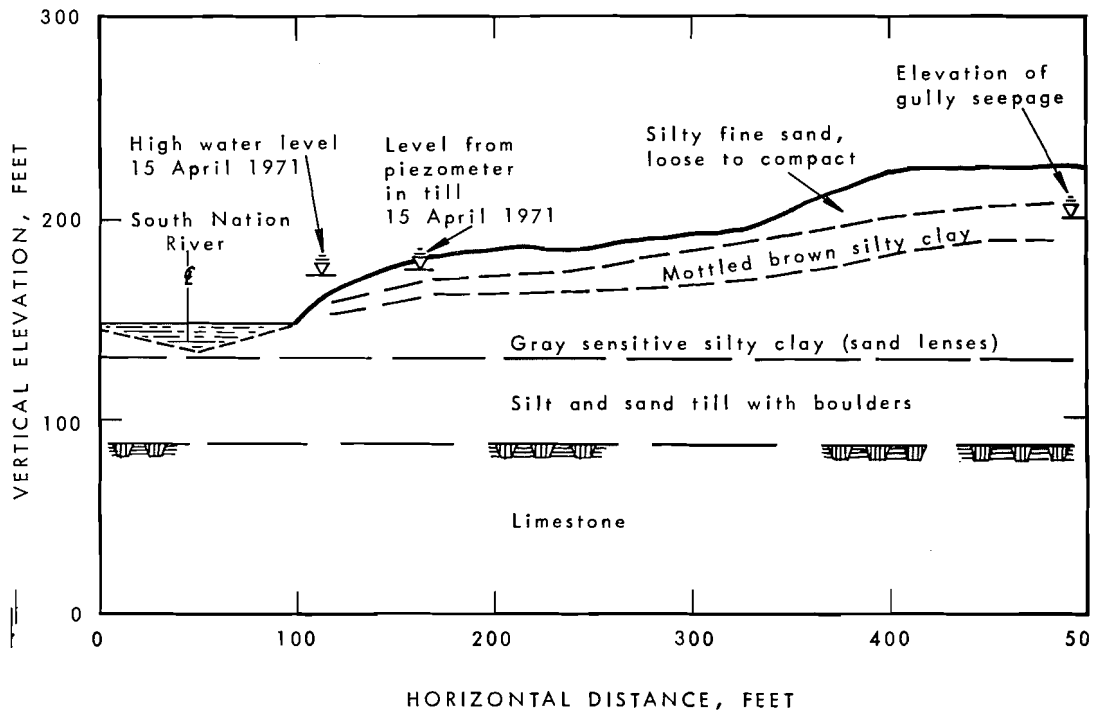
section and geotechnical profile at the landslide site have been reconstructed as shown in Fig. 5. The river water level had risen as much as 26 ft (8 m) (to elevation 172 ft (52.4 m)) during spring floods at the location of the landslide. Piezometer readings indicate a rise in groundwater levels as the river level rose. After about one week of flooding, the river level dropped quite rapidly but the groundwater pressures in the slopes remained high. The river level had dropped to about elevation 145 ft (~44 m) at the time of the slide, but the general groundwater level was nearly coincident with the ground surface (elevation 210 ft (64 m)) over most of the lower part of the slope. It is not known whether there were artesian groundwater pressures in any part of the slope at the time of the slide. Groundwater seepage was

noted on 3 June 1971 near the bottom of the gullies flanking the landslide; the approximate elevation of this seepage is indicated on Fig. 5.

FIG. 5. Cross section and geotechnical profile of the site of the South Nation River landslide.
