# Water Erosion Control Infrastructure (WECI)

Occasionally, the Ministry of Natural Resources will grant South Nation Conservation (SNC) 50% of the budget for different projects under the Water Erosion Control Infrastructure Program (WECI). Some examples are:

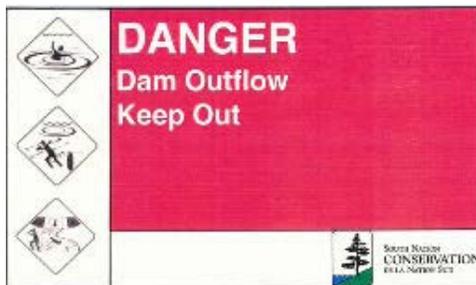
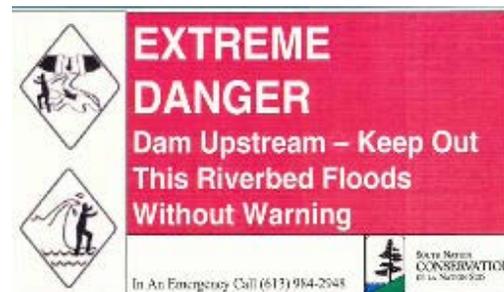
- **Public Safety:** To promote public safety, SNC has installed safety booms and safety signs on its water control structures. The following public safety signs have been installed:
  - *"Danger Dam Ahead. Keep Out"* upstream the dam;
  - *"No Trespassing"* at the gate steel fence;
  - *"Danger Dam Outflow, Keep Out"* on the dam; and
  - *Warning. Dam Upstream. Water Levels and Flow May Change Without Warning* downstream the dam.

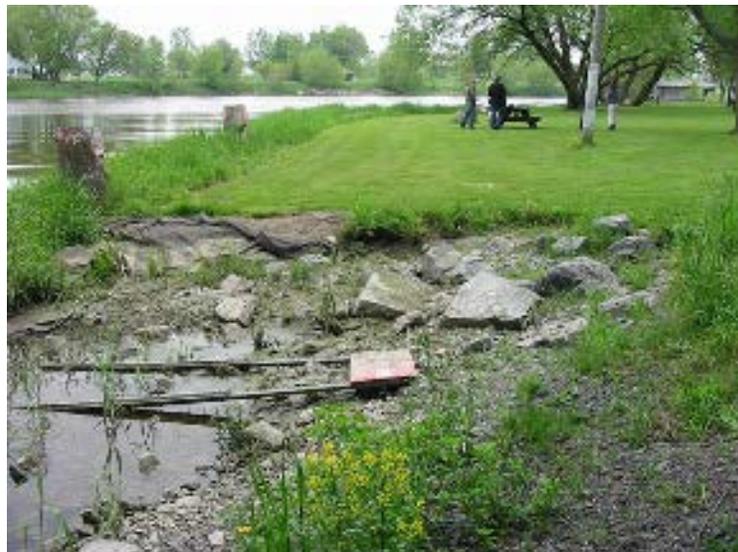
- ## 2. Casselman Erosion Repairs:
- This picture was taken at the High Falls Park in Casselman, ON in the last week of May 2006. The shoreline erosion was located immediately upstream of the weir, west of the bridge. The erosion damage was a product of the spring run off and high water levels. The repairs were complete in 2007.

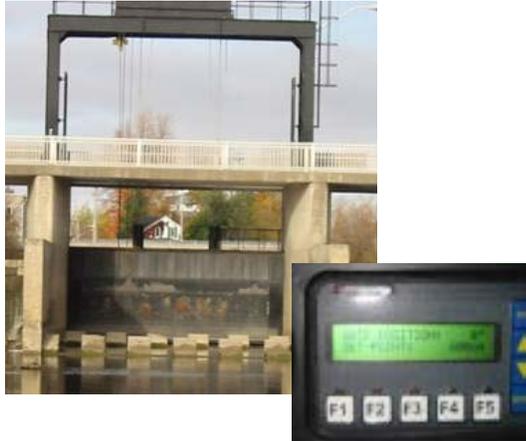
**Gate Control Unit:** In 2004, SNC upgraded the gate control devices at the Chesterville Dam to an automatic system. Therefore, the position of the gate depends in the actual water levels. For example, if the water level rises, the dam will be automatically adjusted.

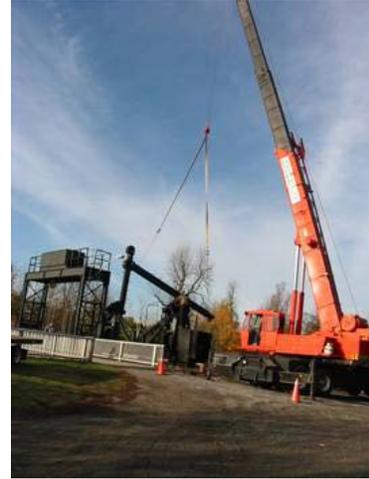
**Loglifter Repairs:** The loglifter is used to haul the logs up and down in the 4 bays at the Chesterville Dam. In 2005, the arm of the loglifter was repaired.

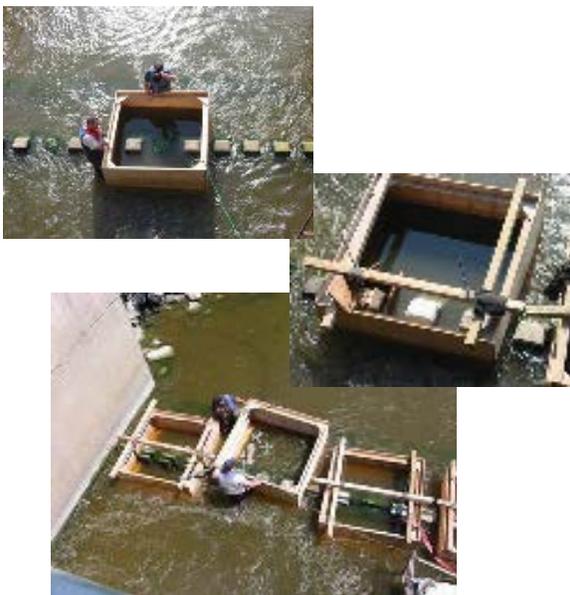
**Concrete Energy Dissipators Repair:** This project was undertaken in 2006 to restore the deteriorated concrete energy dissipators. The reparation procedure included:

- i. Redirection of the flow from the working area;
- ii. Removing the deteriorated concrete;
- iii. Forming the sections to be repaired;
- iv. Applying epoxy-resin patching; and
- v. Water-resistant concrete applied and towed to the elevation of the surrounding material.

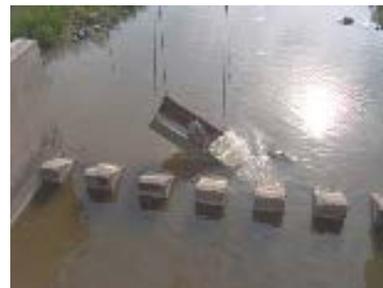
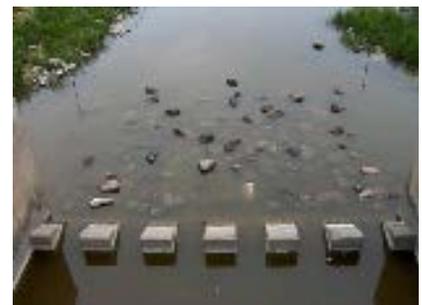
**Placement of Blasted Rock:** Undertaken by SNC in 2005, this project consisted of the placement of riprap in a large hole (16m x 10m x 1.5 m (depth)) immediately downstream of the Chesterville Dam's concrete apron area. The material used was riprap free of fines with average nominal sizes of 18" to 24", with no more than 25% greater than 24". The riprap was placed using a crane, until the grade of the riprap was the same elevation as the grade of the concrete slab.

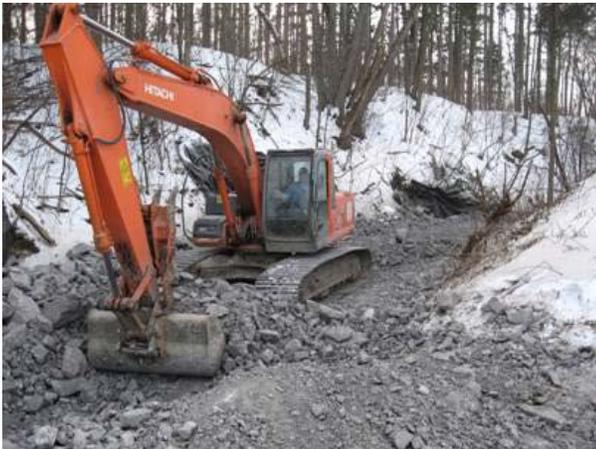
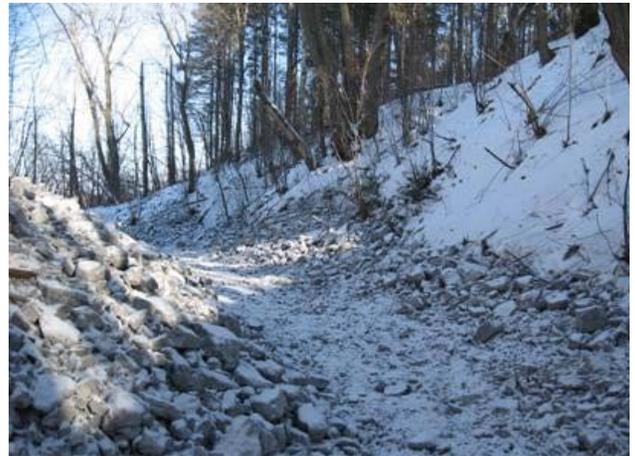
#### 4. Bourget Municipal Drain Stabilization Project:

The Bourget Municipal Drain, located on County Road 8, has steep banks which have eroded over time creating hazardous conditions for the house located approximately 20 meters from the top of the bank. Kollaard Associates was hired to prepare a geotechnical report detailing the methodology of the bank restoration. Since SNC partnered with the UCPR for this project, the UCPR Public Works department executed the proposed methodology.

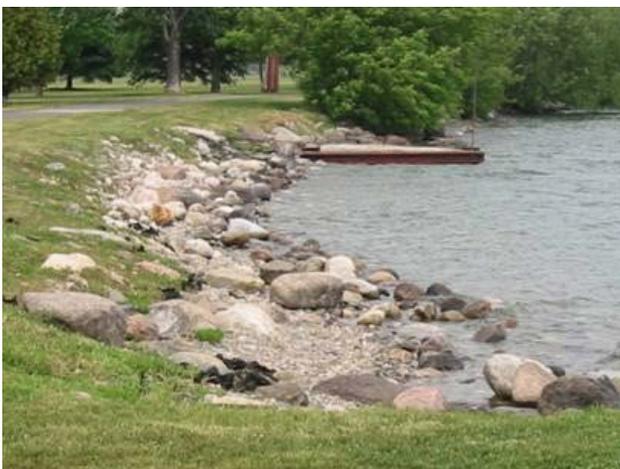
Before

**5. St. Lawrence River Shoreline Assessment and Repair:** In 2005, the Township of South Dundas (SD) and SNC partnered to evaluate the erosion along the St. Lawrence River shoreline in Morrisburg, specifically between the Village dock at the foot of Ottawa Street and the Village beach. The shoreline is subject to wave action from the wind and boat swells and consequently certain sections needed to be repaired. An inspection of the area by SNC and SD identified six or seven sections of concern located between the Morrisburg Park and the Water Treatment Plant.

In addition to repairing the shoreline, erosion prevention using rock protection was part of the project. The rock protection consisted of boulders and smaller interlocking cobbles to fill the gaps. The rocks were placed at the water's edge continuing just above the river bank.
