SOUTH NATION  
CONSERVATION  
DE LA NATION SUD

# 2017 Summary Report: Regional Biodiversity Funding Program Ontario Power Generation SOW # 2017-JW-01-02

January 2018

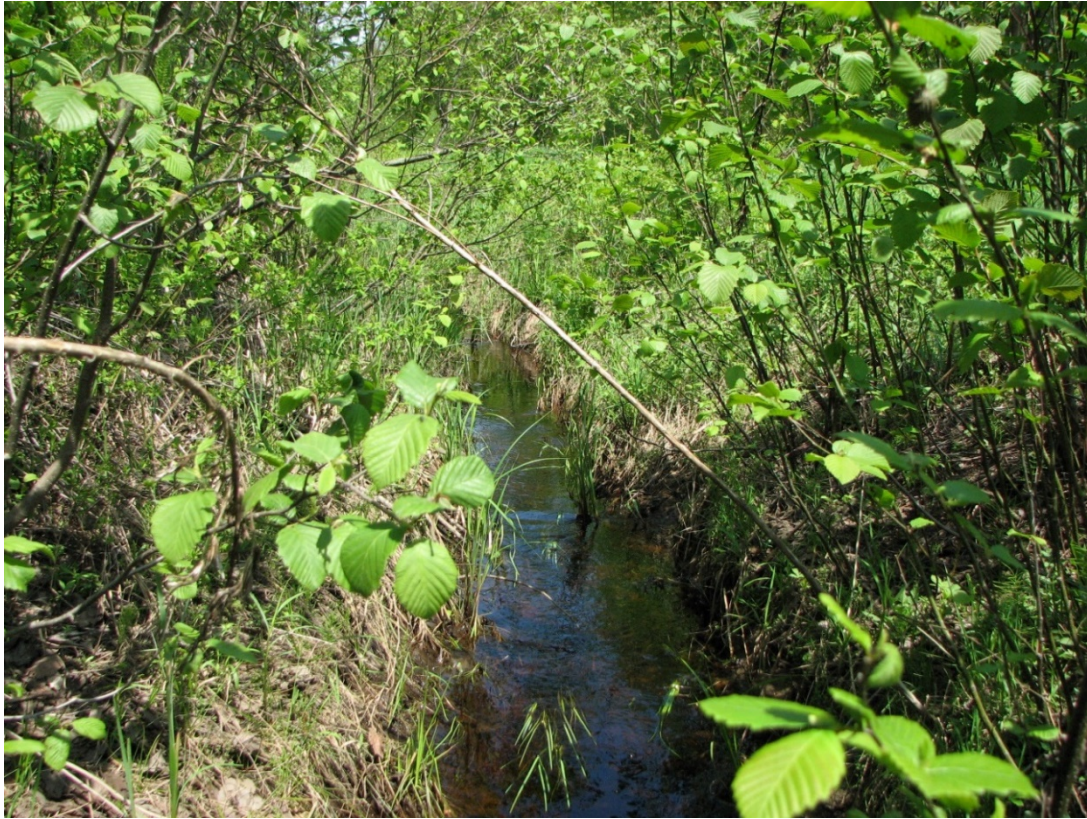
Figure 3 Looking east from Concession Road 6, this headwater drainage feature is measured for flows, as per the Ontario protocol.

- 2) *Headwater drainage feature (HDF) monitoring in spring 2017:* Low water levels in the early part of the year resulted in low flows during the early season sampling of HDF's. As a result, only one channel had sufficient water to be sampled using the Ontario protocol (Figure 3).

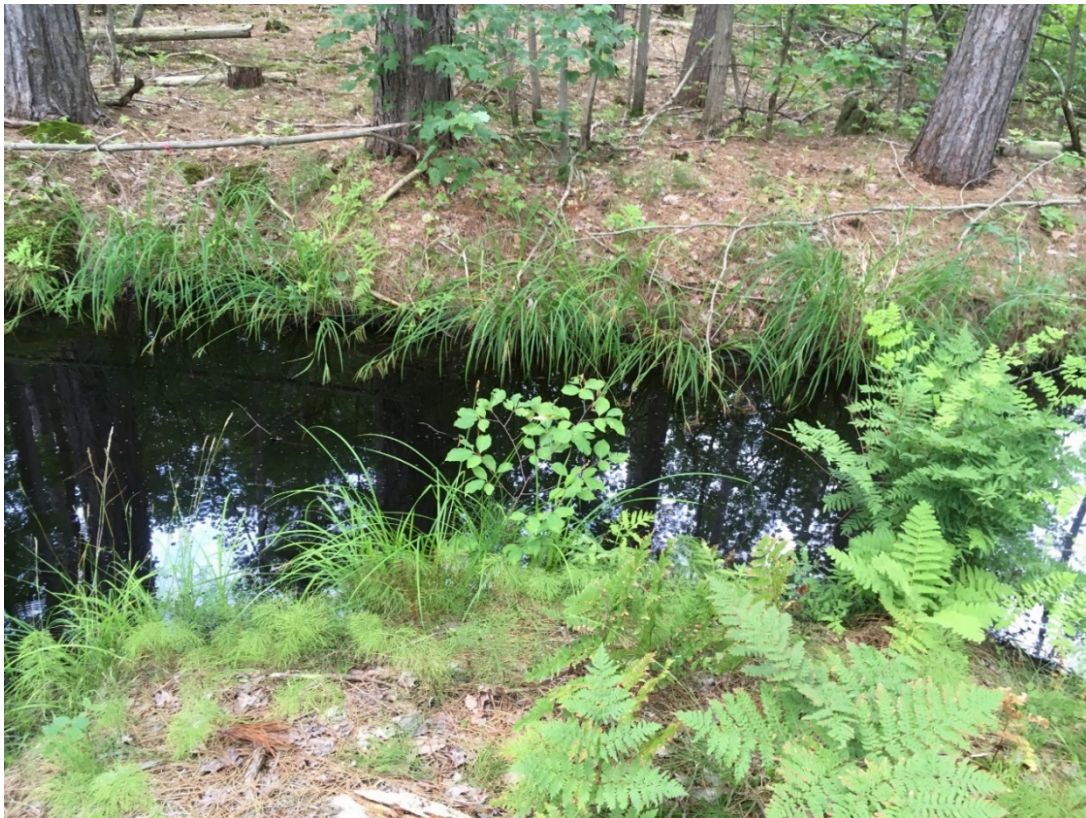
Figure 4 Conditions during baseflow measurements, as seen in this photo, show that water is ponded and not flowing.

- 4) *Water quality and base flow monitoring of site:* Base flows were barely perceptible on the date it was tested. Photos show ponded water that was not flowing, or had very little flow (Figure 4).

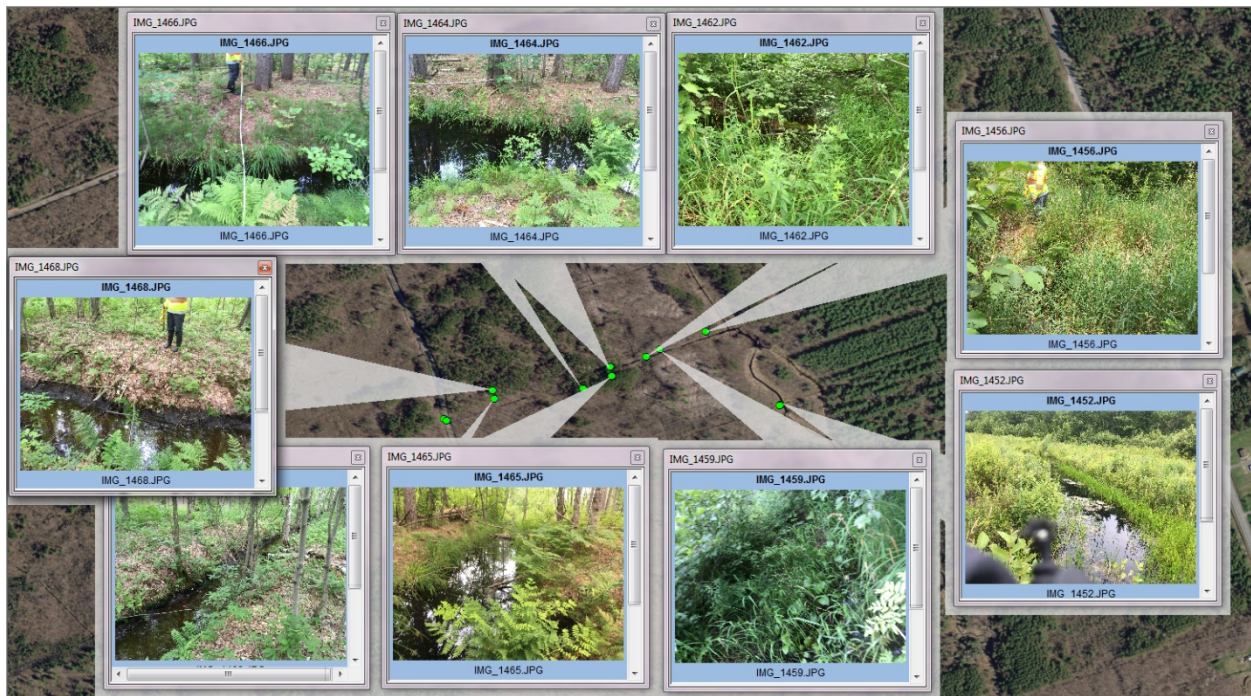
Figure 5 Inset photos show the location where the photos were taken within the project site during the bank measurements activity.

Measurements of the middle drain were taken to calculate the slope and provide a baseline for determining the new channel configuration. Figure 5 shows the locations where measurements were taken. The middle drain is the deepest and is therefore the drain that needed the most design work. Table 2 shows the 6 width and depth measurements taken at roughly 100 metre intervals. Figures 6-8 depict the cross sections of the middle drain. The Ontario Flow Assessment Tool (OFAT) (<http://www.gisapplication.lrc.gov.on.ca/OFAT/Index.html?site=OFAT&viewer=OFAT&locale=en-US>) was used to calculate the sub watershed characteristics. Only the north and middle drains were assessed using OFAT (Figures 9 & 10, Tables 3 & 4). The third drain is too small and could not be located on the OFAT map. Figures 11 & 12 depict the final design for the middle drain.

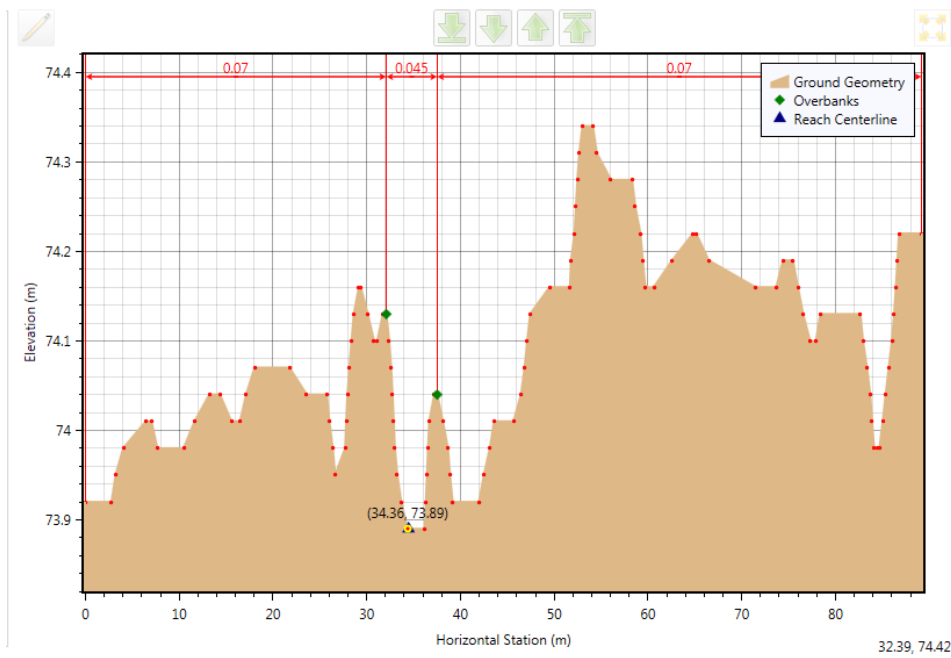
Figure 8 Graph shows cross-section of the lower portion of Drain 2, not to scale.

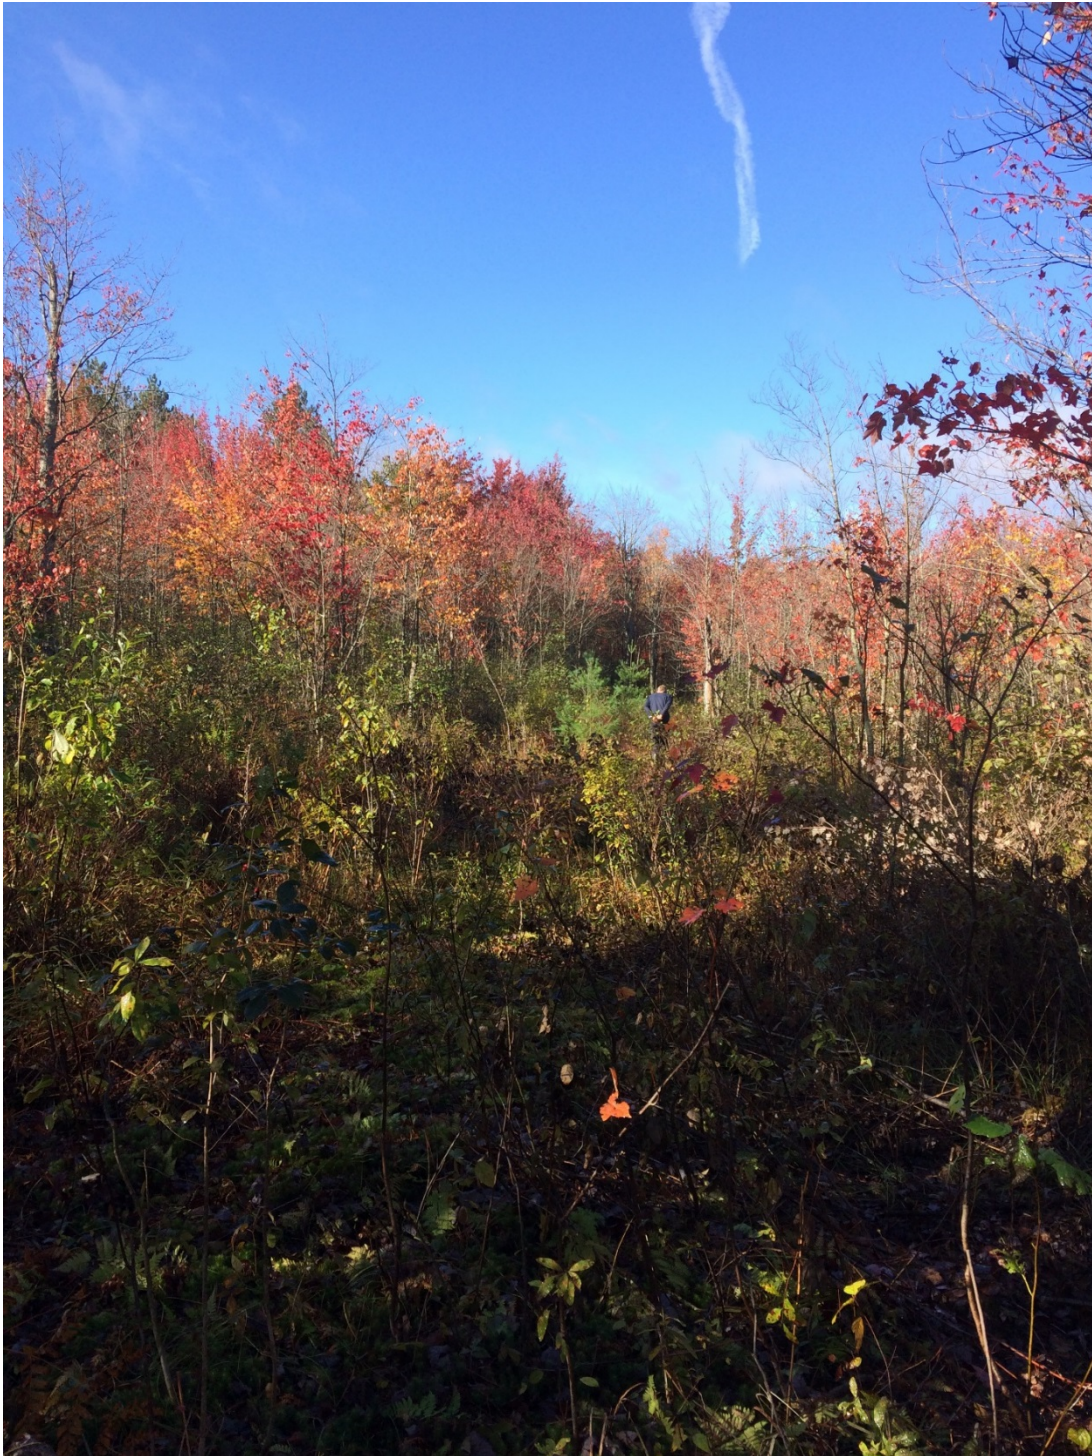
*Figure 13 Looking west towards Concession 6 Road, this photo shows the north bank 3-metre clearance cut by the Contractor (seen in blue shirt).*

- 6) *Site preparation for HDF restoration:* Brushing and vegetation removal was contracted to a local business that has substantial experience with this activity. The Contractor was selected from the businesses that bid on the Request for Quotes issued by SNC. The successful applicant completed the vegetation removal along 1,500 metres of drainage works to provide access for the excavator (Figure 13).

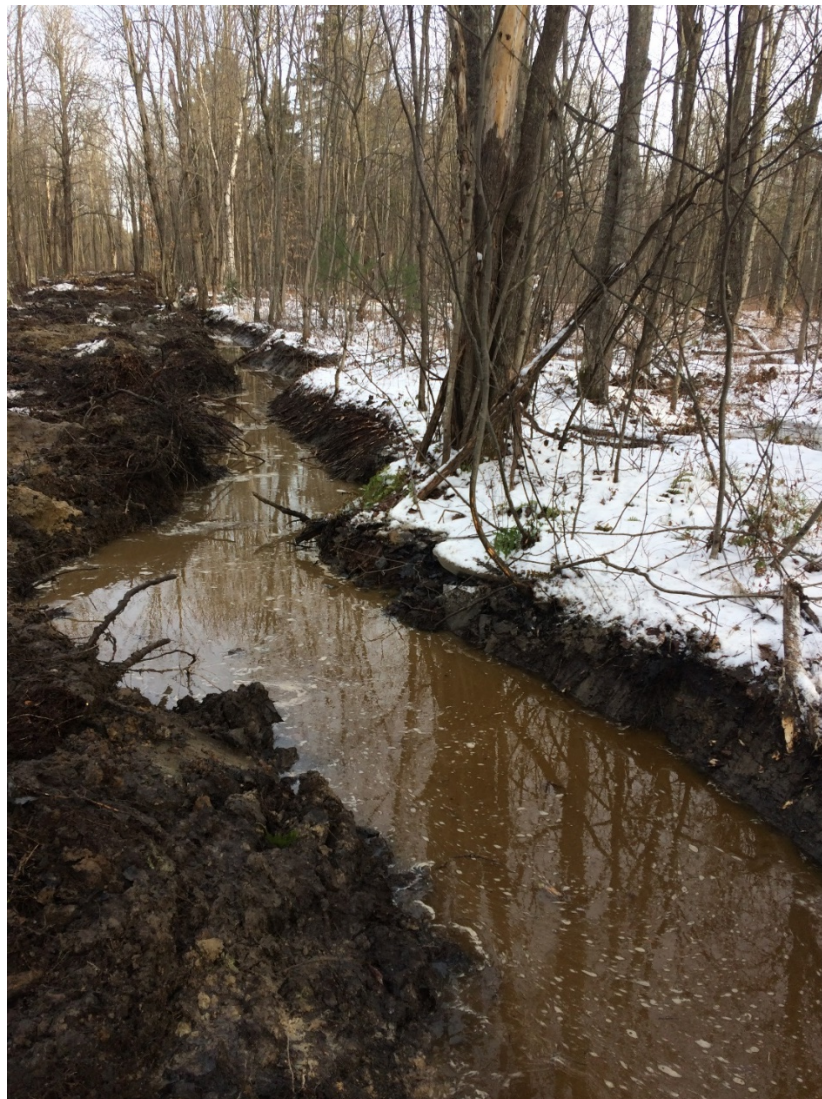
*Figure 14 Excavation works created meanders in the channel to help recreate natural shaping caused when water levels are high. This will typically take place during the spring freshet.*

- 7) *Site restoration of (1,500m)*: Excavation took place in late November. The contractor used a small excavator that weighed approximately 3,600 Kg with wide tracks to prevent deep ruts and the risk of sinking. The project channels were outfitted with silt fencing at approximately 30 metres upstream of the outlet to prevent large volumes of sediment from entering the wetland. After installing the silt fence, the contractor began excavating at the outlet-end of the channel and worked upstream (Figure 14). This action prevented water from impounding above the work area. The silt fences were removed, apart from one that was frozen in Drain 1. That silt fence will be removed early in the spring, to prevent water backing-up.
