SOUTH NATION
CONSERVATION
DE LA NATION SUD

State of the Nation Report

June 2014

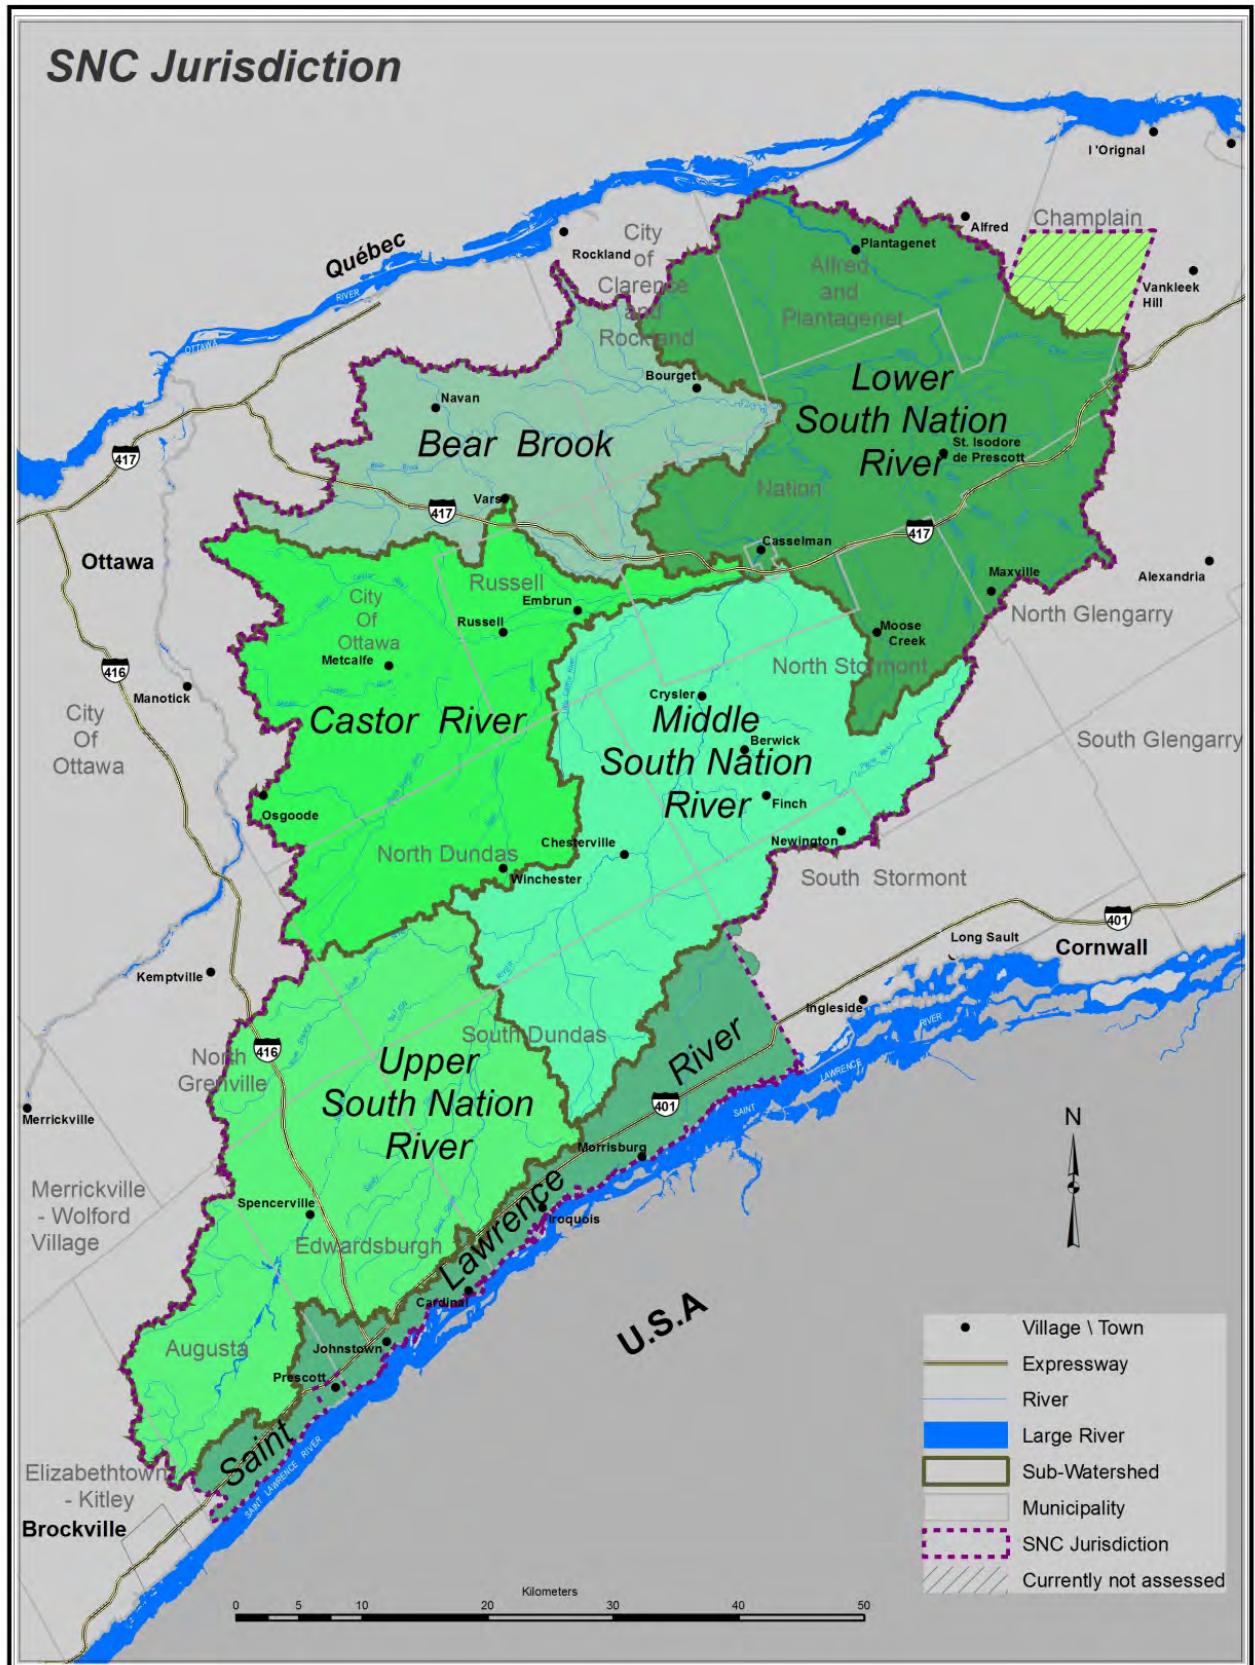
Figure 1: South Nation Conservation jurisdiction, 2014.

SNC's jurisdiction (Figure 1) is located within the counties of Leeds and Grenville, Stormont, Dundas and Glengarry, Prescott-Russell, and the City of Ottawa. It embodies the South Nation River watershed, which flows in a north-easterly direction from the headwaters just before Brockville to Plantagenet before discharging into the Ottawa River. This watershed is approximately 4200 km², and descends a total of 80m in elevation over a length of 180km.

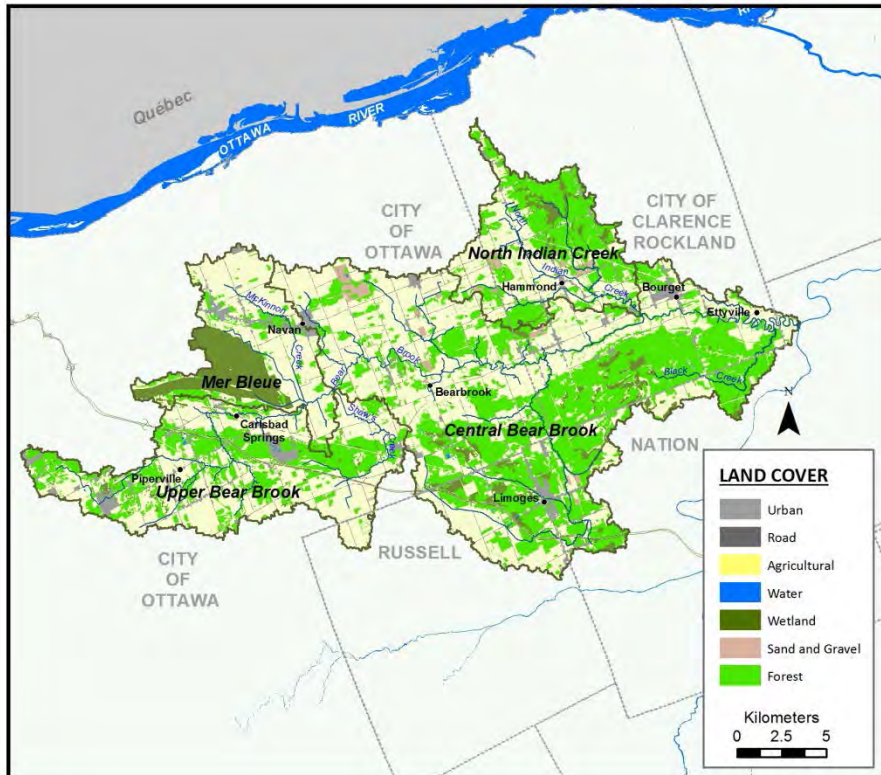
Figure 2: Bear Brook 6th order subwatershed, monitored in 2008

5th Order Subwatersheds:

- Upper and Central
- Bear Brook
- Mer Bleu
- North Indian Creek

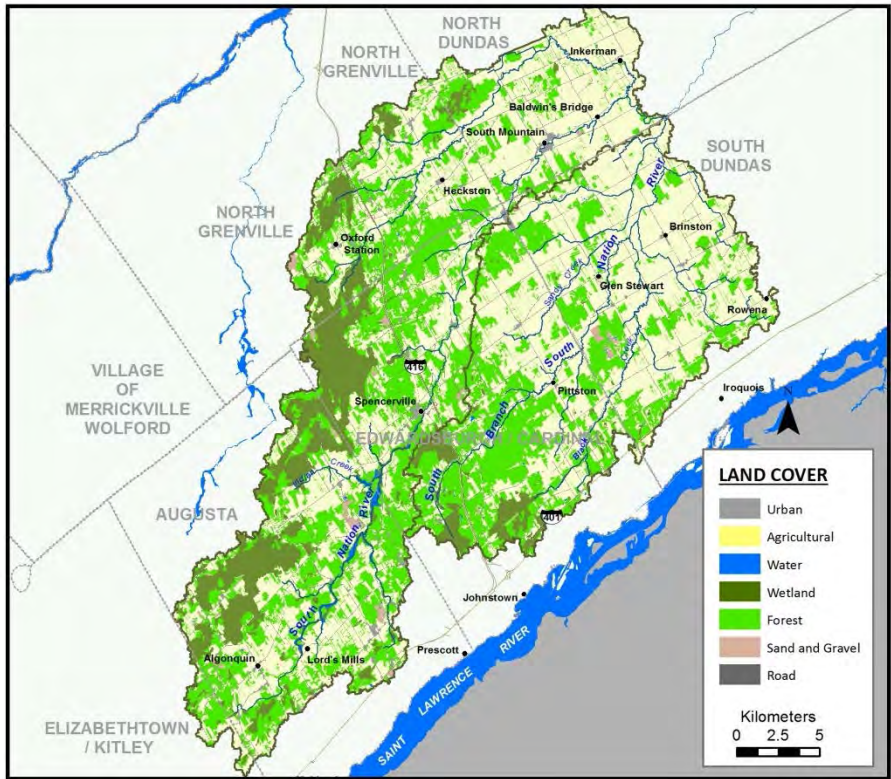
Figure 3: Upper South Nation 6th order subwatershed, monitored in 2009

5th Order Subwatersheds:

- Headwaters South Nation River
- South Branch South Nation River

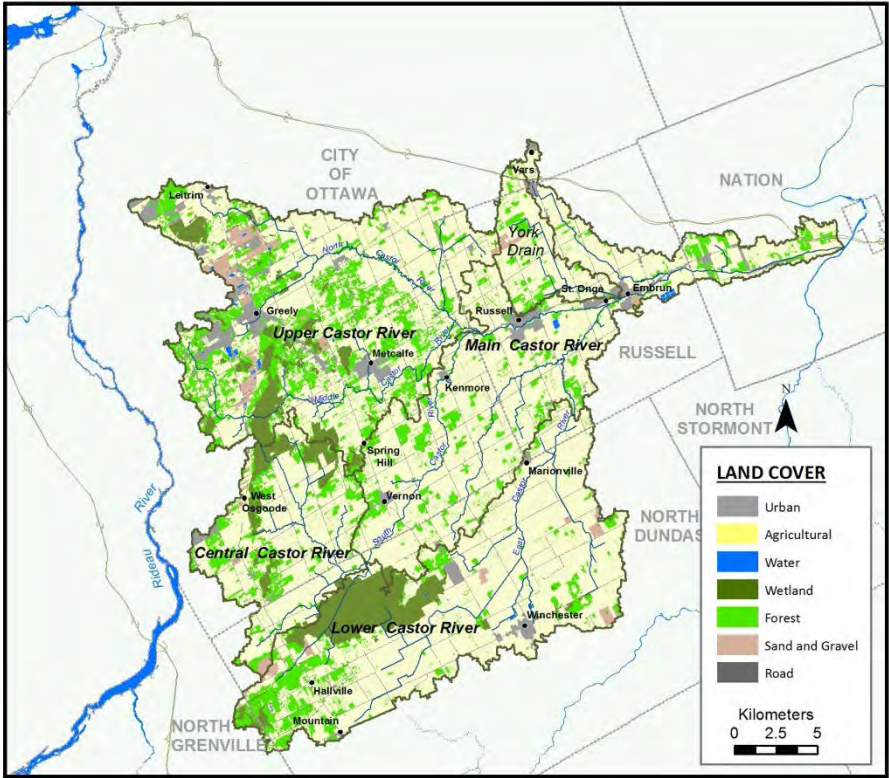
Figure 4: Castor River 6th order subwatershed, monitored in 2010

5th Order Subwatersheds:

- Main Castor River
- Upper Castor River
- Central Castor River
- Lower Castor River
- York Drain

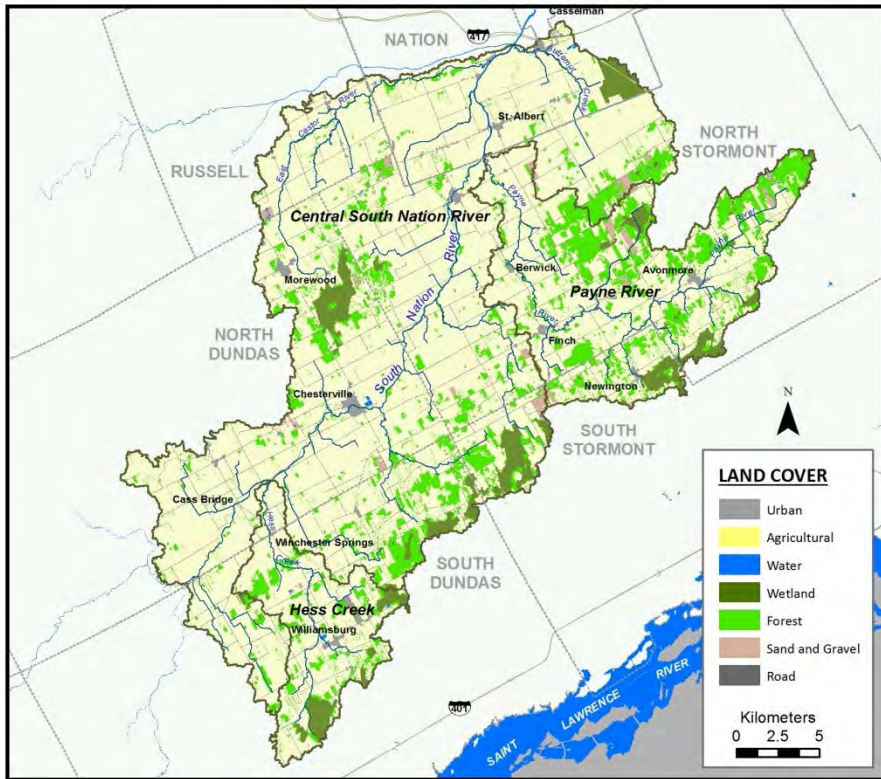
Figure 5: Middle South Nation River 6th order Subwatershed, monitored in 2010

5th Order Subwatersheds:

- Central South Nation River
- Hess Creek
- Payne River

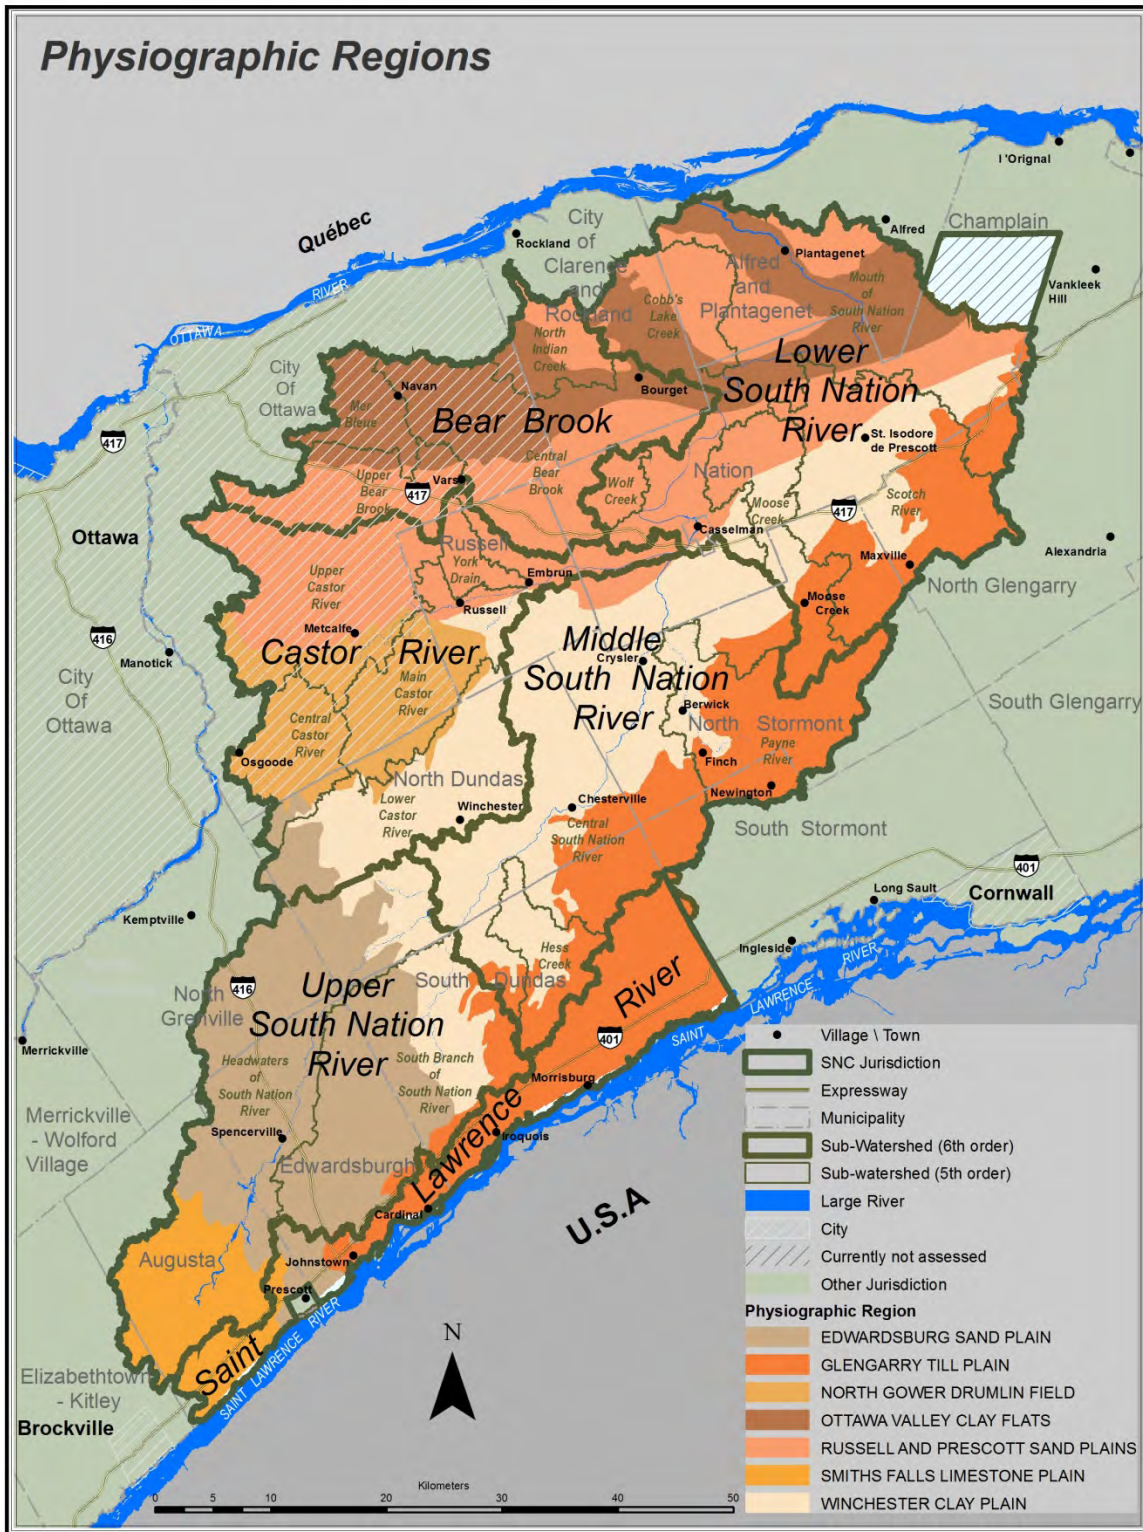
Figure 7: Physiographic regions within the State of the Nation study area

Edwardsburg Sand Plain: The bedrock and most of the boulder clay are covered by sand. The sand surface is largely level with hummocks or ridges in some places. The soils are acid and deficient in nutrients.

North Gower Drumlin Field: Drumlins arise from a clay plain. While the drumlins have good drainage, the clay soils are poorly drained.

Glengarry Till Plain: The undulating to rolling surface consists of drumlins with clay flats. The loamy till is often less than 8 m deep, but does reach a depth of 30 m. Its stoniness is noticeable.

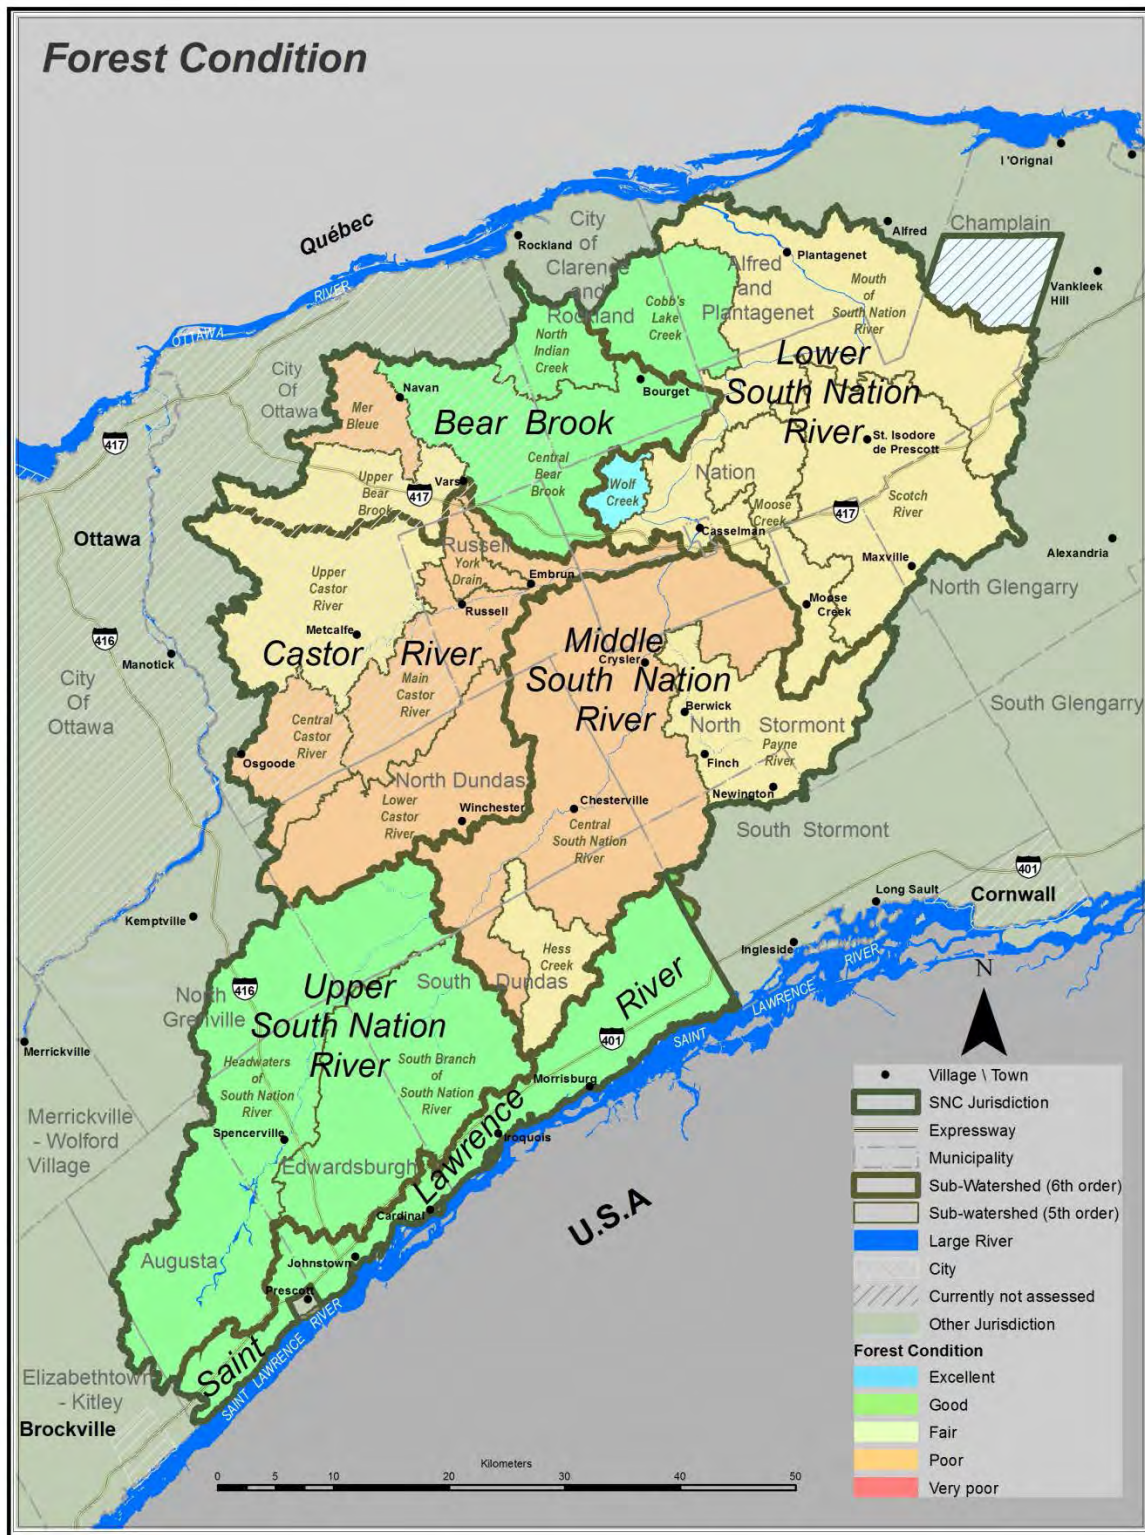
Figure 8: Forest conditions within the South Nation Conservation jurisdiction

Lower South Nation River Subwatersheds), as well as the North Gower Drumlin Field (Castor River subwatershed). Forested riparian cover is low throughout SNC's jurisdiction, with 24.1% of 30-m buffers on either side of streams in forest cover. This parameter trends with physiographic unit, similar to forest cover and forest interior.

Overall, forest cover is good in SNC’s jurisdiction at 29.5%. Large forest blocks including the Larose Forest, Warwick Forest Tract and Edwardsburg Land Assembly contribute to good forest interior habitat. Large forest blocks are typically found in areas that have lower land capability classes for agriculture. This includes physiographic units that are associated with shallow soils such as Smith’s Falls limestone plain, or soils that are affected by water and wind erosion such as the Russell and Prescott sand plains and Edwardsburg sand plains.

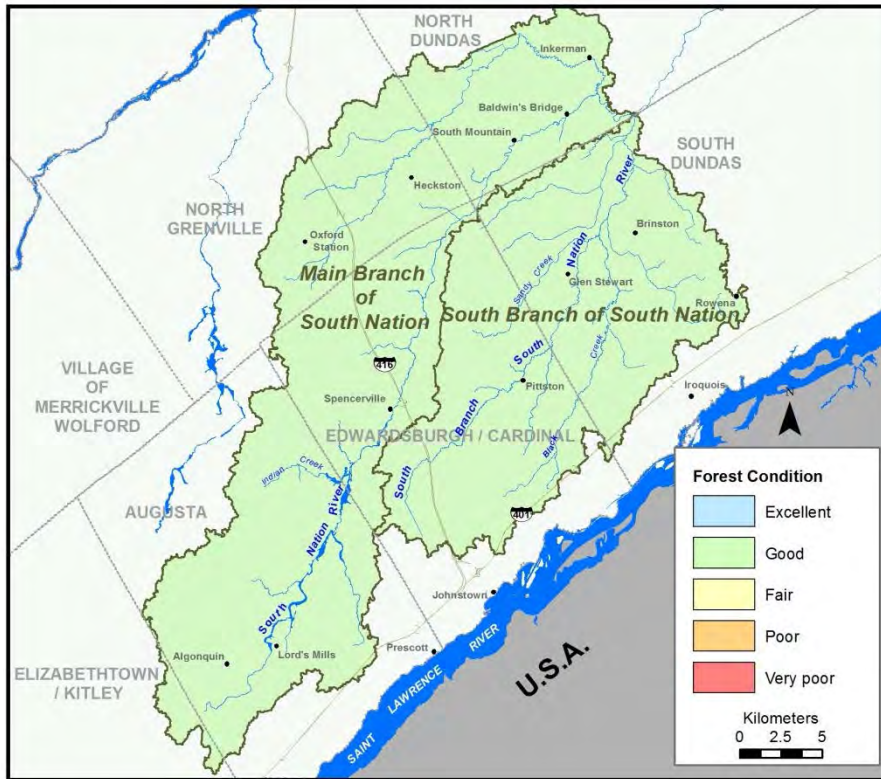
Figure 10: Forest conditions in Upper South Nation Watershed

The upper reaches of the South Nation River is located primarily in Edwardsburg sand plain (63%), and Smiths Falls limestone plain (17%). The physiography of this area has aided in the preservation of high forest cover and forest interior, especially in the Main Branch subwatershed. Similarly, the South Branch subwatershed has good forest cover and forest interior habitat in the upper reaches. As the lower reaches of this subwatershed flow through Winchester clay plain, lower forest cover is observed.

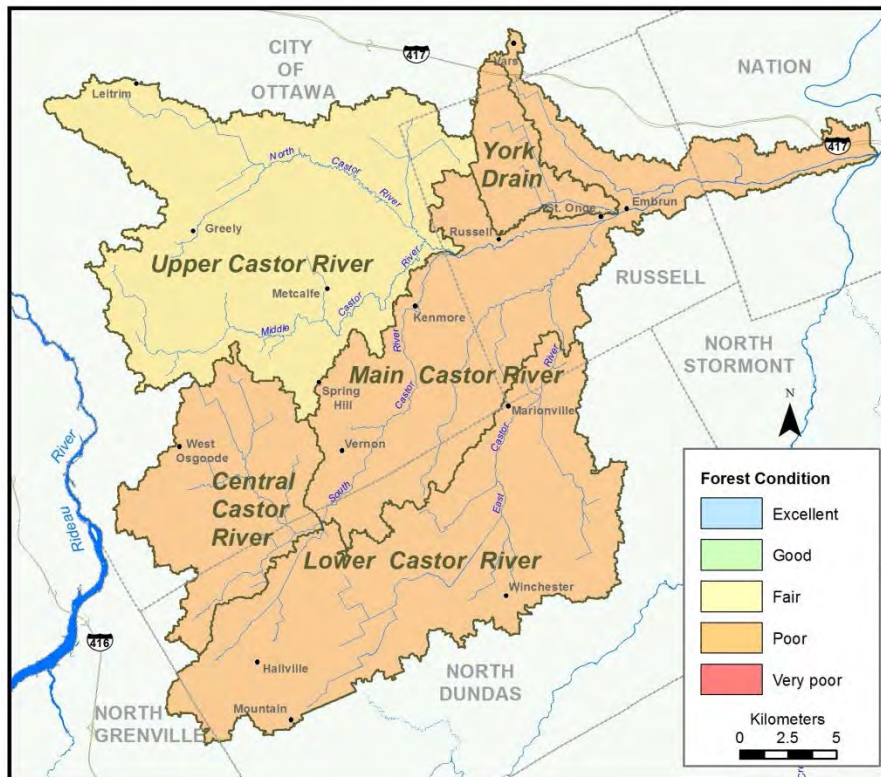
Figure 11: Forest conditions in Castor River Watershed

Most of the Castor River watershed is located in physiographic units that yield high land capability classes for agriculture, including Winchester clay plain (24%) and North Gower drumlin field (34%). Consequently, low forest cover, and forest interior is observed across most of the watershed. The Upper Castor subwatershed is located primarily in Russell and Prescott sand plain, resulting in the highest forest cover in the watershed at 28.8%. This subwatershed has low forest interior habitat, a result of several quickly urbanizing communities, including Findlay Creek, Greely, and Metcalfe. Forested riparian cover remains low across the entire subwatershed.

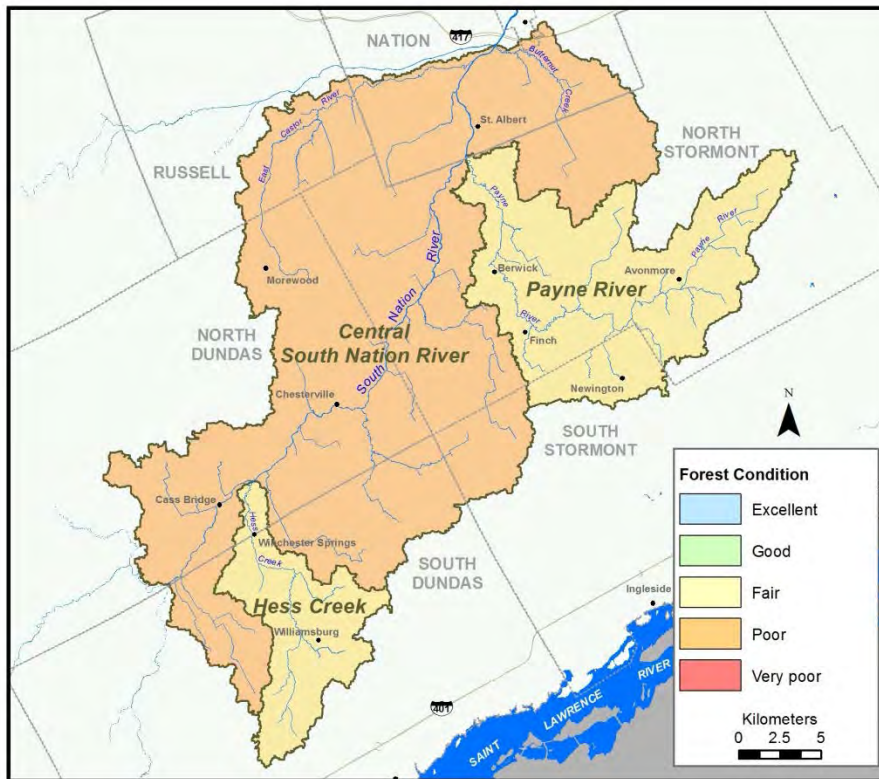
Figure 12: Forest conditions in Middle South Nation Watershed

The Middle South Nation watershed is comprised of three subwatersheds – Hess Creek, Payne River and the central reaches of the South Nation River. The Central South Nation subwatershed is located in the Winchester clay plain (71%), where low forest cover and low forest interior is observed. Hess Creek and Payne River subwatersheds observe similar trends in their lower reaches; the headwaters of these two systems are located in Glengarry till plain, where good to fair forest cover and forest interior are observed. Forested riparian cover trends with physiographic unit, similar to forest cover and forest interior. Over-all riparian cover is low within the Middle South Nation watershed.

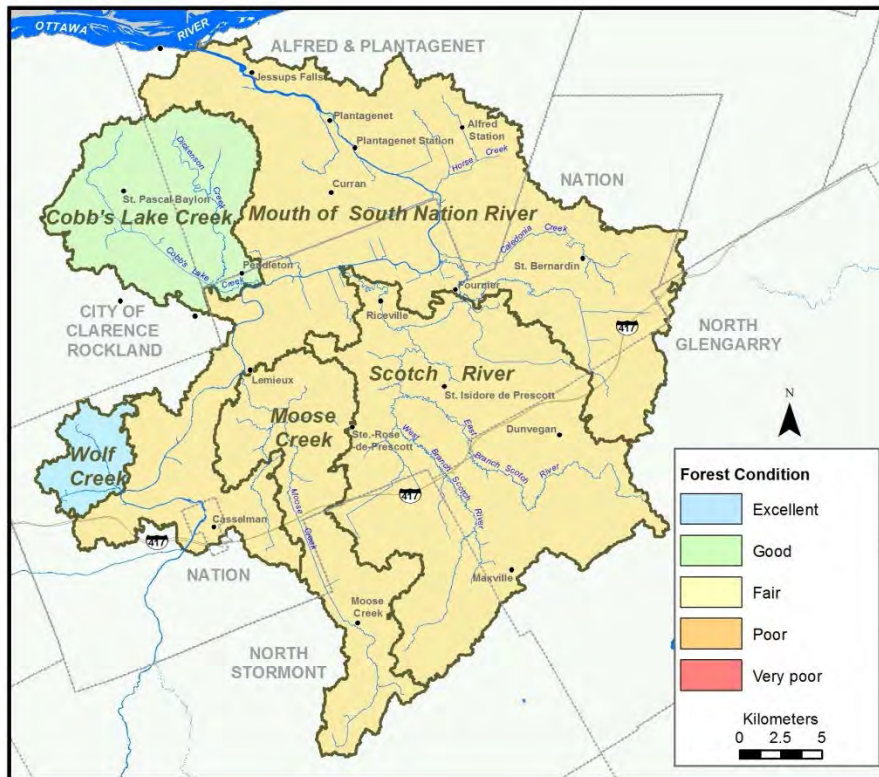
Figure 13: Forest conditions in Lower South Nation Watershed

Overall, forest cover and forest interior are good within the Lower South Nation watershed. Large tracks of forest exist within the Russell and Prescott sand plains located in Wolf Creek (Larose Forest), and the headwaters of Cobb's Lake Creek subwatersheds. Additional forest cover is located within several forested wetlands and forests situated along the Glengarry Till plains in the headwaters of the Moose Creek, and Scotch River subwatersheds. Similar to other watersheds, lower forest cover and forest interior is observed on land located within Winchester clay plains, and Ottawa Valley clay flats. Riparian cover is low throughout this watershed and requires improvement.

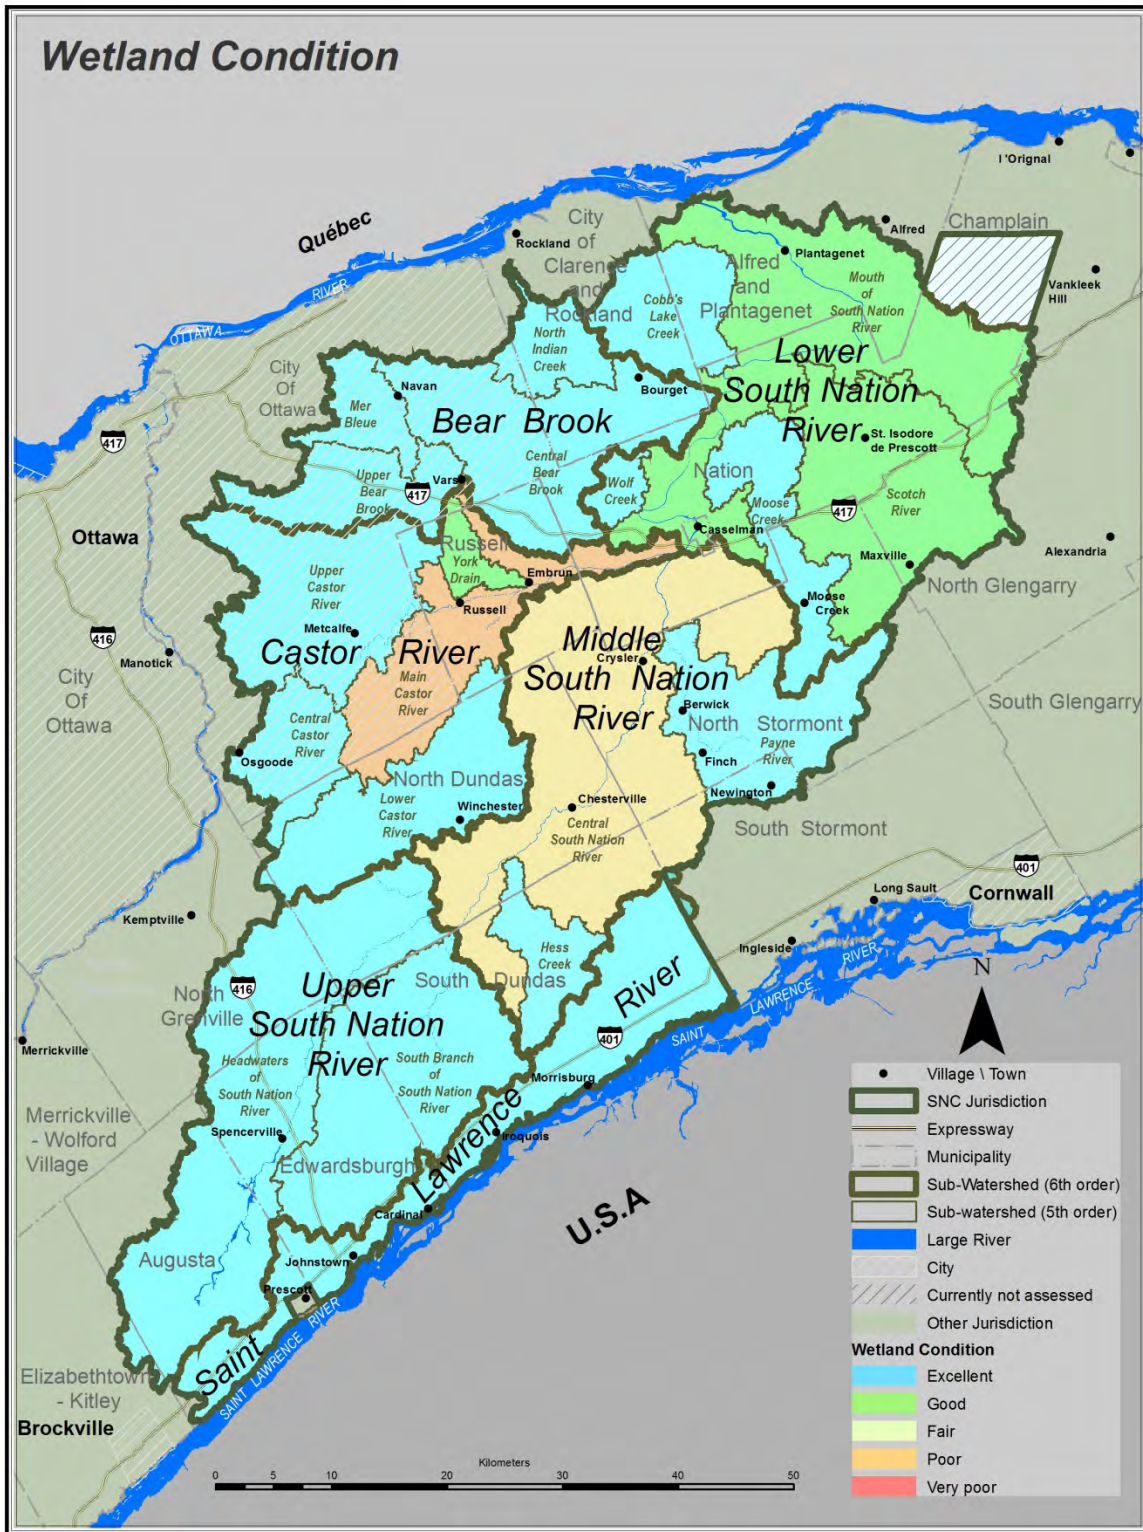
Figure 14: Wetland conditions within the South Nation Conservation jurisdiction

Wetland cover results are excellent within SNC’s jurisdiction, with 17% of the area in wetland cover (see Figure 14). The large proportion of wetland habitat can be attributed to the physiography of the area, and several large wetland complexes. Table 11 provides a summary of the wetland cover results across SNC’s jurisdiction. Tables 12 to 16 and Figures 15 to 19 provide results for the St. Lawrence River subwatersheds, as well as the 5th order subwatershed results for the South Nation watershed. Grading according to Conservation Ontario Guidelines is also presented.

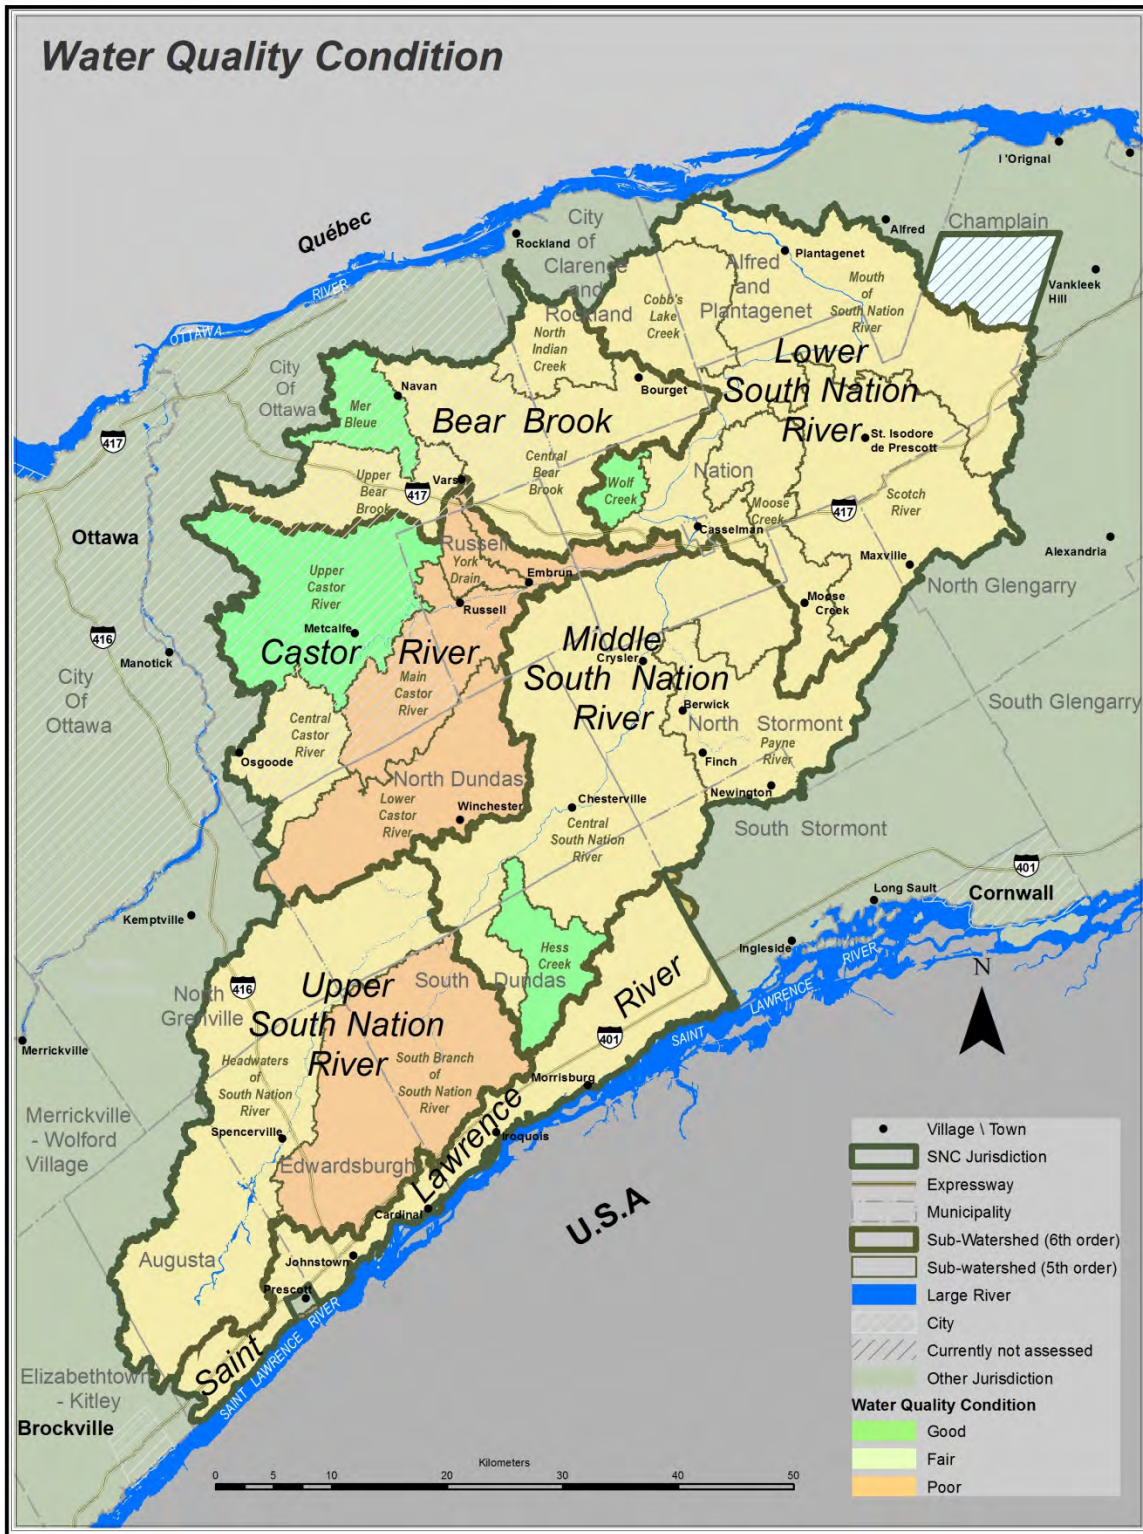
Figure 20: Water quality conditions within the South Nation Conservation jurisdiction

SNC's jurisdiction covers a large and diverse landscape; the biological condition of streams is variable across the study area. 37% percent of the test sites assessed are in good condition, while 40% are in fair condition, and 23% are in poor condition. Table 17 provides a summary of the bioassessment results across SNC's jurisdiction; Figure 20 illustrates the water quality at the 5th order subwatershed scale, and Figure 21 depicts the water quality results at each sampling site. Tables 18 to 23 and Figures 22 to 26 provide St. Lawrence River subwatershed, and 5th order South Nation River subwatershed results.

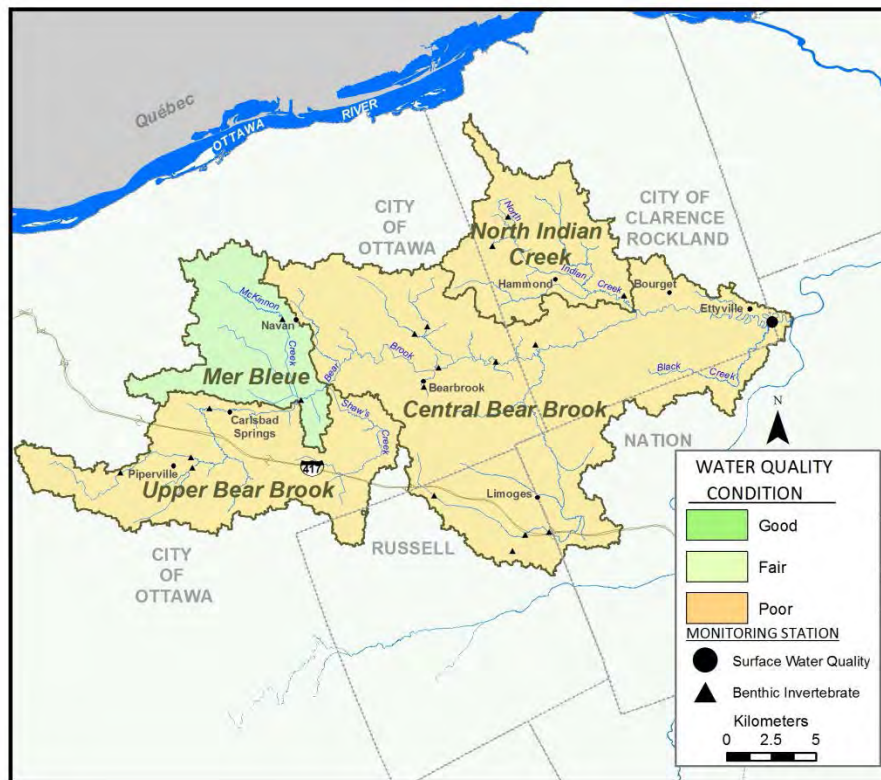
Figure 22: Water quality conditions in Bear Brook Watershed

The condition of test sites in the Bear Brook watershed range from good (7 sites, 39%) to fair (10 sites, 56%). One site was assessed as poor. Figure 22 depicts average subwatershed conditions. Sites observed in good condition, are located in areas with good forest cover, especially along the banks of the river (riparian buffer). The site that was assessed as poor, had very little riparian cover, and noticeable sedimentation issues within the watercourse.

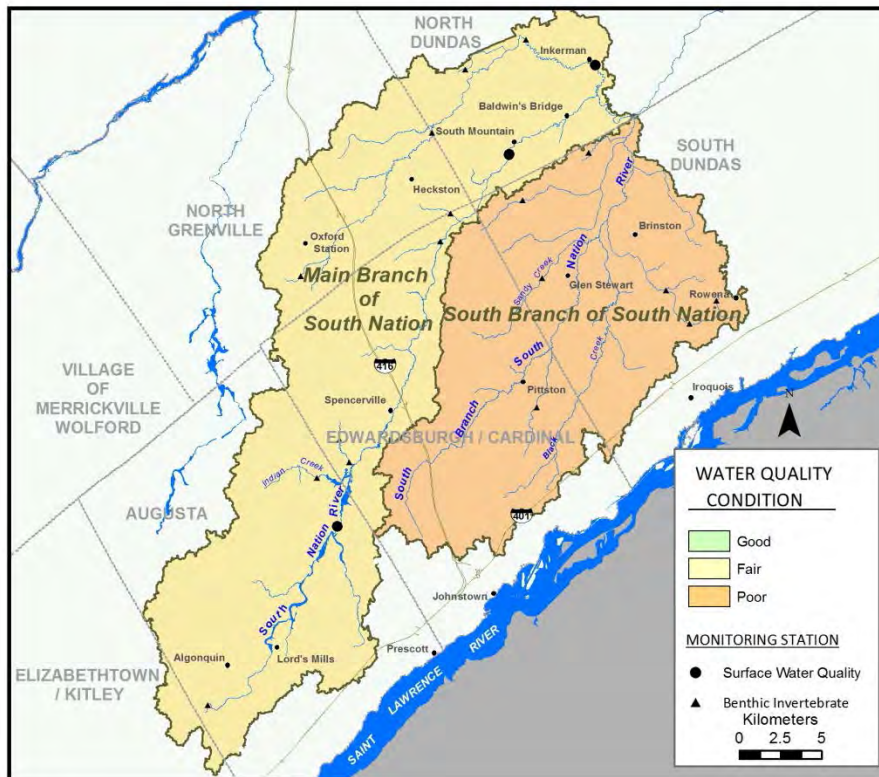
Figure 23: Water quality conditions in Upper South Nation Watershed

The condition of test sites in the Upper South Nation watershed are variable, with 5 sites in good condition (28% of sites), 7 sites in fair condition (39%), and 6 sites in poor condition (33%). All sites assessed as healthy are located in the Main Branch subwatershed. Sites assessed in poor condition are located in the South Branch subwatershed.

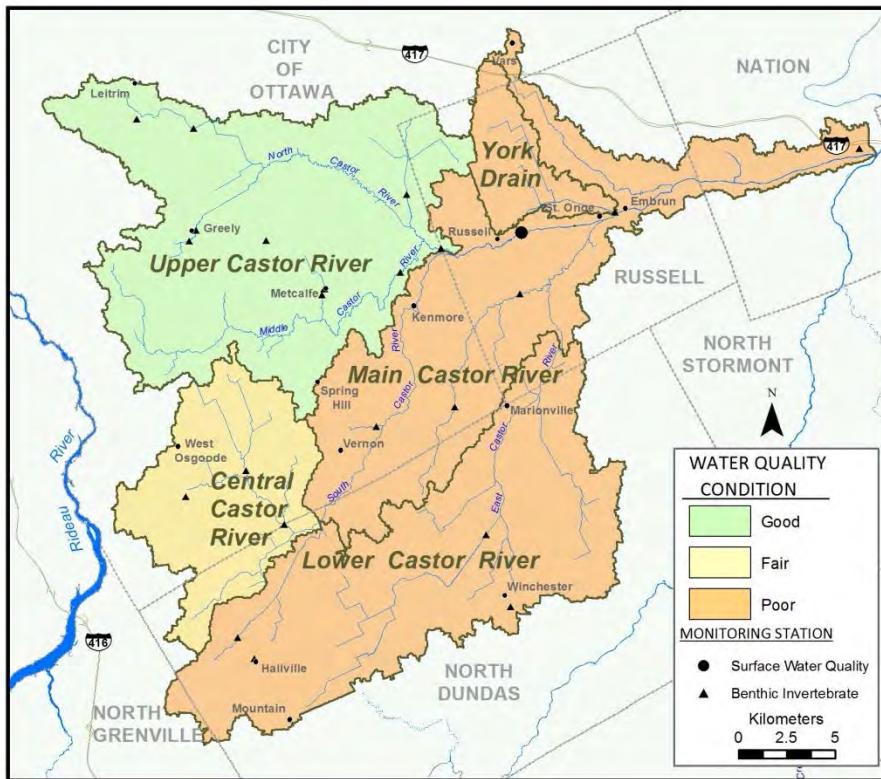
Figure 24: Water quality conditions in Castor River Watershed

River condition results in the Castor watershed are variable, with 32% of the watershed in good condition, 32% in fair condition, and 36% in poor condition. Most sites observed in good condition occur in the Upper Castor subwatershed. This subwatershed is located primarily in Russell and Prescott sand plains, and observes high forest cover. This subwatershed is under development pressure; future bioassessments will be important for monitoring potential impacts within this minimally impacted subwatershed.

Most sites observed in poor condition are located in the Main Castor and Lower Castor subwatersheds. These systems are located in physiographic units that yield high land capability classes for agriculture. Forest cover and riparian cover are low, limiting in-stream habitat features.

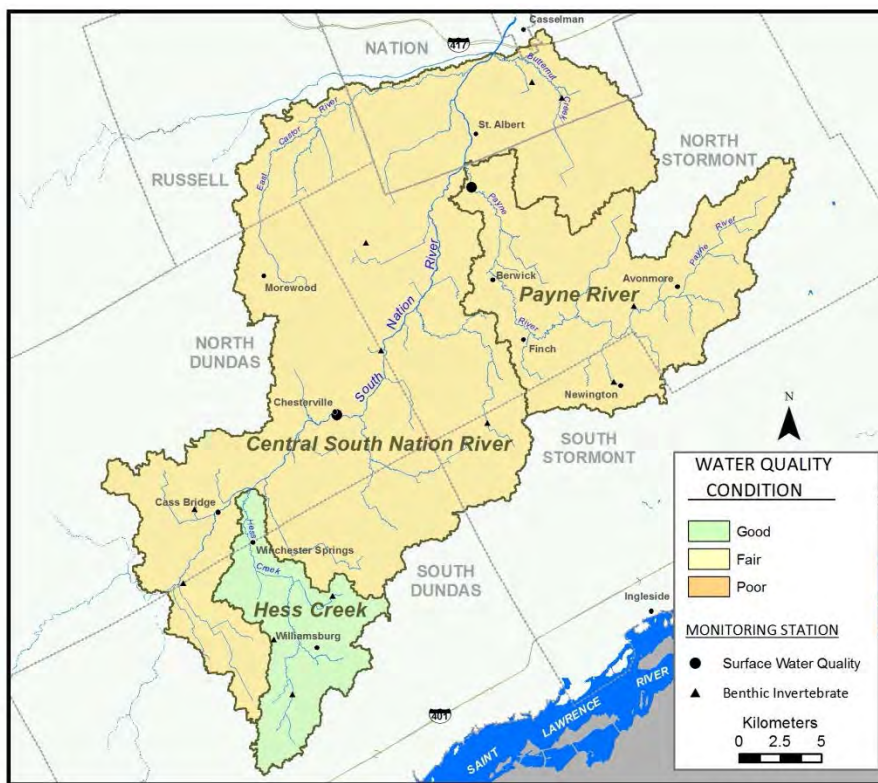
Figure 25: Water quality conditions in Middle South Nation Watershed

River conditions in the Middle South Nation watershed are variable, with 50% of the watershed in good condition, 30% in fair condition, and 20% in poor condition. Sites observed in good condition are located in the headwaters of the Hess subwatershed and Payne subwatershed. These sites are located in Glengarry till plain, where good to fair forest cover and forest interior are observed.

Sites in fair to poor condition are located in physiographic units that yield high land capability classes for agriculture. Forest cover and riparian cover are low, limiting in-stream habitat features.

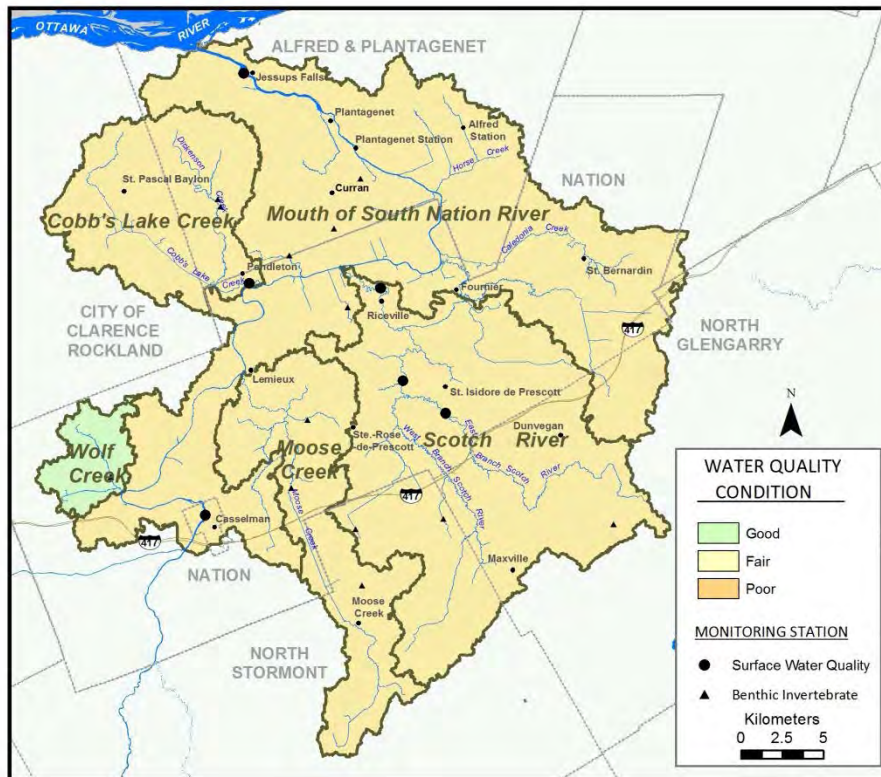
Figure 26: Water quality conditions in Lower South Nation Watershed

River conditions in the Lower South Nation watershed are variable, with 42% of the watershed in good condition, 50% in fair condition, and 8% in poor condition (Table 27 and Figure 25). The Wolf Creek subwatershed remains one of the least disturbed subwatersheds in SNC’s jurisdiction, resulting in healthy river conditions. Additional sites observed in good condition are located in the headwaters of the Moose Creek, and Scotch River subwatersheds. These sites are located in Glengarry till plain, where good to fair forest cover and forest interior are observed.

Sites in fair to poor condition are located in physiographic units that yield high land capability classes for agriculture. Forest cover and riparian cover are low, limiting in-stream habitat features.

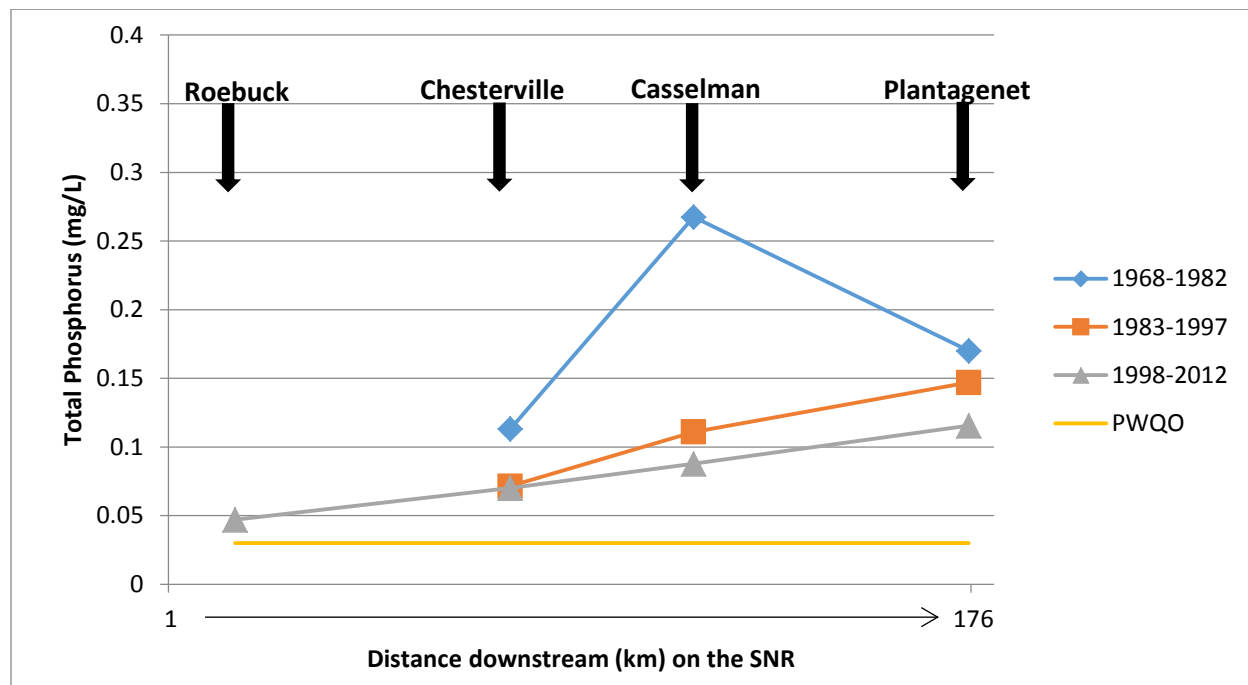
Figure 27: Total phosphorus results in the South Nation River

Total phosphorus levels have been decreasing over time (Figure 27). Trends show a dramatic decrease in total phosphorus concentrations from the first 15-year period (1968-1982) to the second 15-year period (1983-1997). This decrease can be attributed to the construction or improvement of sewage treatment lagoons in Embrun, Casselman and Winchester, as well as the decision to restrict phosphate concentrations in detergents.

A decrease is observed from the second 15-year period (1983 – 1997) to the third 15-year period as well (1998-2012). This is likely due to improvements in agricultural land management, Programs implemented by South Nation Conservation, such as the Total Phosphorus Management Plan, and the Clean Water Program, as well as the increase of forest cover on the landscape.

Total phosphorus levels are decreasing over time. Initial declines observed in the 1980's and 1990's can be attributed to the construction or improvement of sewage treatment lagoons, as well as the decision to restrict phosphate concentrations in detergents. Declines in total phosphorus continue to be observed – the result of improvements in agricultural land management, projects implemented through the Clean Water Program and the Total Phosphorus Management Program, as well as the increase of forest cover on the landscape.
