# North Castor River 2015 Stream Watch Report

## Watershed Feature Summary

## Introduction

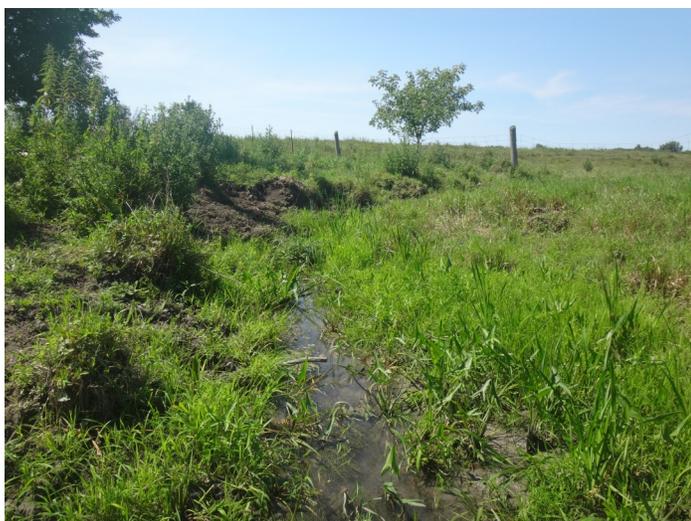
A section of the North Castor River without a suitable buffer between the stream and agricultural practices.

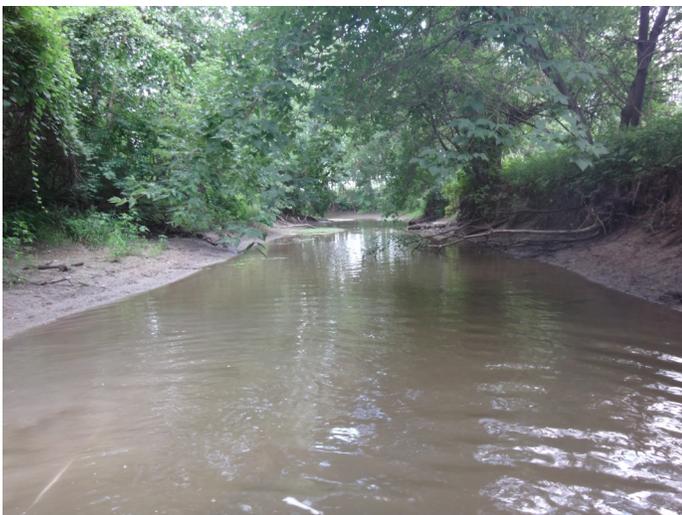
Stream bank erosion along the right bank of the North Castor River may cause future bank failures.

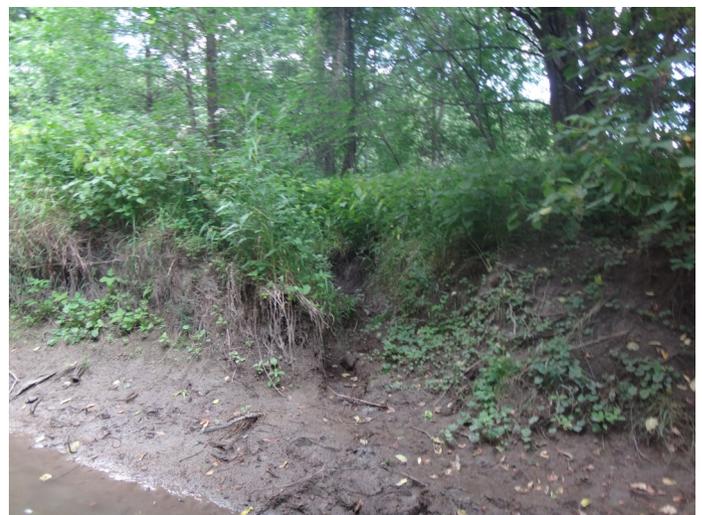
Stream bank erosion has left bare and exposed soil on the bank of the North Castor River in some sections.

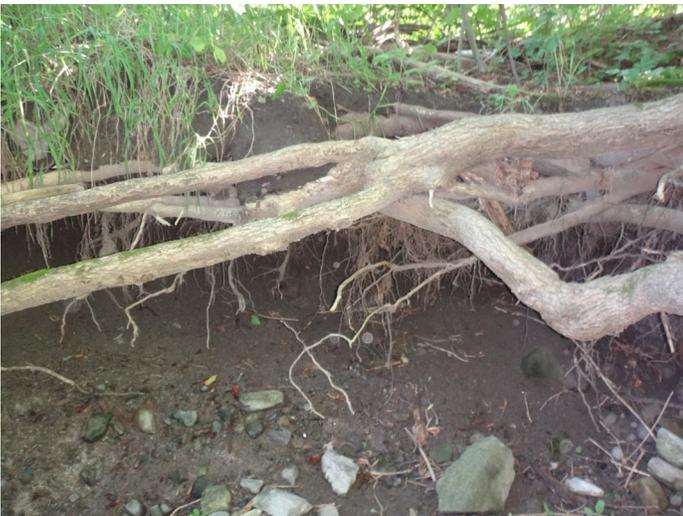
Bank undercutting is occurring along the North Castor River in a few areas near the upper reaches of the river.

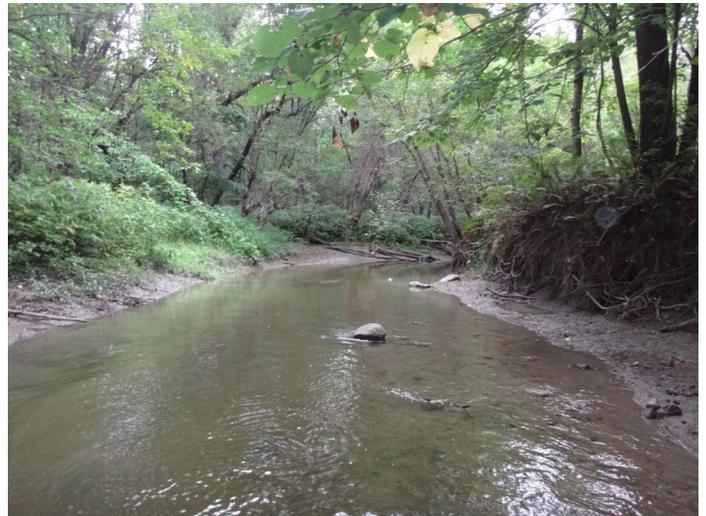
Bank undercutting on the right bank of the North Castor River.

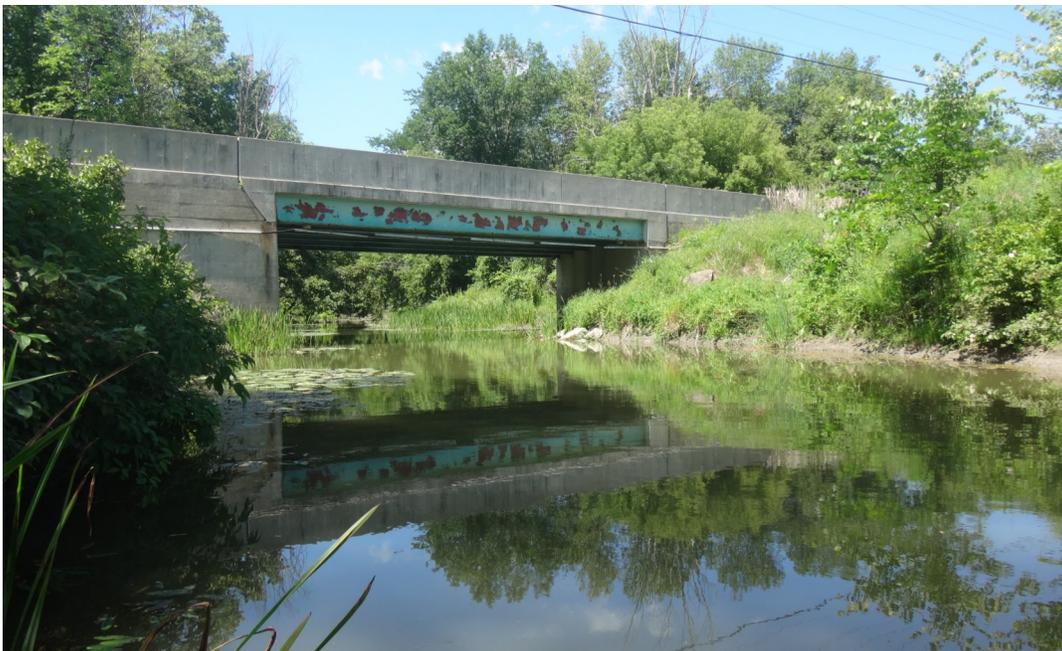
Bridges and other river crossings represent the majority of the altered areas along the North Castor River. A bridge such as the one shown above increases the amount of hardened shoreline and reduces habitat availability.

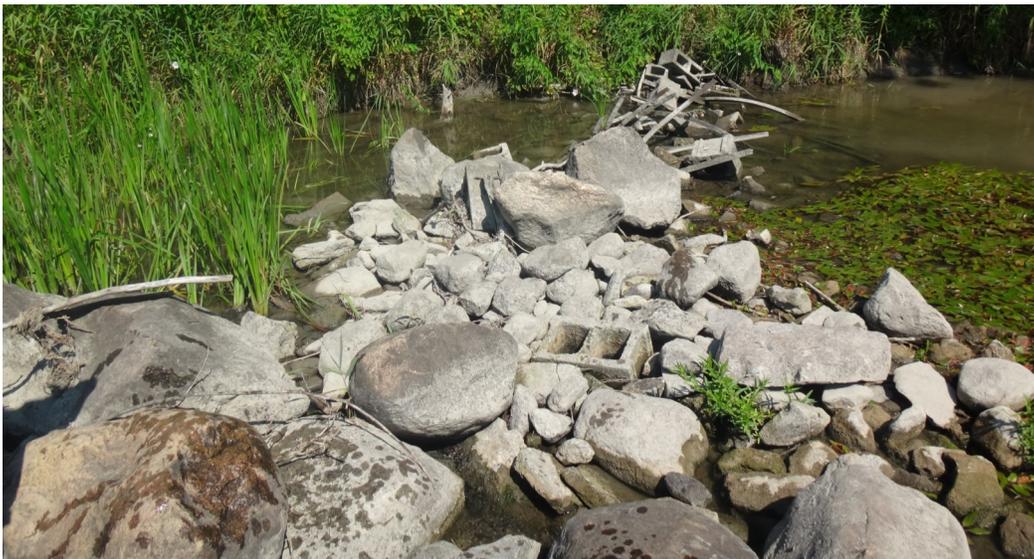
Old stream crossings can reduce flow, create stagnant pools, and increase water temperatures.

Along the North Castor River, several areas could benefit from the removal of low water crossings or perched culvert crossings. There are many old and abandoned low water crossings that are no longer in use since bridges and other infrastructure was built within the North Castor River Subwatershed. As well, there are some culvert crossings where there are perched or raised culverts at certain times of the year. If they were removed or repaired, water flow would be increased and fish migration routes restored to the river. In the future, the removal or repair of abandoned low water crossings and perched culverts ought to be prioritized based upon impact to water quality and quantity. Then, projects can be undertaken to restore water flow to natural form and function in the North Castor River.

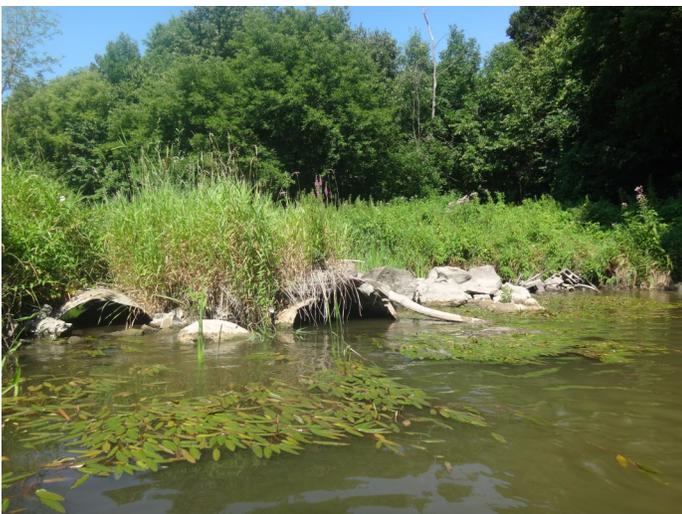
Abandoned stream crossings are obstructions to fish migration.

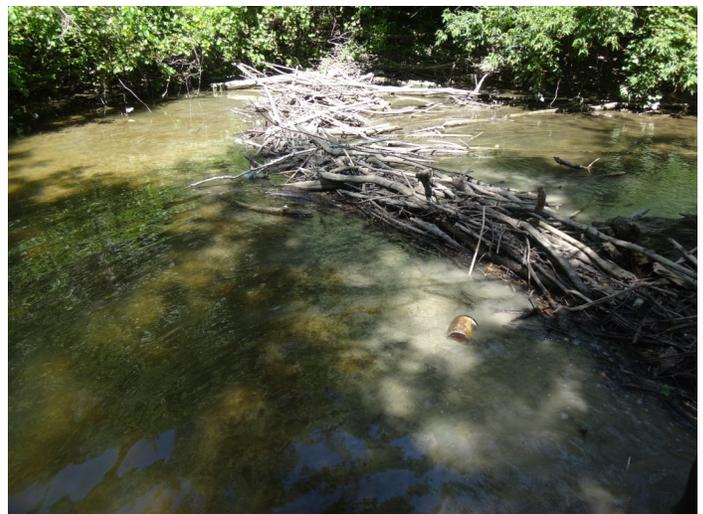
An old beaver dam can act as a barrier to fish migration.

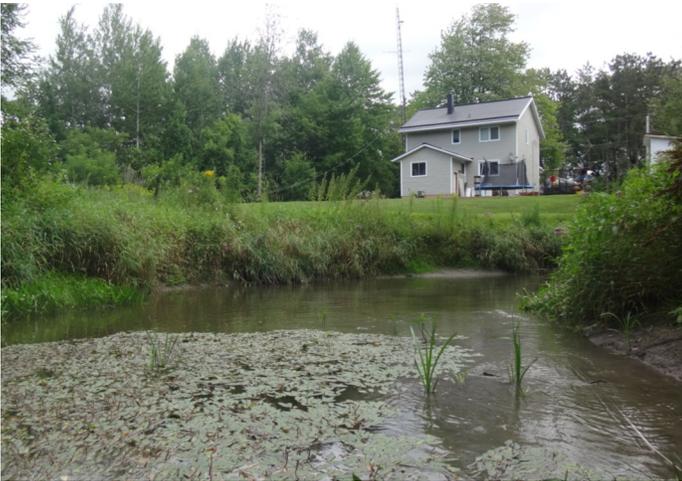
There are several areas along the North Castor River where riparian planting could improve stream shading and habitat.

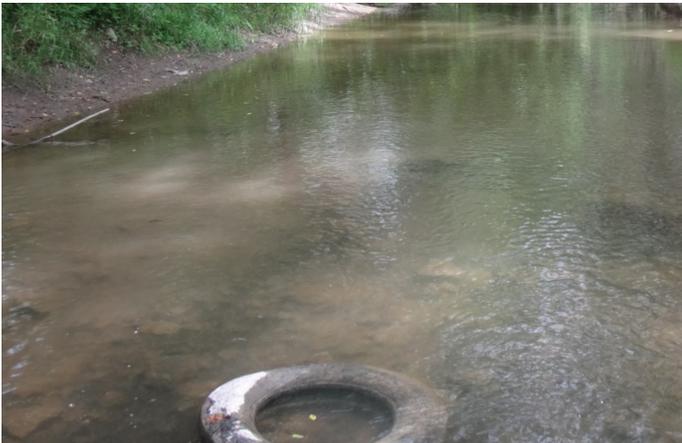
Tires, propane tanks, farm equipment, and household garbage were commonly found within the North Castor River.

A large amount of garbage was found in the North Castor River along the banks and on the stream bottom. Most of the garbage was found downstream of bridges that allow easy access to the river. Future projects ought to involve stream garbage clean-ups in areas identified through Stream Watch to remove the garbage from the stream. Volunteers and land owners in the North Castor River Subwatershed should be encouraged to participate in stream cleanups.

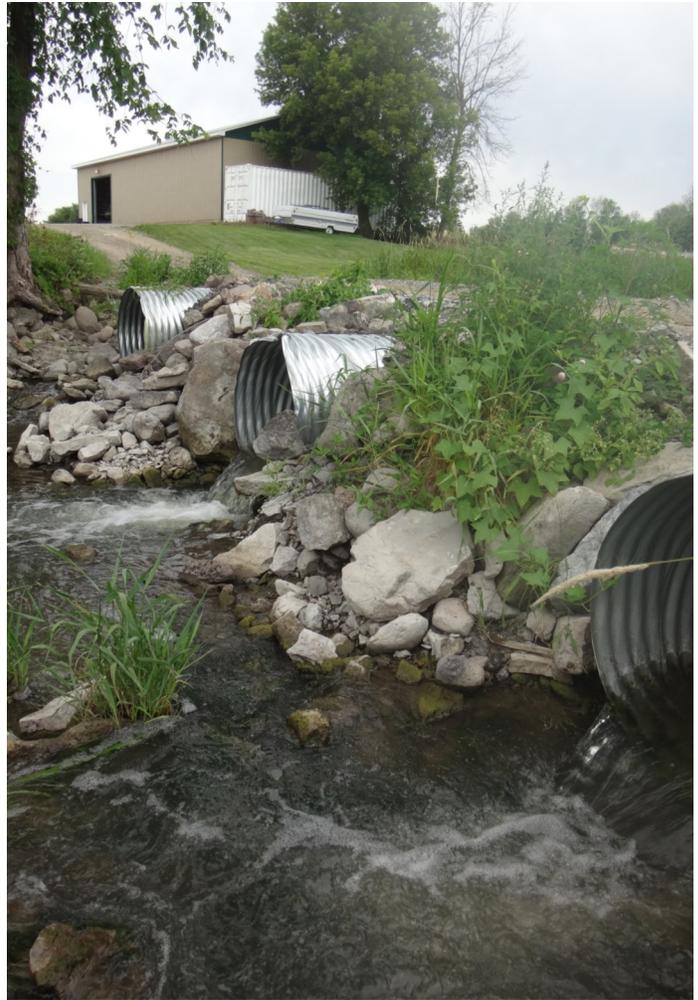
A triple-perched culvert was identified along the stream that could be improved to allow more effective fish migration in low water flow times.
