Hoasic Creek Subwatershed Plan

- Final Report -

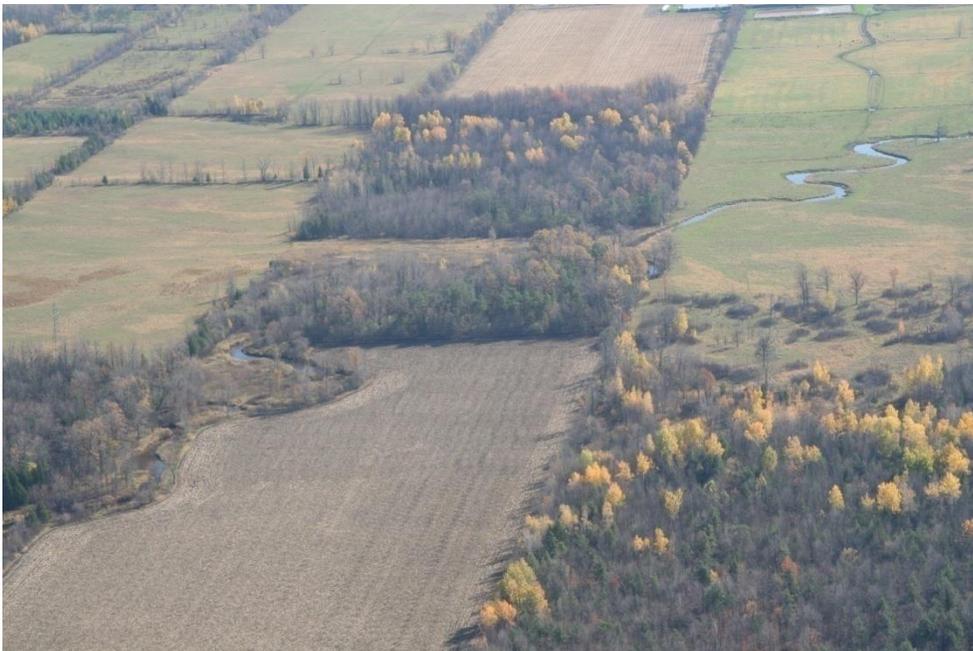
Photo 2. Hoasic Creek meandering through agricultural lands and segmented forests

In recognition of the dynamic properties of wetlands, minor fluctuations in size are expected over a number of years. Although Hoasic Creek is the major drainage system in the area, the physiographic characteristics of the region cause natural ponding and slow drainage. Wetlands play an important role in the hydrologic system as they hold water during times of high water levels and slowly release it during times of low flow, thus decreasing peak flows. The Geographical Information System modeling shows a slight increase in woodland cover from 1980-2008, which includes *swampy areas*, which by definition implies that the majority of unevaluated wetland areas are also woodlands. It may be argued that drainage issues from Hoasic Creek are causing greater areas to be flooded, including forests and agricultural areas outside the designated Provincially Significant Wetland boundary.

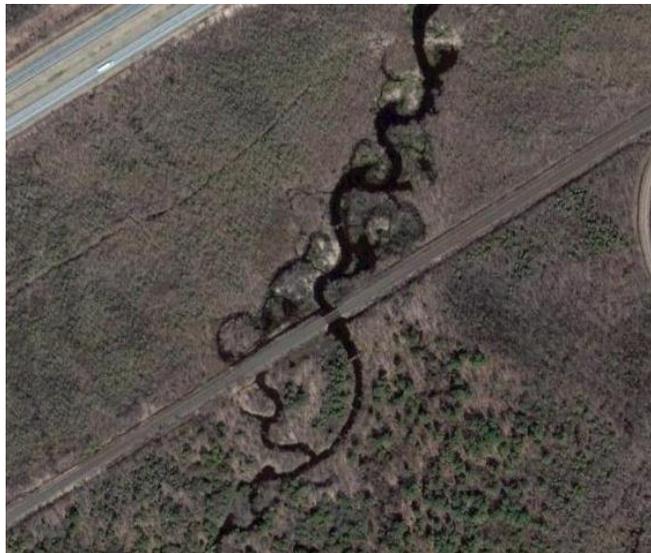
Photo 3. Hoasic Creek south of Highway 401 at CN Rail.

The relatively flat topography and many meanders throughout the system cause sediment build-up. Many of the larger sediment particles settle out of the watercourse and become embedded in the substrate, as there is insufficient energy in the current to move them. This feature seems to be evident in the creek south of the Highway 401 where old oxbow lakes can be seen where the creek has taken a new path (Photo 3).

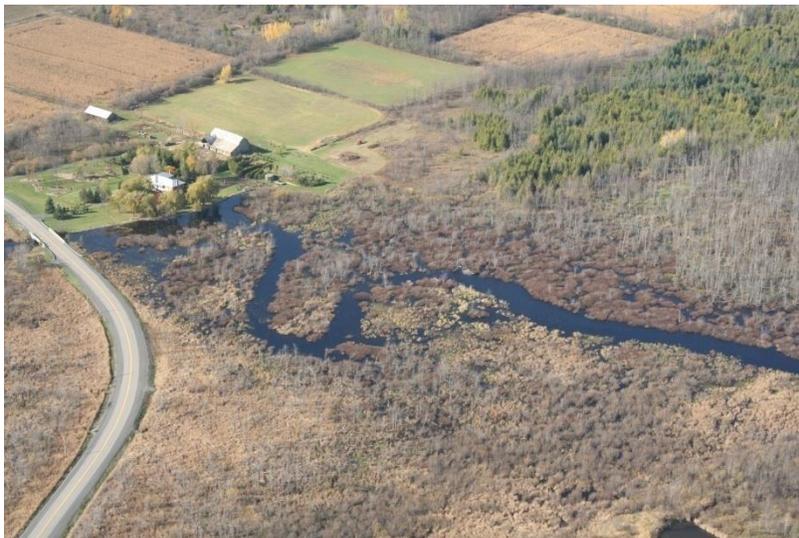
Photo 4. Hoasic Creek Wetland at County Road 18

Surface water levels did not vary a great deal at the County Road 18 location, as it is in the midst of the Hoasic Creek wetland (Photo 4). An anomaly at this site is the period of low water from mid-May to mid-June. A large rainfall on May 31st, 2009 seemed to have caused levels to somewhat increase, but the cause of low water levels in spring is unclear. A beaver dam has been located at the County Road 18 Bridge, but was removed in 2008, rebuilt in 2009, and removed by Township staff. This area continues to be affected by ongoing beaver activity.

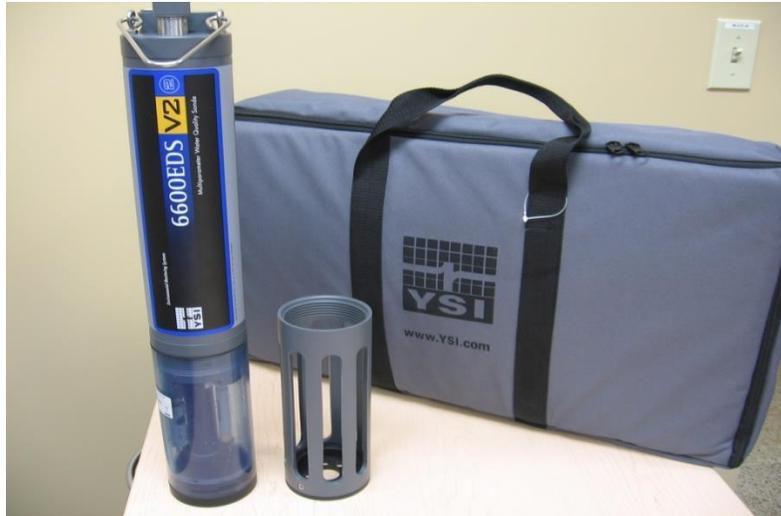
Photo 5. Equipment used for deployment of YSI Multi-parameter Water Quality Sonde Unit

Field sampling locations were selected to best meet project objectives for water quality/fisheries monitoring in Hoasic Creek. Station 1 at Highway 2 and Station 3 at Froatburn Road (Map 7) were selected to monitor upstream and downstream DO concentrations (mg/L). Permanent data loggers (YSI Multi-parameter Water Quality Sonde Unit) (Photo 5) were deployed in Hoasic Creek from September 3, 2009 to September 15, 2009 and June 20th to June 29th, respectively.

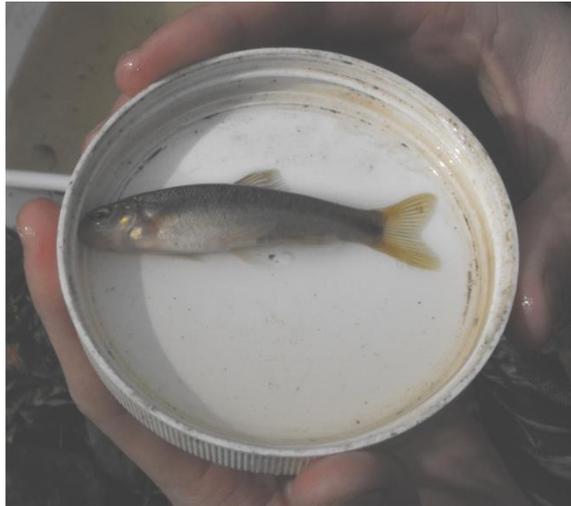
Photo 6. Cutlip Minnow found in Hoasic Creek during OSAP sampling.

A range of fish species were observed in Hoasic Creek from 1973 to 2009 (Table 12). The majority of species captured in Hoasic Creek in 2008 are not considered rare for the region. However, there are current and historic species which are both culturally significant and sensitive. These include the Northern Pike (*Esox lucius*), Yellow Perch (*Perca flavescens*), and Smallmouth Bass (*Micropterus dolomieu*). Additionally, the Cutlip Minnow (*Exoglossum maxillingua*) (a provincially threatened species at risk) was first documented in the Creek in 2008 (Photo 6). The species and its critical habitat are both protected in Ontario by the *Endangered Species Act* as well as the *Fisheries Act*. The main habitat requirements of this species include warm water, fine gravel for spawning and slow moving sections, all of which are fish habitat features in Hoasic Creek. Important findings from Station 1 included the previously unrecorded Largemouth Bass (*Micropterus salmoides*) and the re-confirmed presence of the Round Goby (*Neogobius melanostoma*). This is the second consecutive year that the Goby was recorded at this station suggesting that its population has established at the mouth of Hoasic Creek. A single Goby was captured in 2008 and two were recorded in 2009.
