SOUTH NATION
CONSERVATION
DE LA NATION SUD

Moose Creek Bioengineering Project

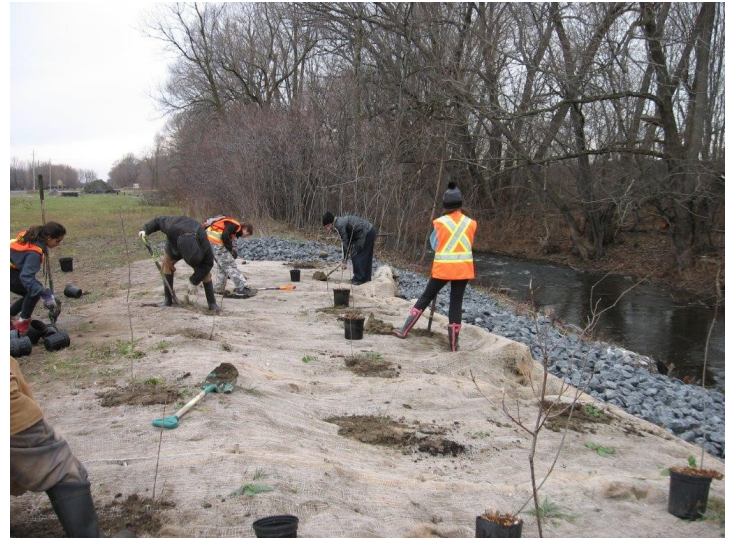
Tree Planting

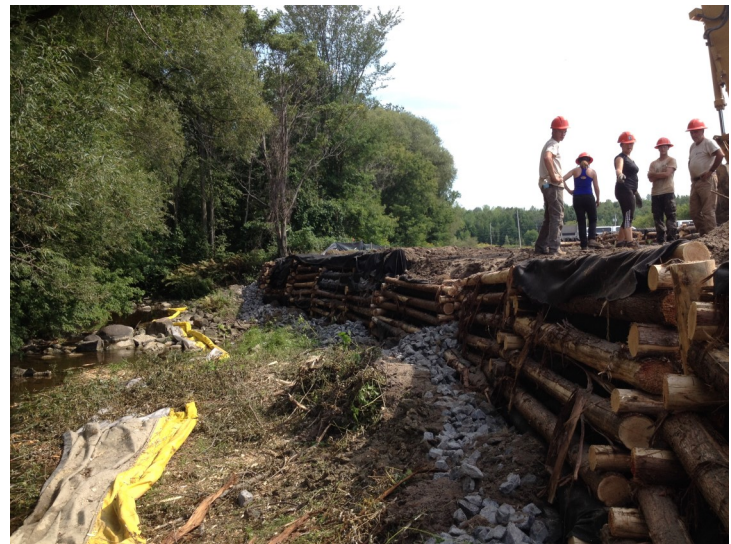
Newly constructed crib wall

The excavation began at the north end of the site and proceeded in a southerly direction. Once the excavated hole was large enough to be fitted with a crib, the heavy machinery operator would place the crib and then back-fill with Gabion stone and then top with soil. The soils were compacted and smoothed by the contractor and SNC staff placed coir geo-textile mats over top of the excavated soils to protect against wind and water erosion. The coir mats also helped to prevent any shifting of soils; although soils will continue to settle for quite some time afterwards. In total, 19 cribs were installed to complete the bank stabilization project. Volunteers including, local high school students and landowners helped plant the native trees and shrubs.
