**GEOLOGICAL SURVEY OF CANADA
MISCELLANEOUS REPORT 56**

The Lemieux landslide of June 20, 1993, South Nation Valley, southeastern Ontario - a photographic record

G.R. Brooks, J.M. Aylsworth, S.G. Evans, and D.E. Lawrence

1994

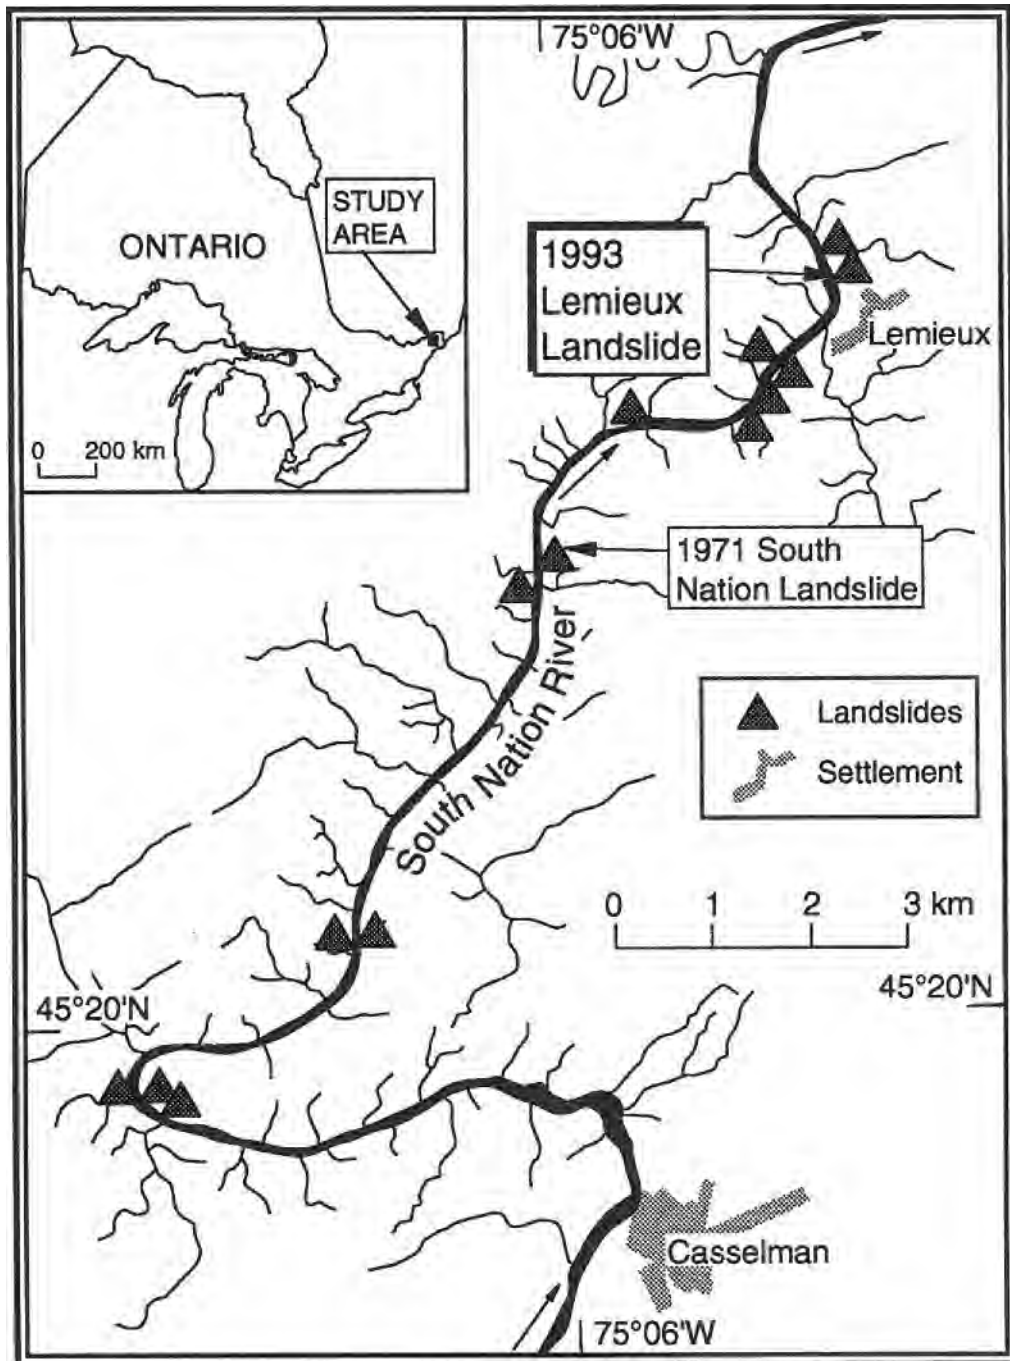
Figure I. The June 20, 1993 landslide is located beside the former townsite of Lemieux, Ontario, 50 km east of Ottawa. The Lemieux landslide is the most recent of a long series of sensitive clay flows and retrogressive slides that have occurred along the Casselman-Lemieux reach of South Nation Valley (modified after Richard, 1982).
