An earthflow in sensitive Champlain Sea sediments at Lemieux, Ontario, June 20, 1993, and its impact on the South Nation River^s

S.G. EVANS AND G.R. BROOKS

Geological Survey of Canada, 601 Booth Street, Ottawa, ON K1A 0E8, Canada

Can. Geotech. J. 31, 384-394 (1994)

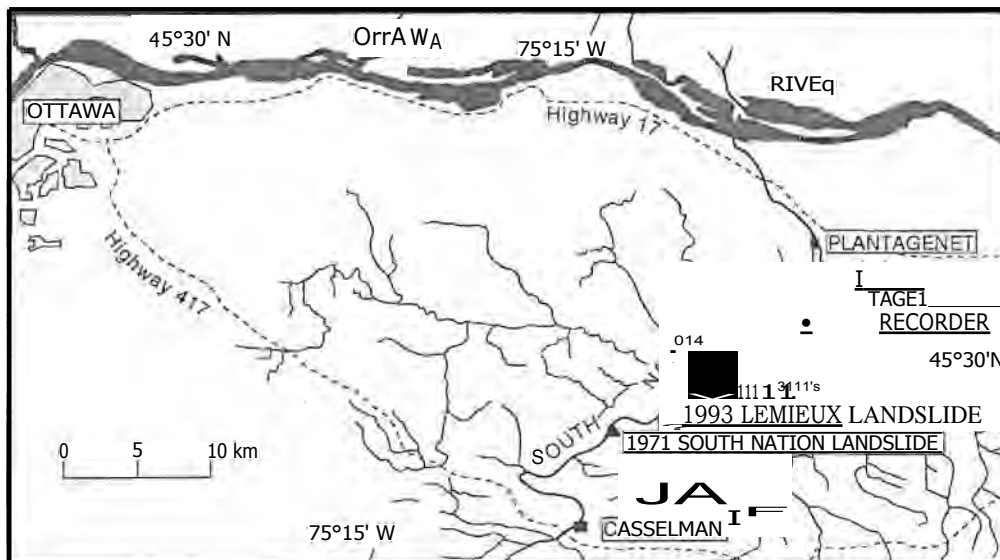
The debris dammed the South Nation River, causing flooding upstream. In addition, when the river overtopped the debris dam 3 days later, it adversely affected water quality for agricultural and domestic use downstream. Trees washed out of the debris were also a hazard to boaters along both the South Nation and Ottawa rivers.

FIG. 1. Aerial view of the 1993 Lemieux landslide which took place on June 20, 1993. View is toward the southwest looking up the South Nation River. Severed County Road 16 is seen at bottom left and County Road 8 bridge discussed in text is seen upstream of the landslide in the middle distance. Note impoundment of river and upstream flooding. Photo taken on June 23, 1993.
